ANNUAL REPORT OF THE MINISTER OF MINES

THE NATAL SLIDE OF NOVEMBER 24th 1968

## THE NATAL SLIDE

By K. E. Northcote

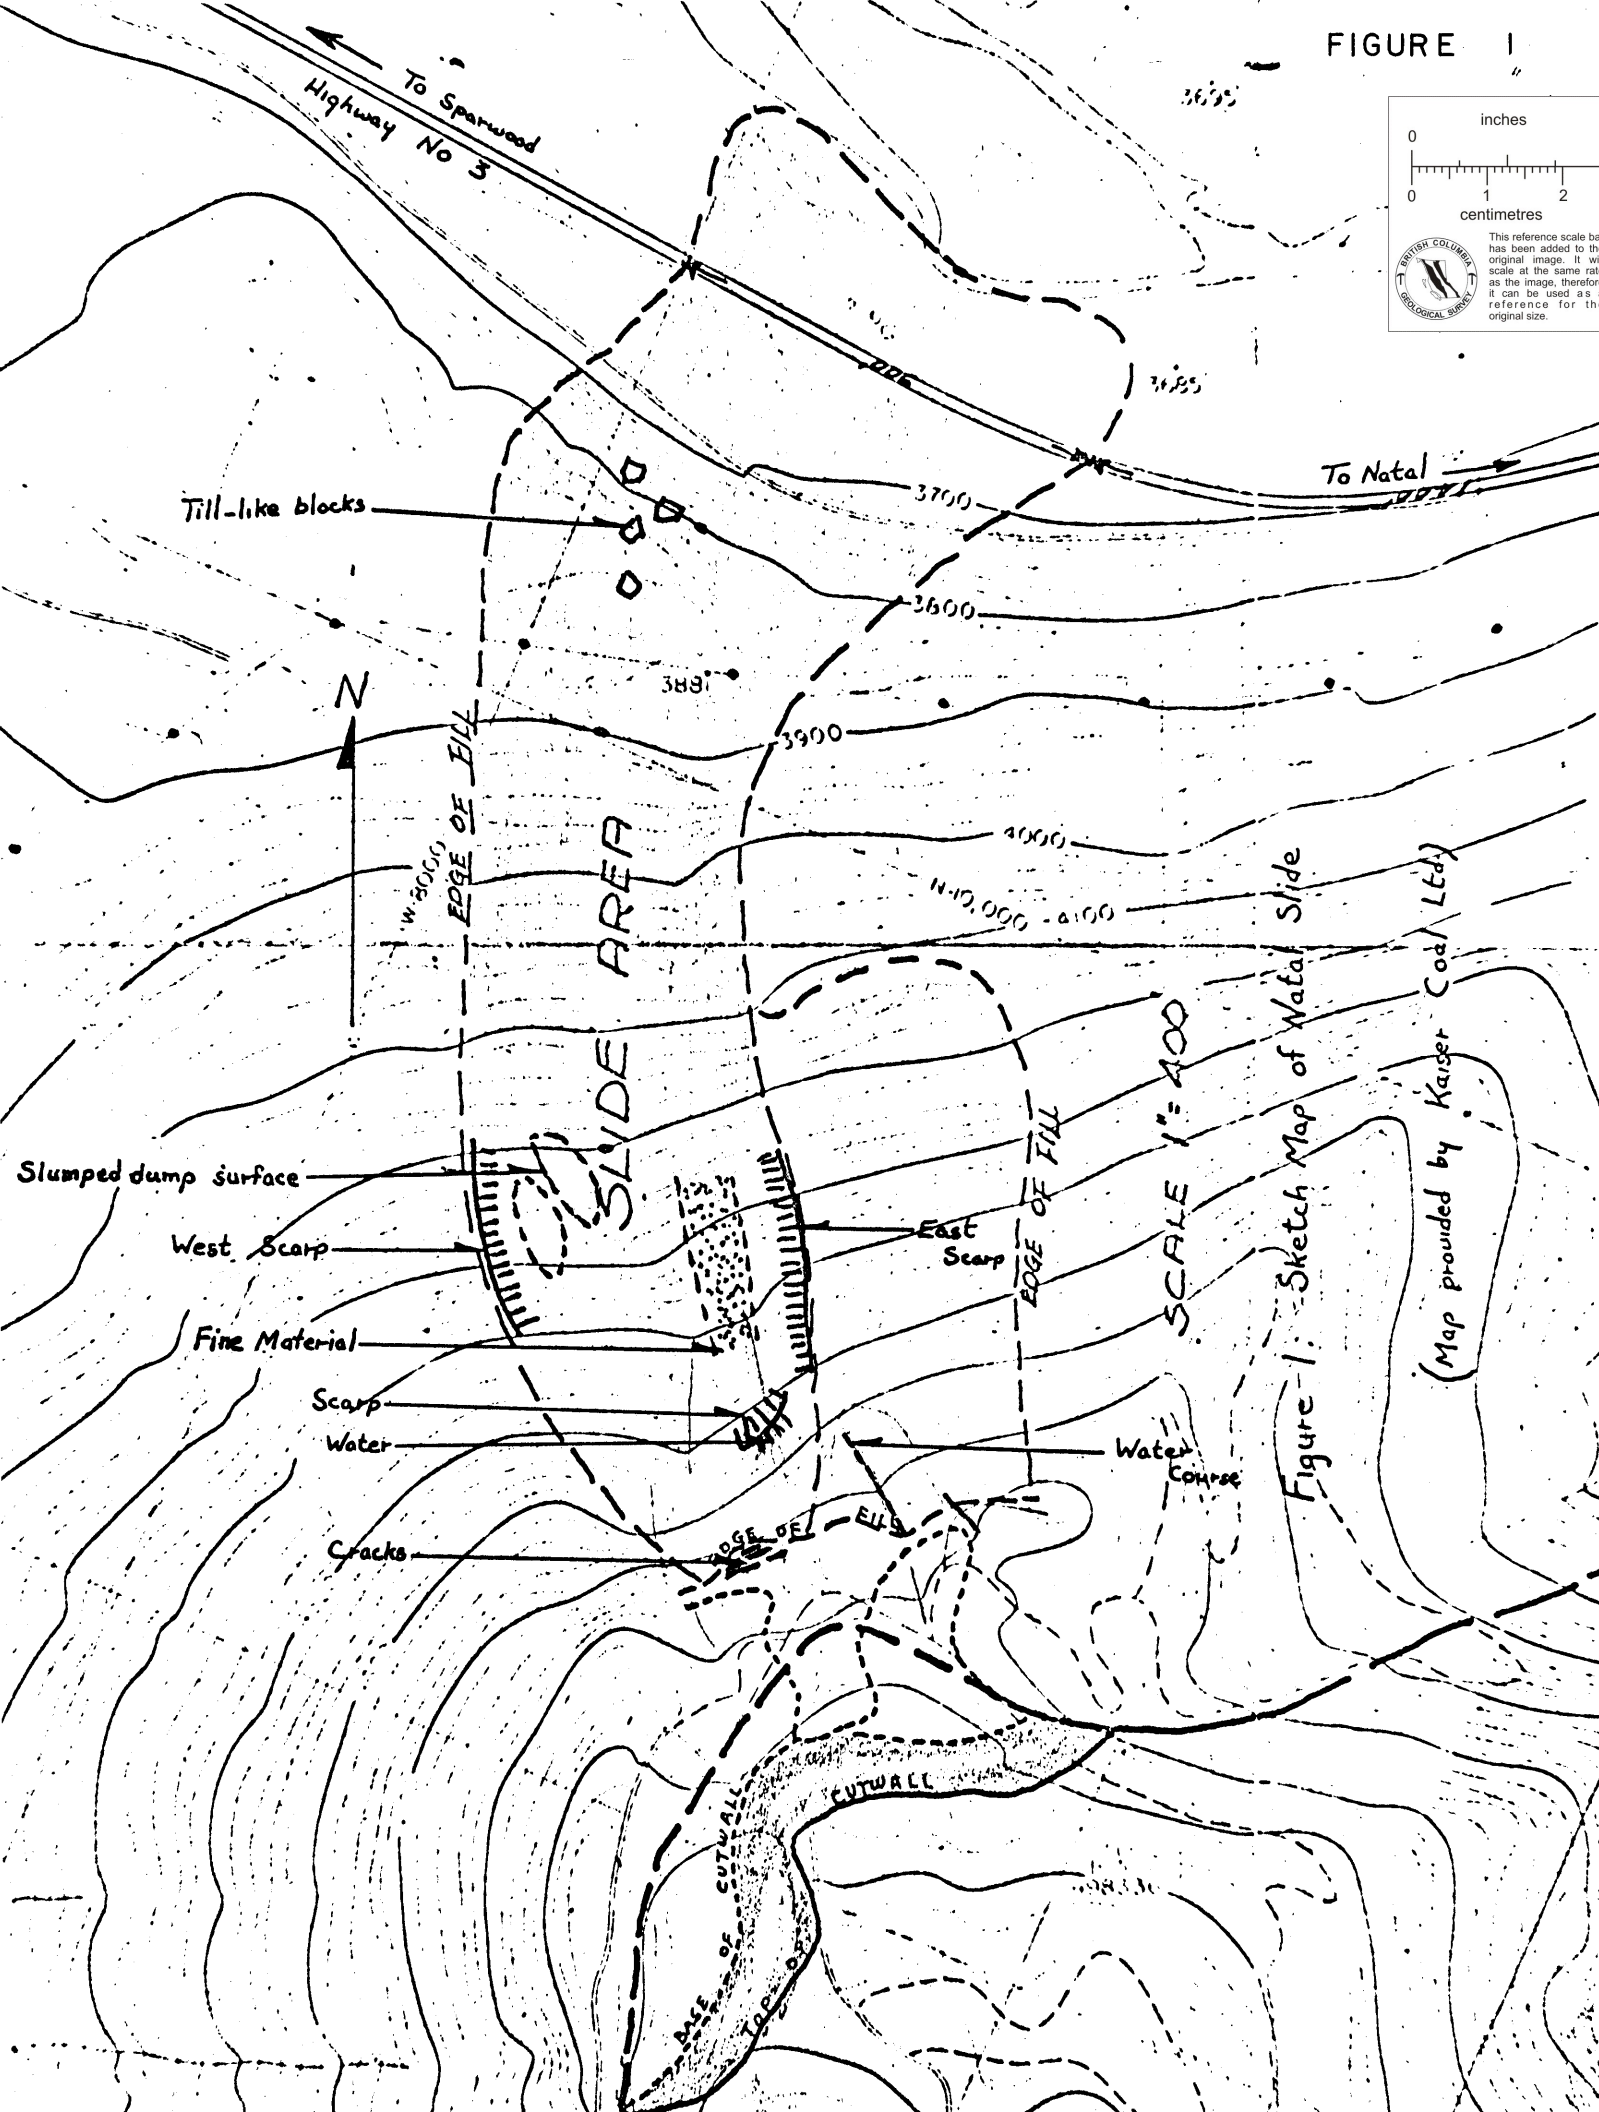
Figure 1: Sketch Map of Natal Slide

The slide material consists mostly of blocks of cobble and boulder-size bedrock stripped off Balmer No. 10 coal seam at 4,900 feet elevation on the north end of Sparwood Ridge (see Fig. 1). A small part of the slide material consists of overburden stripped off the Kootenay Formation during mining, material underlying the dump, and surface material torn from the hillside by the slide. The slide debris originating from the Kootenay Formation is composed of siltstone, sandstone, shale, and a minor amount of coal and carbonaceous shale. Overburden visible in the slide

Small scarps from 10 to 30 feet high were formed at the head of the slide and on its east and west sides at elevation 4,400 to 4,500 feet (see Fig. 1). The scarp on the west side of the slide is composed of oxidized till-like material with an abundantly sandy matrix containing scattered angular rock fragments of pebble to boulder size. This till-like material forms surface material of the original hillside on which the stripping waste was dumped. A close inspection was not made of the scarps on the east side and near the head of the slide for reasons of personal safety as loose material was still falling

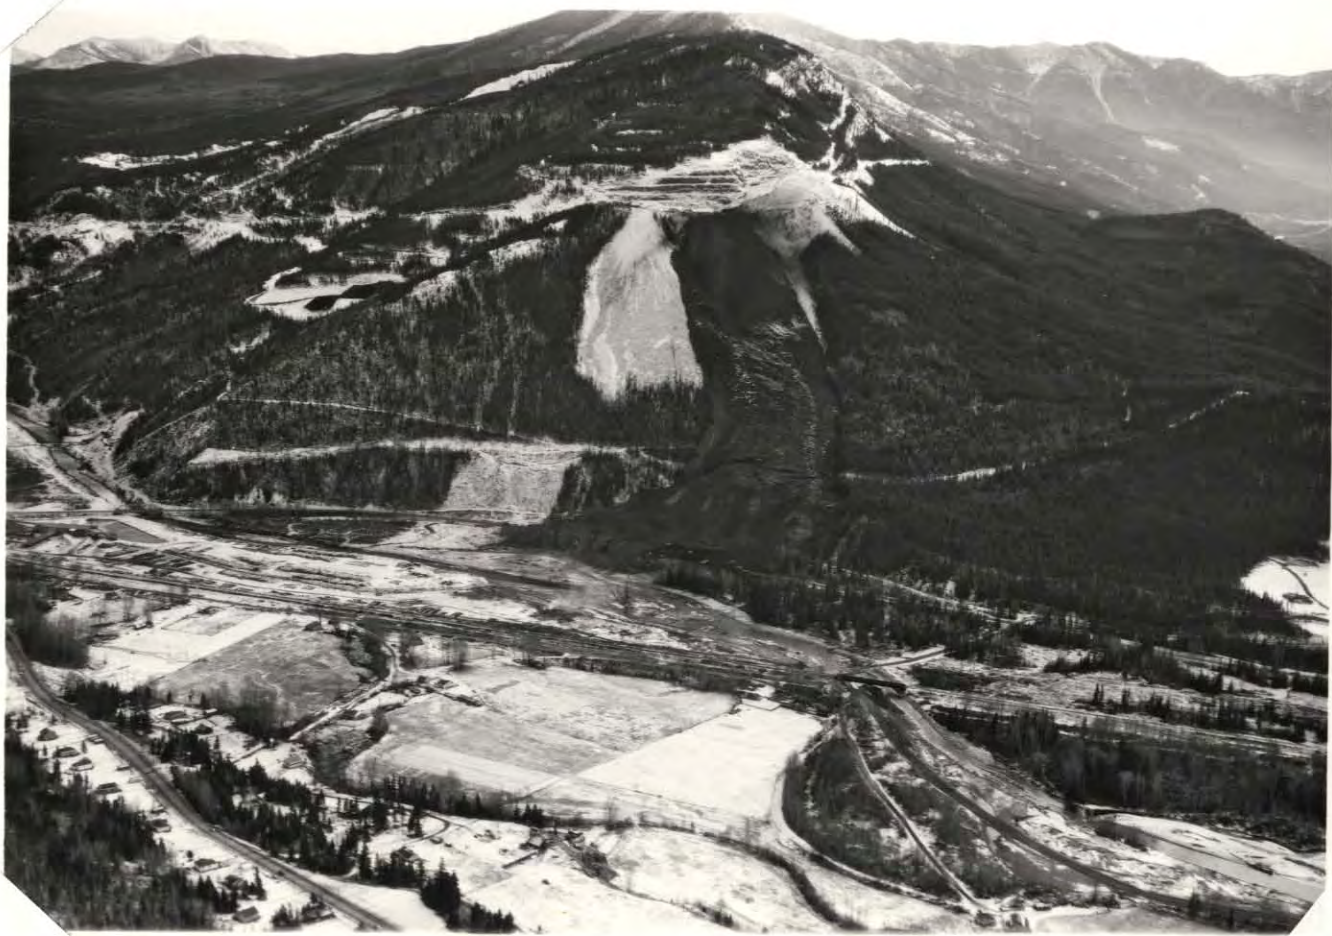
PLATE I.--Natal Slide, Sunday, November 24, 1968.

A slide occurred at about 11:30 A.M., Sunday, November 24, 1968, on the south side of Michel Creek valley between Sparwood and Natal. At least two persons were killed. The slide originated within and beneath waste rock dumped at elevation 4,800 feet on the north end of Sparwood Ridge (see Fig. 1 and Plates I to III and V to VII). The waste material was being removed from one of Kaiser Coal Ltd.'s open-pit mining operations. A consulting engineer, C. O. Brawner, is investigating the slide for Kaiser.

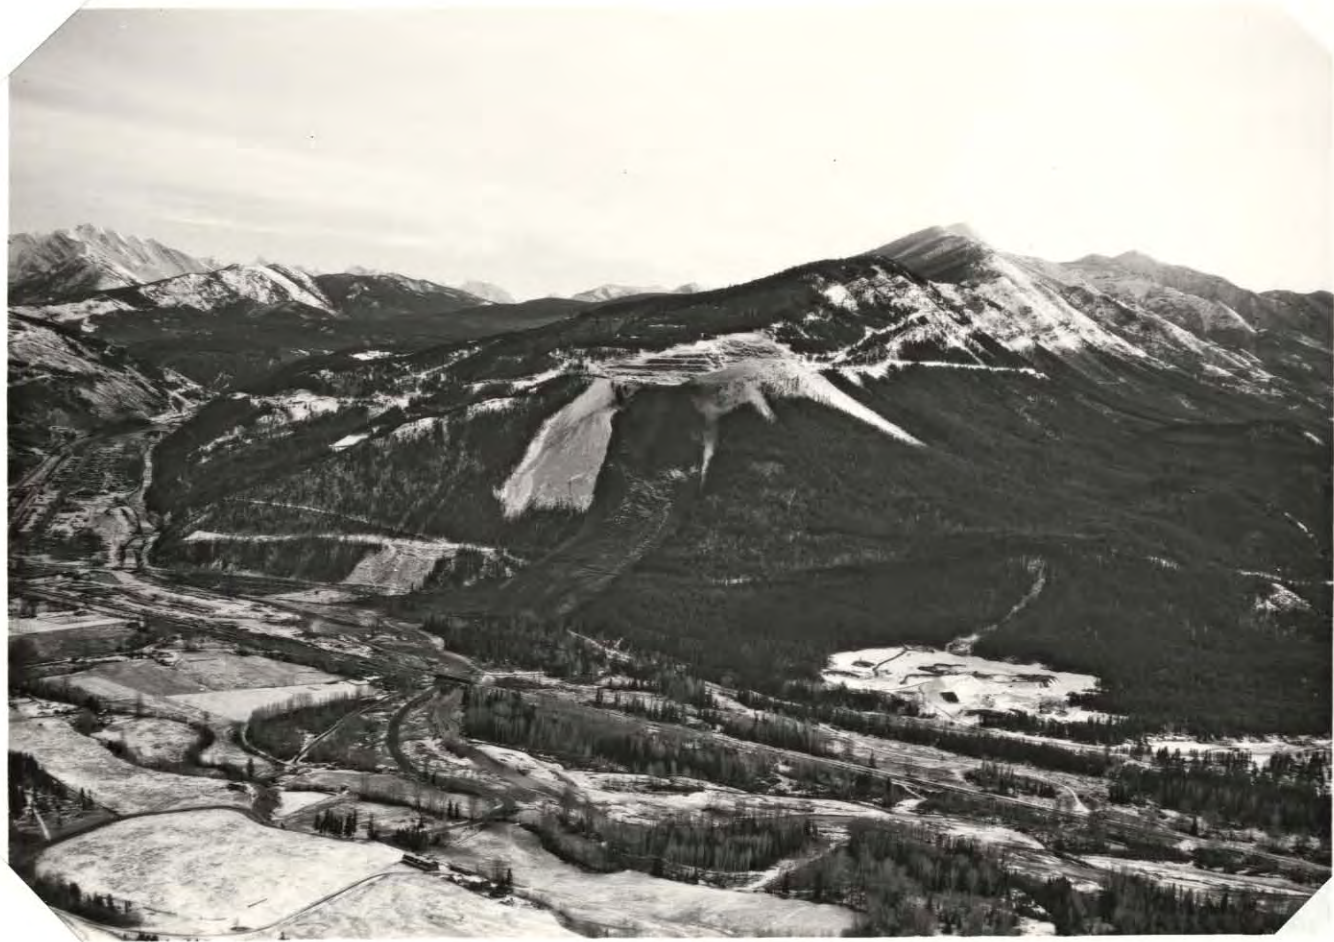
PLATE II.--Natal Slide; town of Michel in Michel Creek valley on left.

The slide area extends from 4,700 feet to 3,700 feet elevation, is 3,200 feet long, and averages 600 feet wide. Highway No. 3 was covered for a length of 900 feet by slide debris said to be from 5 to 40 feet deep. Surface material on the hillside, a marshy area above the highway, and several hundred feet of pavement were torn up. A car containing the bodies of two people was found under slide debris about 100 feet from the west side of the slide.

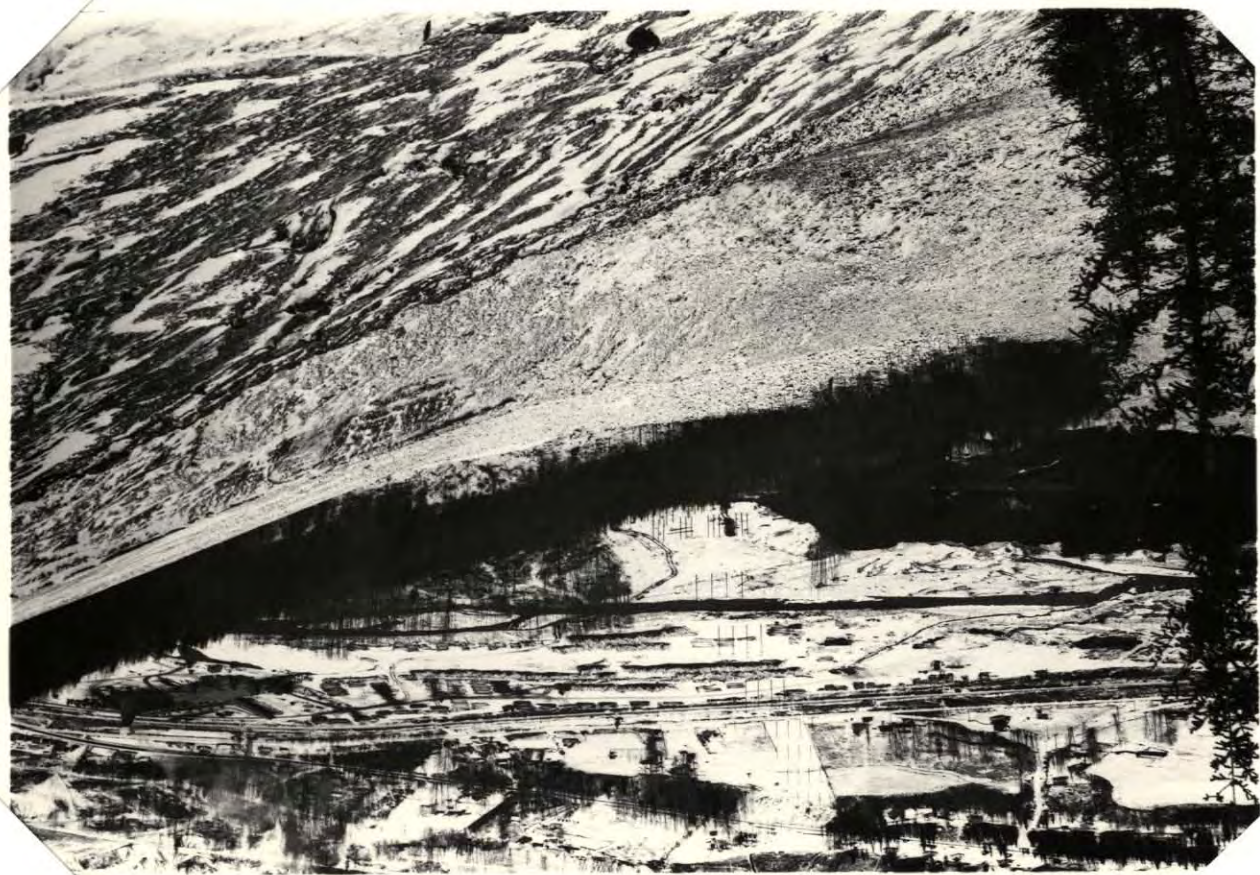
PLATE III.--View showing stratified scarp on east side of slide.

from the head of the slide. However, through field glasses from a point more than half way across the slide, the scarp at the head of the slide appeared to be composed of fine-grained material containing scattered subangular boulders and cobbles. The impermeable nature of this material is shown by a small spring and four or five water trickles emerging near the top of the scarp and flowing over its face. This scarp is probably composed of original overburden. A photograph (see Plate III) shows stratification of the upper part of the east scarp and indicates that at least this part is waste dump material. The lower part of the east scarp may be original ground surface material but this is not definitely known.

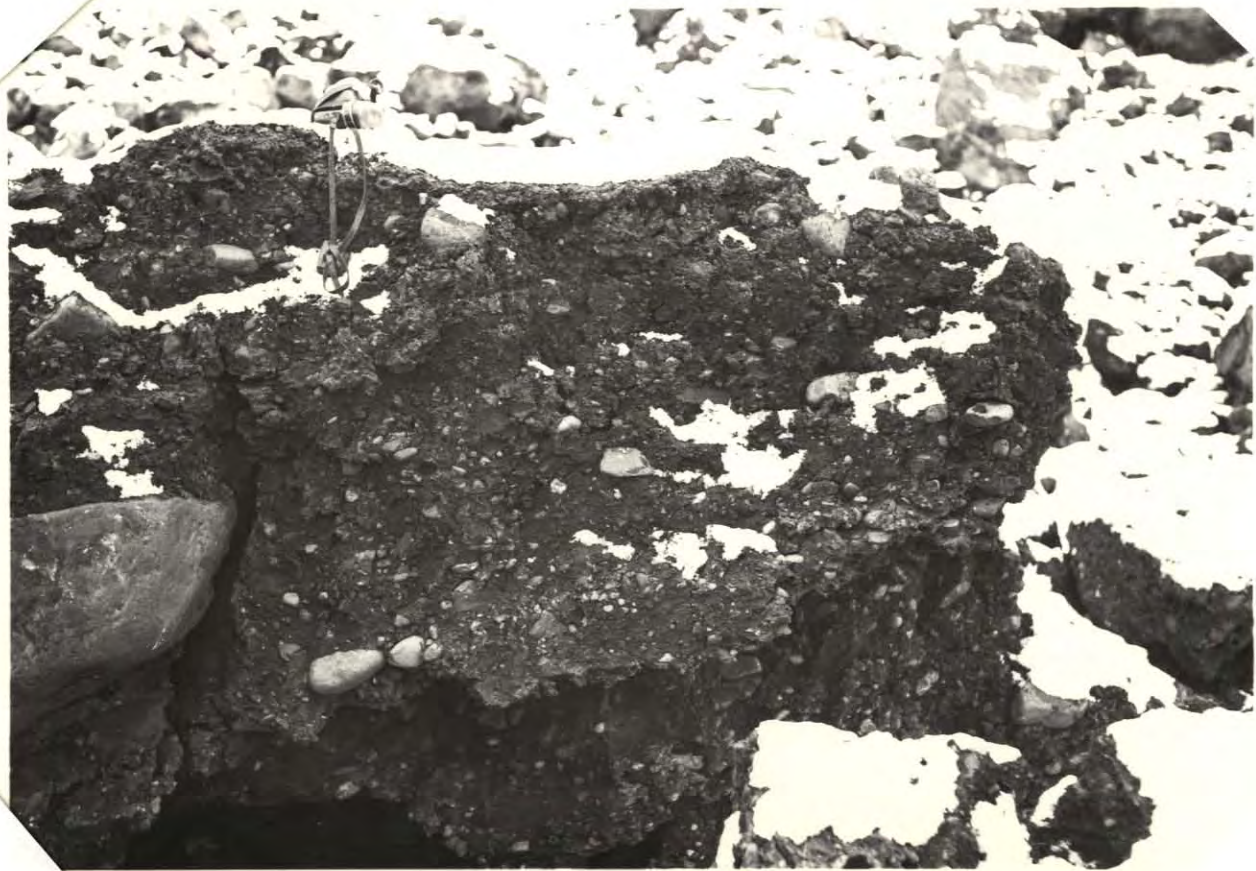
PLATE IV.--Stratified till-like material.

debris is largely stratified till-like material containing rounded cobbles and boulders in a clayey or sandy matrix. Muddy material, believed to have been torn from a marsh above the highway, is found near the bottom of the slide.

- (2) Overburden underlying the waste dumps may have been overloaded resulting in failure. C. O. Brawner suggested that dump material was too porous for water to be the sole cause of the Natal slide. He suggests the slide originated by failure of underlying till-like material as a result of overloading by the waste dumps. In addition a build-up of pore pressure and loss of cohesion in this material would contribute to failure. Dry till-like material with a clayey matrix when moistened would act as a lubricated surface and the material with a sandy matrix when saturated would have little strength to withstand load pressure.

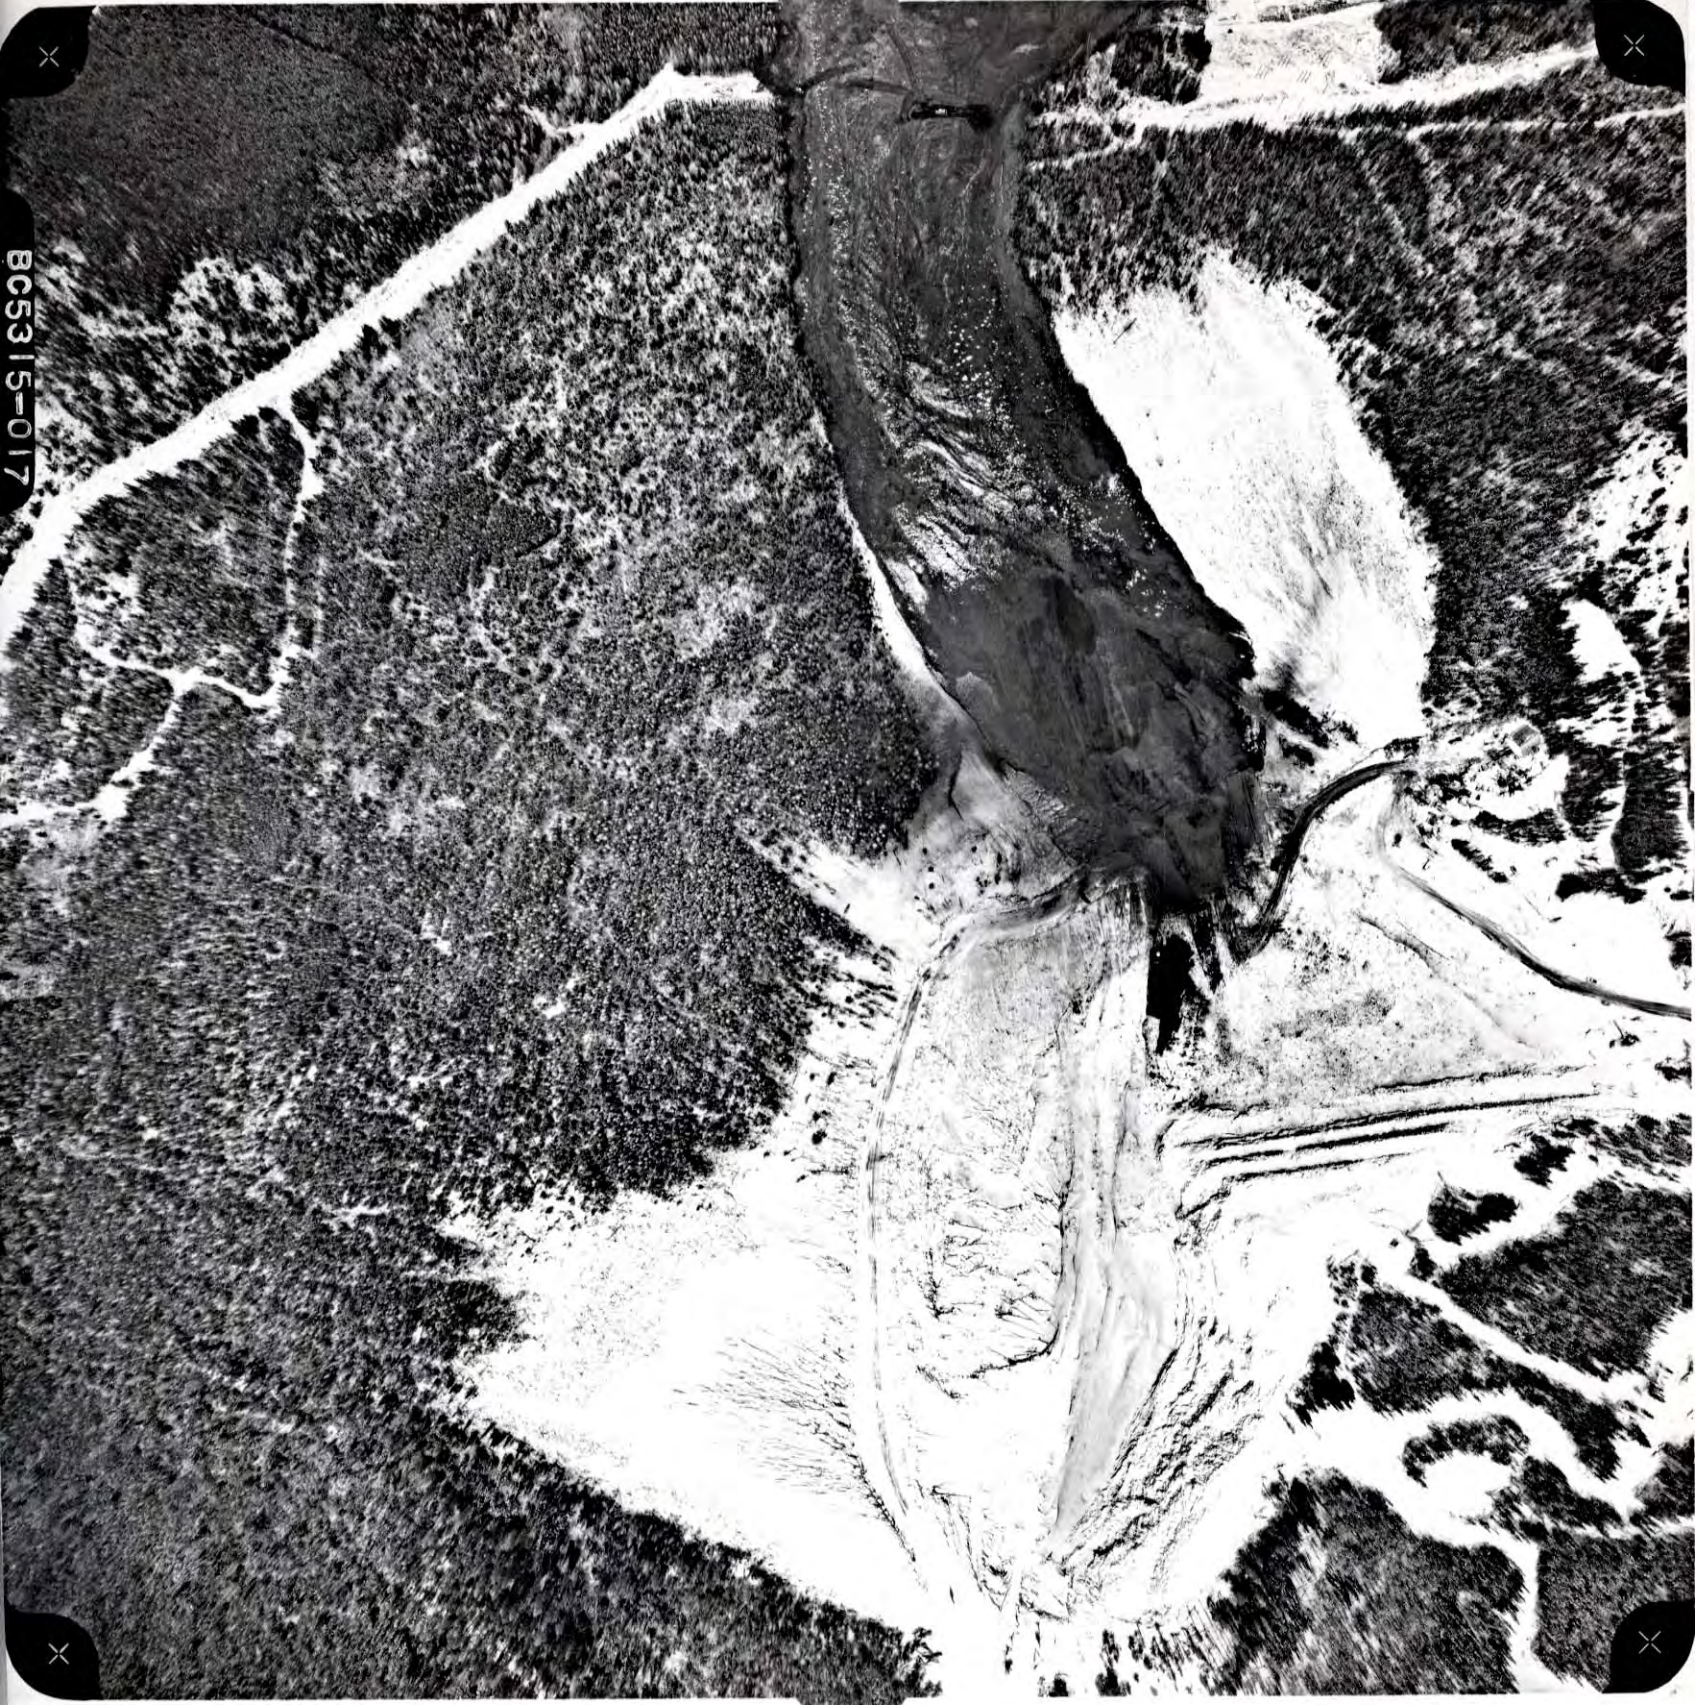
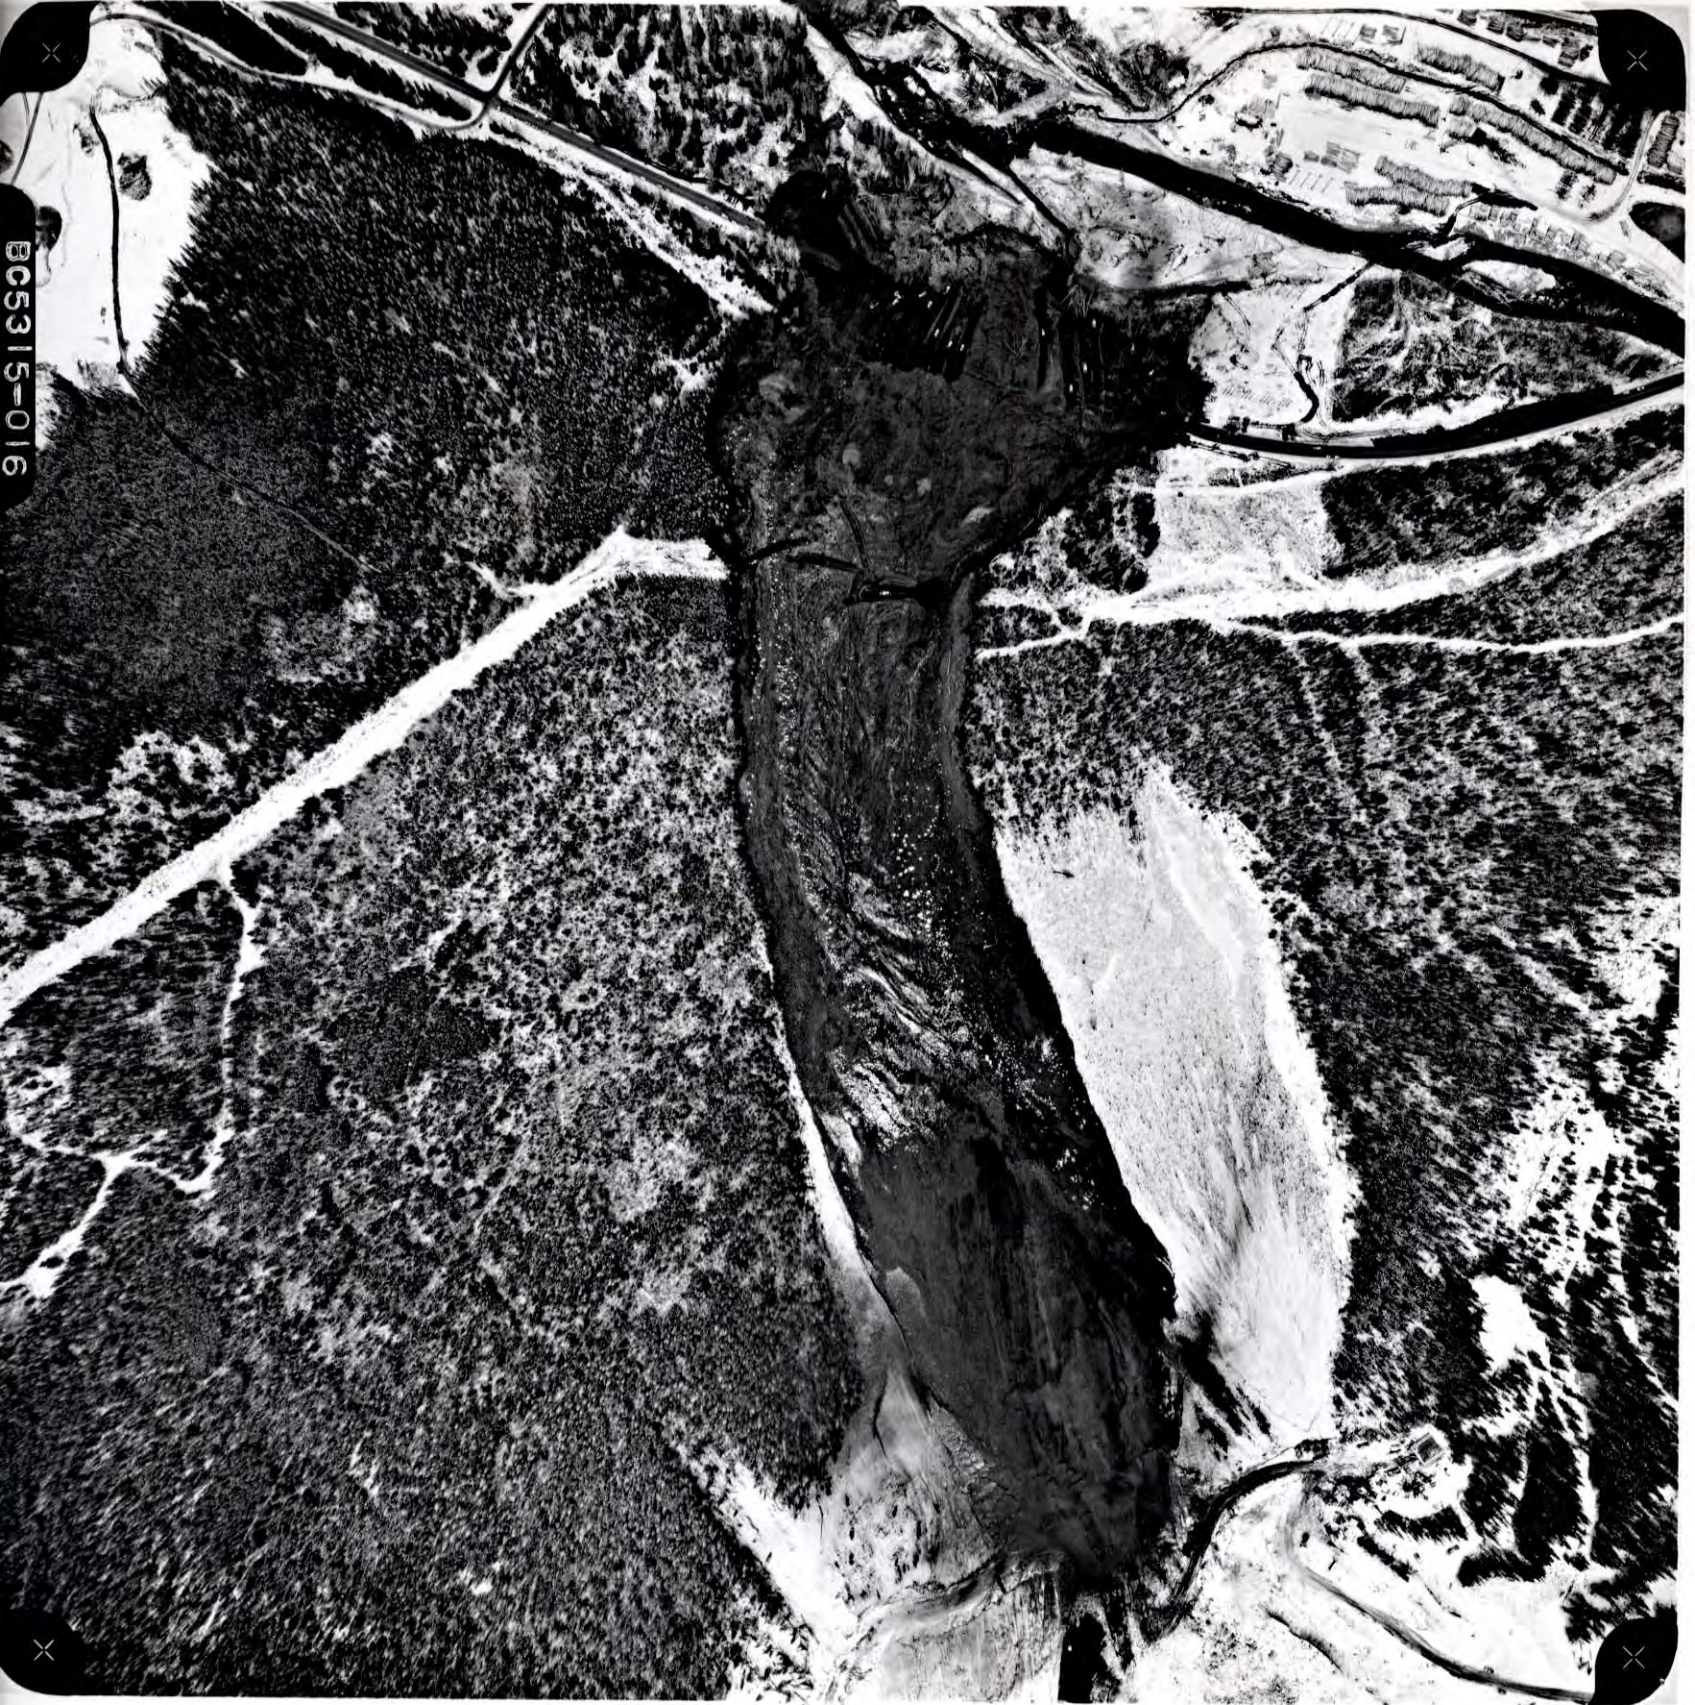
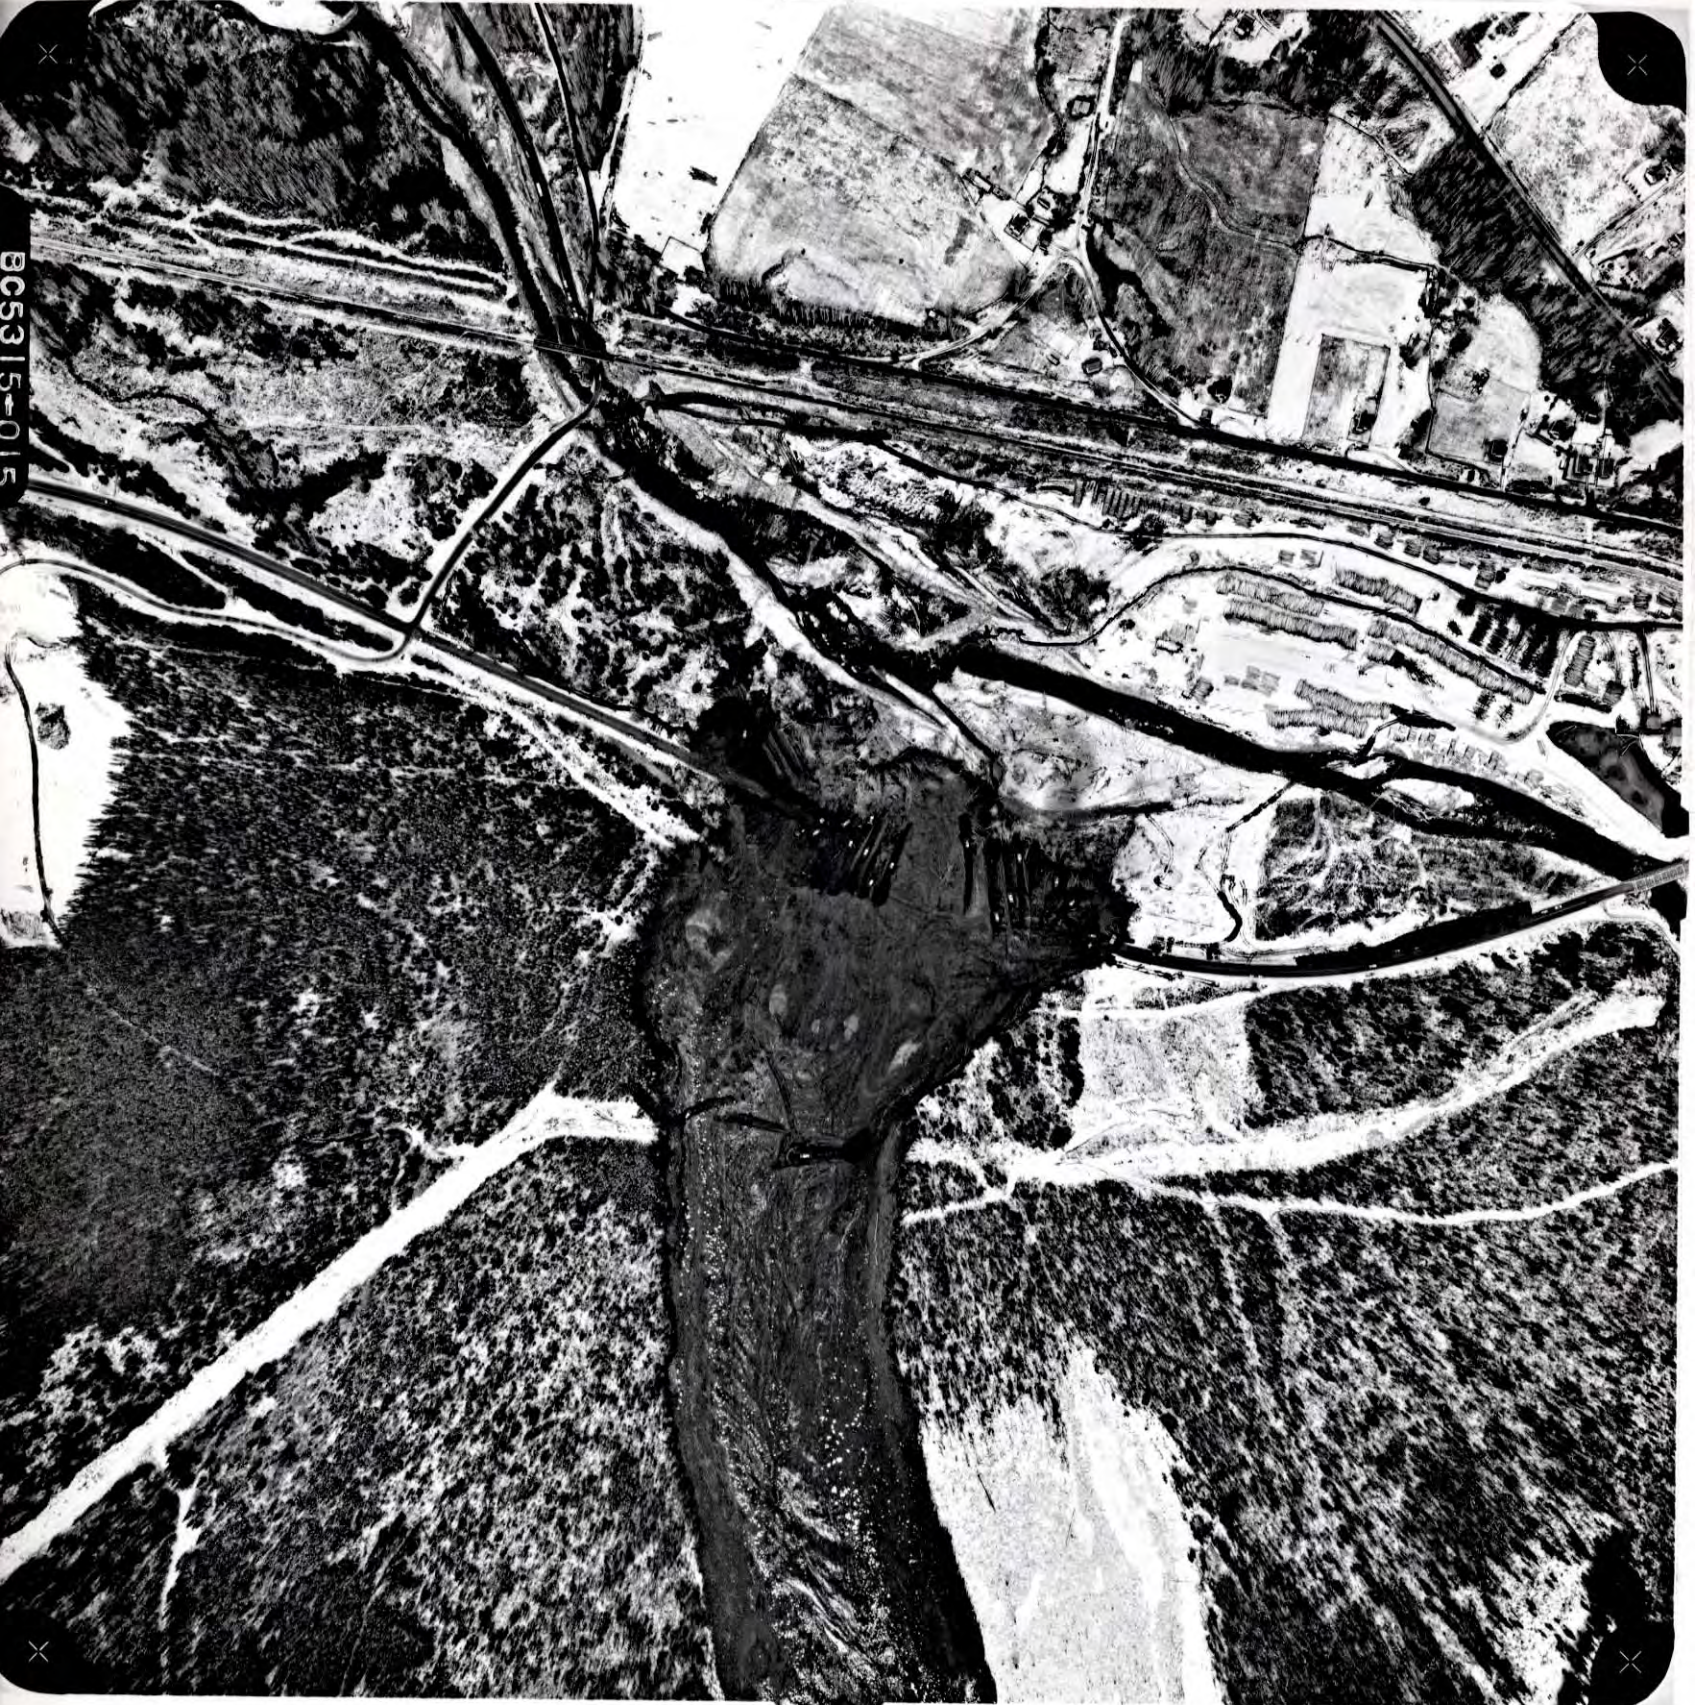
- (c) The air crew photographing the slide noted two inverted V-shaped cracks on the surface of the east dump. These cracks are visible on photographs (see Plates V to VII). C. O. Brawner considered these cracks to present no hazard.
