REPORT ON THE CLOSING OF THE
JORDAN RIVER MINE
OF
SUNRO MINES LIMITED

REPORT ON THE CLOSING OF THE
JORDON RIVER MINE
OF
SUNRO MINES LTD.

A.J. RICHARDSON
CENTRAL MINE ENGINEERING

June 1977

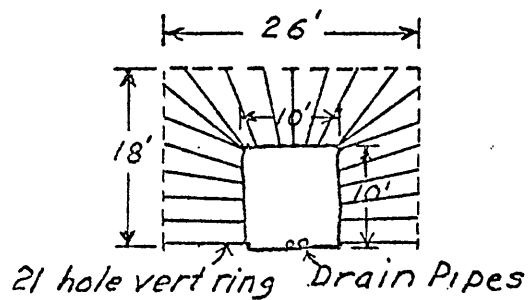
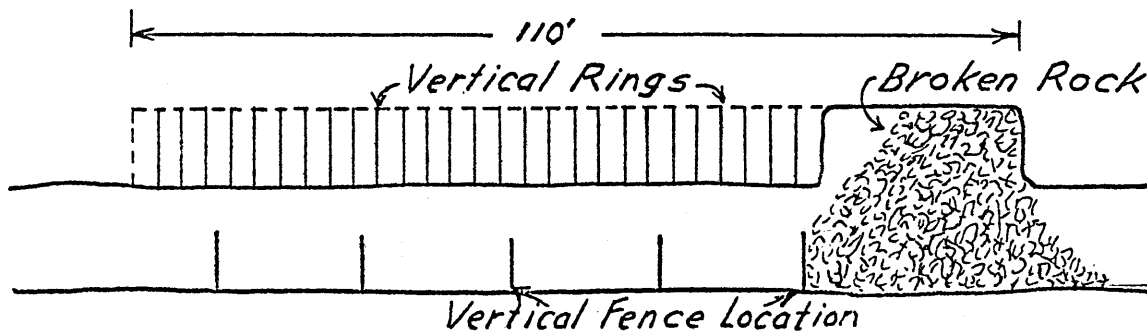
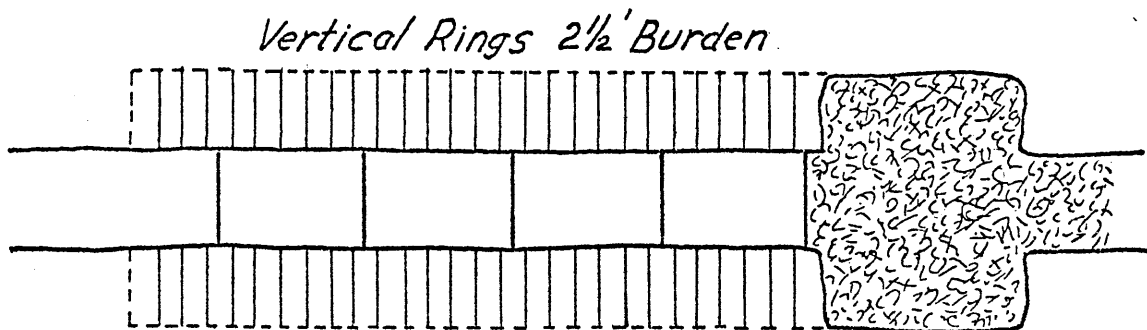
CHOKE BLASTED ROCK PLUG AT PORTAL +6700'

The 5100 level cross section is approximately 10 feet by 10 feet and it was agreed that the back and sides should be broken out an additional 8 feet in order to provide the necessary swell to plug the void. The initial slot was started in a widened out section of the level about 20 feet ahead of the normal cross section. This proved to be fortunate because it took several combinations of hole spacing and ring burden to determine the optimum pattern for breaking the ground with vertical rings. Some redrilling and blasting of the slot was required and by the time this was complete the broken muck was tending to flood back and bury the lower side holes of unblasted rings. To stop this a 6 foot vertical timber fence was constructed between the last ring of one blast and the first ring of the next blast. Burden between rings was 2 1/2 feet. Each

ring consisted of 21 holes, seven in each side and seven across the back. The side holes were drilled with a jackleg and the back holes with a stoper. When 12 such rings were drilled off then six were blasted at once using 10 foot tape fuse and thermalite igniter cord. Explosive was CIL 75% Cilgel. Before each blast, a 6 inch and a 4 inch drainline was connected and laid between the rails and covered with old plank and loose rock. Despite the fact that the pipe was of old lightwall construction it provided necessary drainage up to the last blast when it was abandoned.
