Subject: P.4287A - B.C. Museum of Mining
Concentrator Mill Building
Capital Cost Estimate Update

REPORT ON STUDY OF THE
EXISTING CONCENTRATOR MILL BUILDING
AT BRITANNIA BEACH, B.C.

PREPARED BY:
JOHN IDIENS, P.ENG.
JUNE 15, 1982

STUDY OF THE EXISTING CONCENTRATOR MILL BUILDING AT BRITANNIA BEACH, BC

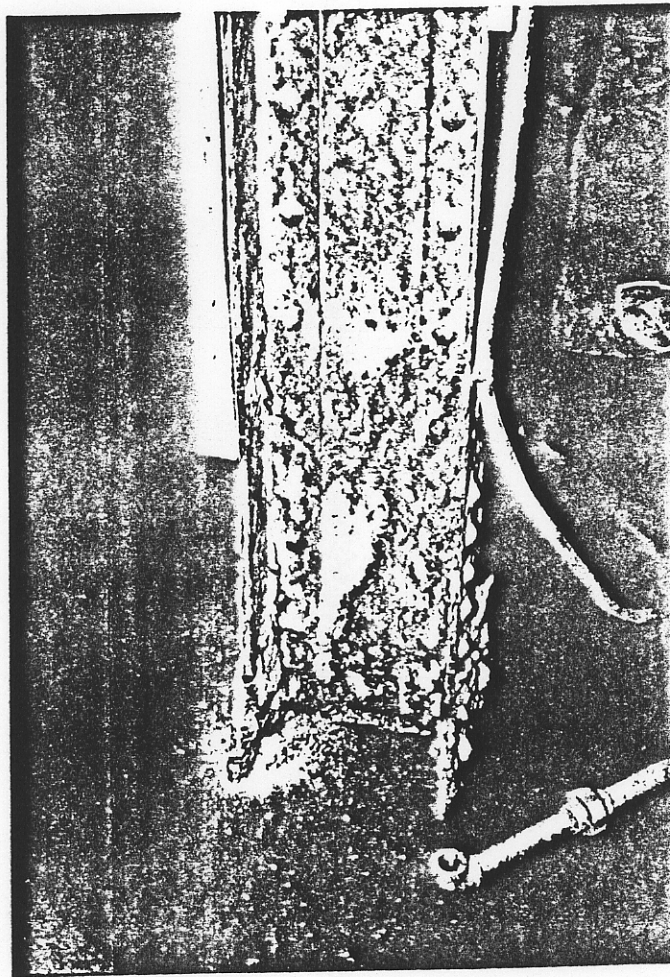
FIGURE 1

The steel purlins, trusses and roof bracing are in fair to good condition. However, there appears to be very little paint left on any of the members in the building. Most surfaces are covered with a thin layer of mill scale, whereas in a few areas a thicker layer of mill scale and some rusting are present. The presence of mill scale and rusting become more apparent as one proceeds from roof to ground. The only place where excessive corrosion has taken place is at the lower 3 to 5 feet of columns, most of which are located on the lower levels. (See figure 1)

It is estimated that 40 to 60 corroded column bases should be repaired. This can be accomplished by strengthening the lower portion of the column with steel. Perhaps an easier method would be to pour a concrete pedestal around the steel column to some predetermined height, depending on the extent of the corrosion. Any bent truss chord members, bracing struts and crimped column flanges should be repaired.

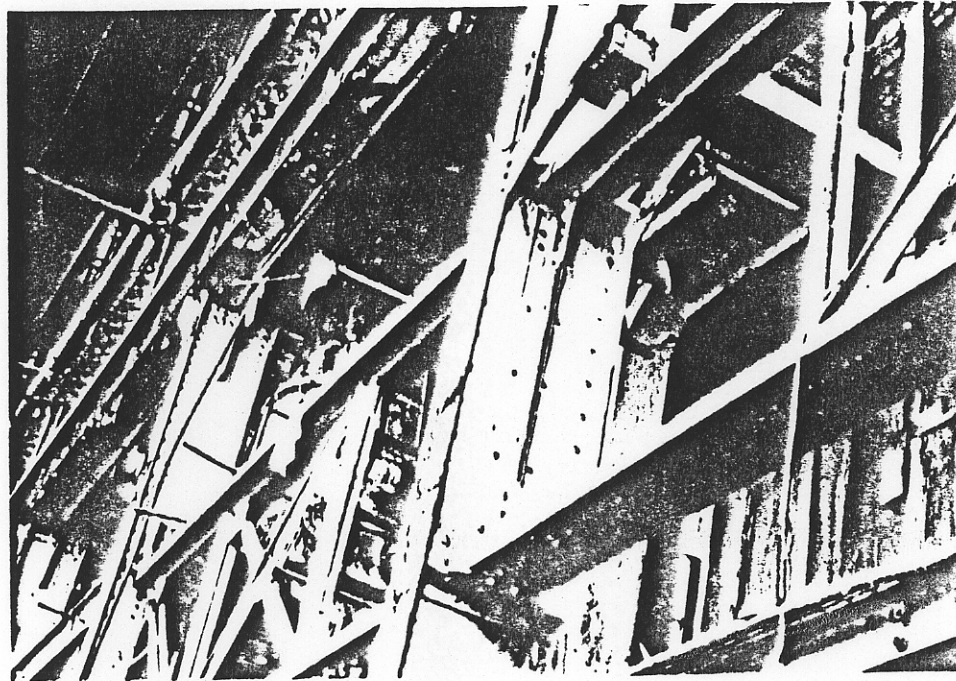
FIGURE 2

Several panels of cross bracing have been removed from the column lines. Some web members have been removed from the vertical trusses employed to stiffen the structure each side of the crane bays (see figure 2). On the front wall three bays of wall girts have been removed in order to provide access to a building addition on the north side.

All bracing members which have been removed should be replaced. This includes cross-bracing between the columns as well as web members in the vertical trusses each side of the crane bays.

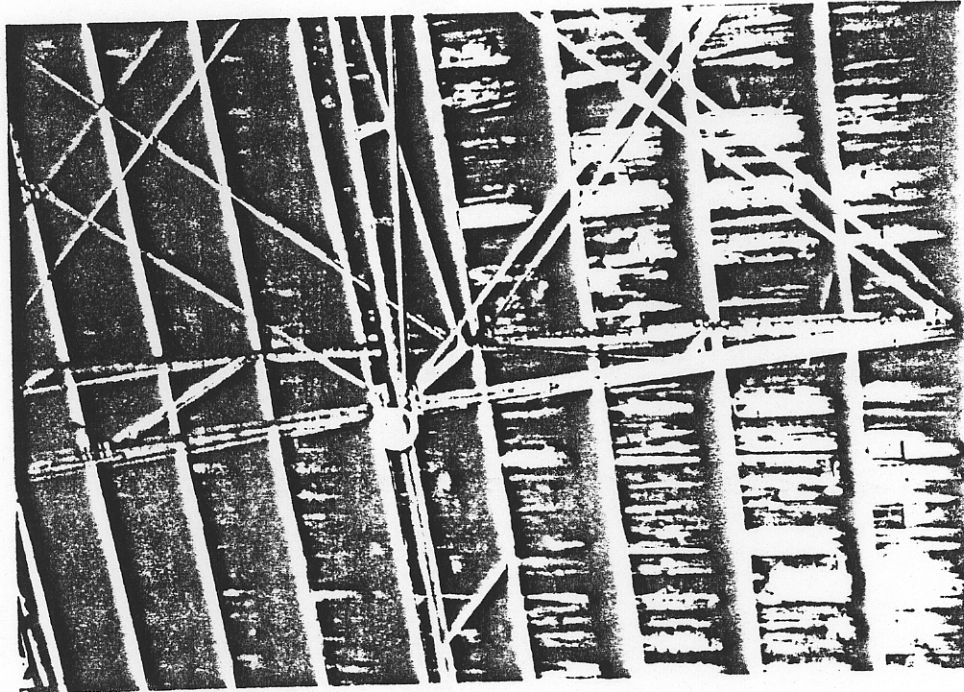
FIGURE 3

The 2" timber decking is generally in good condition. (See figure 3) Even though certain areas were wet from the roof leaking above, no sign of significant deterioration of the wood was present. The deck is badly discoloured in certain areas, probably due to action of chemicals emitted during the mineral processing. The asphalt shingles are approximately ten years old. No close examination was made owing to the difficulty of access to the roof; however, it is clear that certain areas of roofing and/or flashings are leaking due to the presence of moisture under the timber decking. The gutters remaining on the eaves are in poor condition.

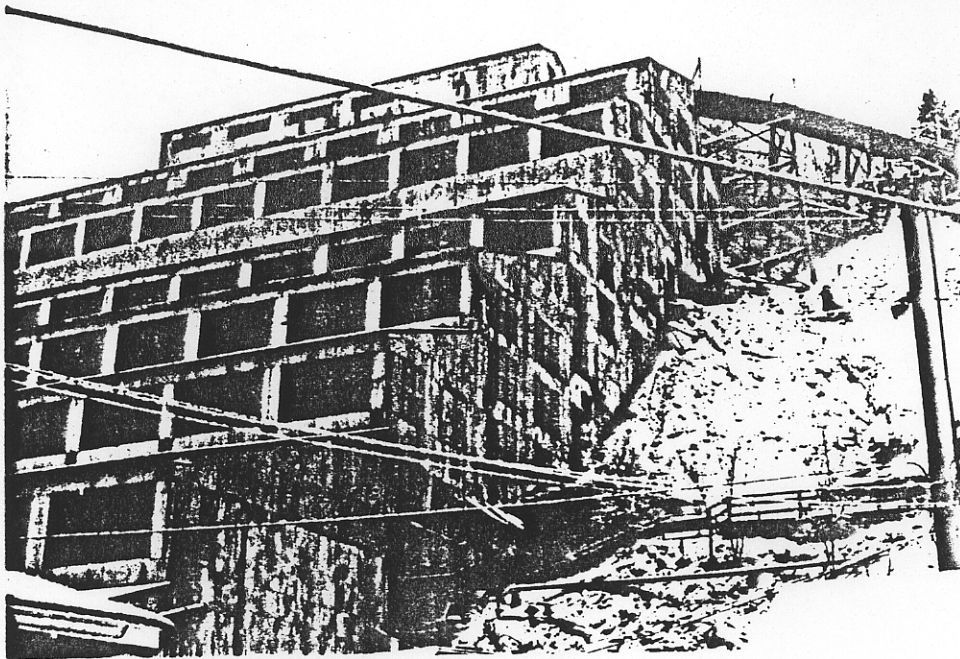
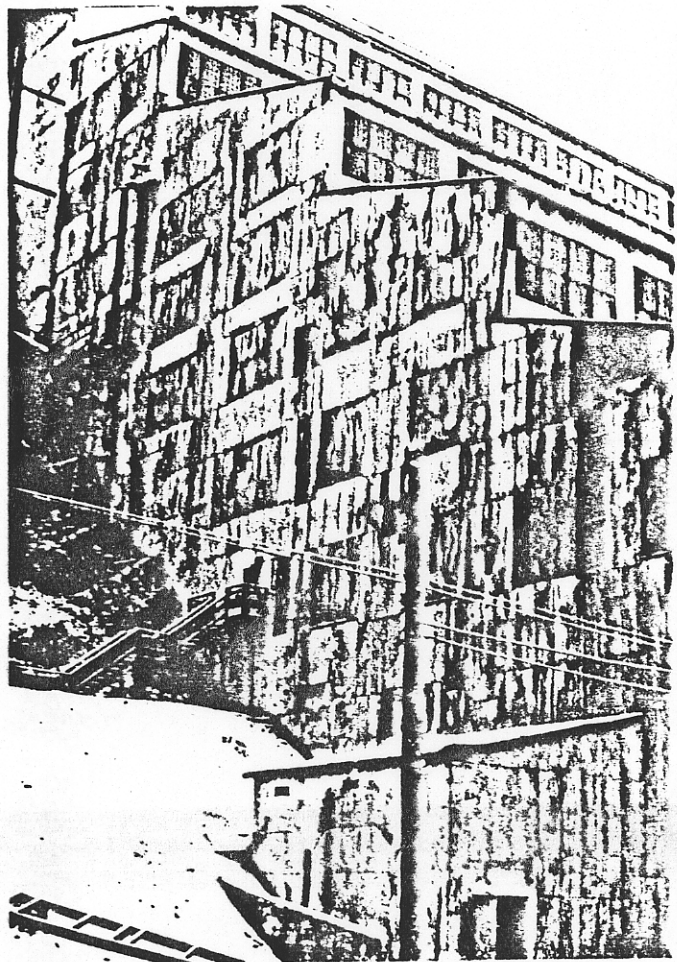
The steel siding is in generally poor condition. (See figures 4 & 5) In many areas, particularly lower down on the walls, the cladding has completely rusted through. In other areas, it has been removed. Although it is very difficult to estimate, it was observed that approximately 40 percent of the cladding was loose or poorly attached to the supports. On the rear wall of the building, a light gauge layer of aluminum cladding has been placed over the original steel cladding. The condition of this secondary cladding is not much better than the original envelope.

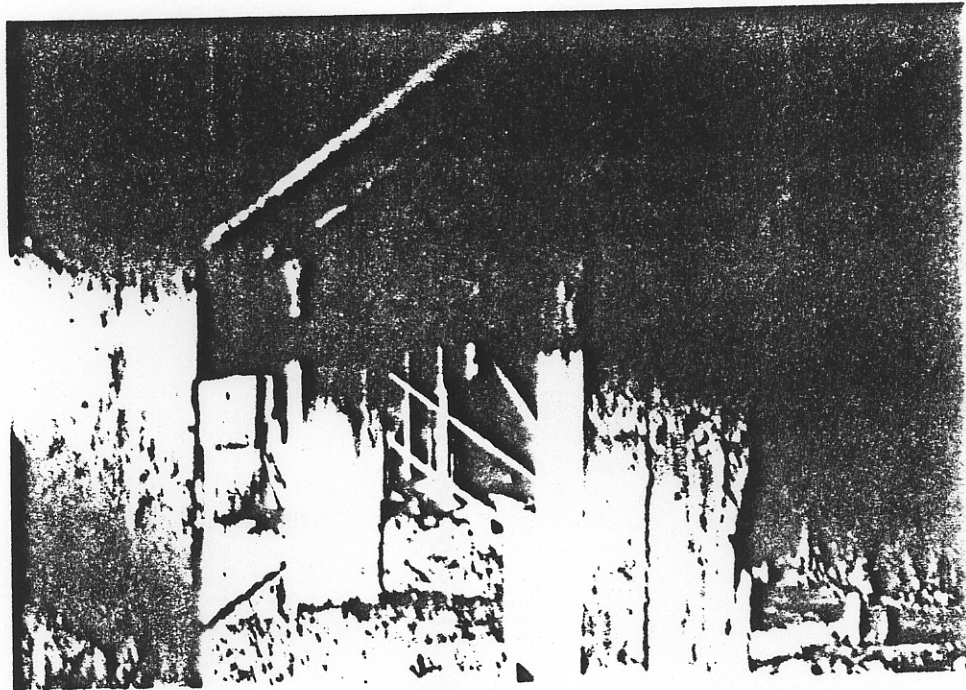
FIGURE 6

The building foundations could not be inspected in detail because in most cases they were not readily accessible. However, where it was possible to view the footings, the condition of the concrete appears to be sound. Many concrete columns (see figure 6) were inspected and found to be in good condition.

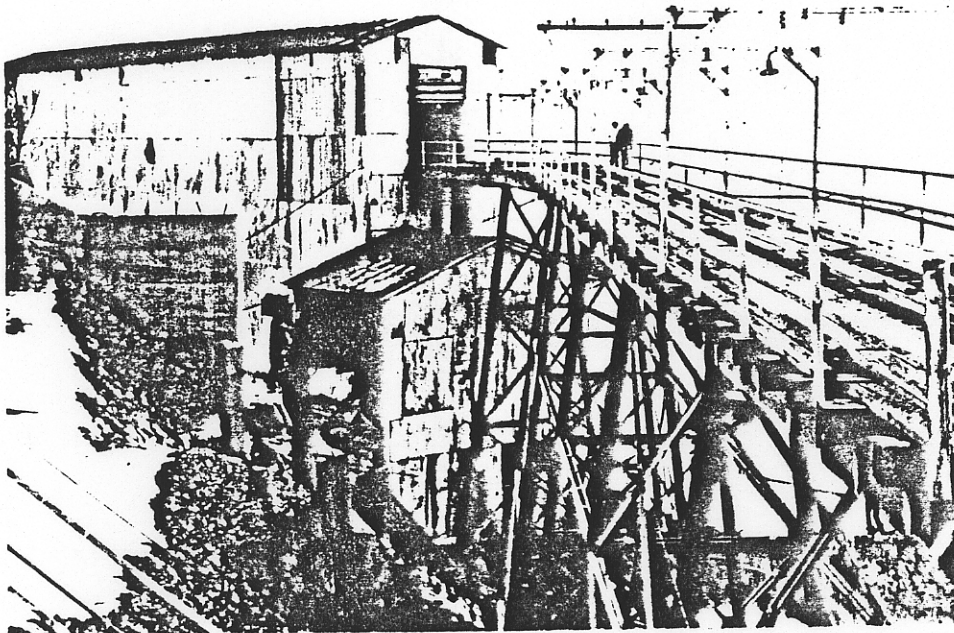
FIGURE 7

The steel supports which have been recently painted appear to be in fairly good condition (see figure 7). On the southwest trestle, however, some of the bracing has been bent. Furthermore, mine tailings have been deposited around the steel columns, thereby limiting the column inspection to the portion above grade. The timber decking and railway ties showed some deterioration. In addition, the decking was loose and many planks have been displaced or removed.

The exposed structural steel requires no repair work except for the bent bracing on the southwest trestle. The mine tailings under this trestle should be removed to such an extent that a detailed examination of the column bases can be made. At some future date, a decision may be made to repaint the steel for maintenance purposes although the paint at present appears to be in fairly good condition.
