Public Works
Canada

Structural Inspection

Britannia Mines

November 1990

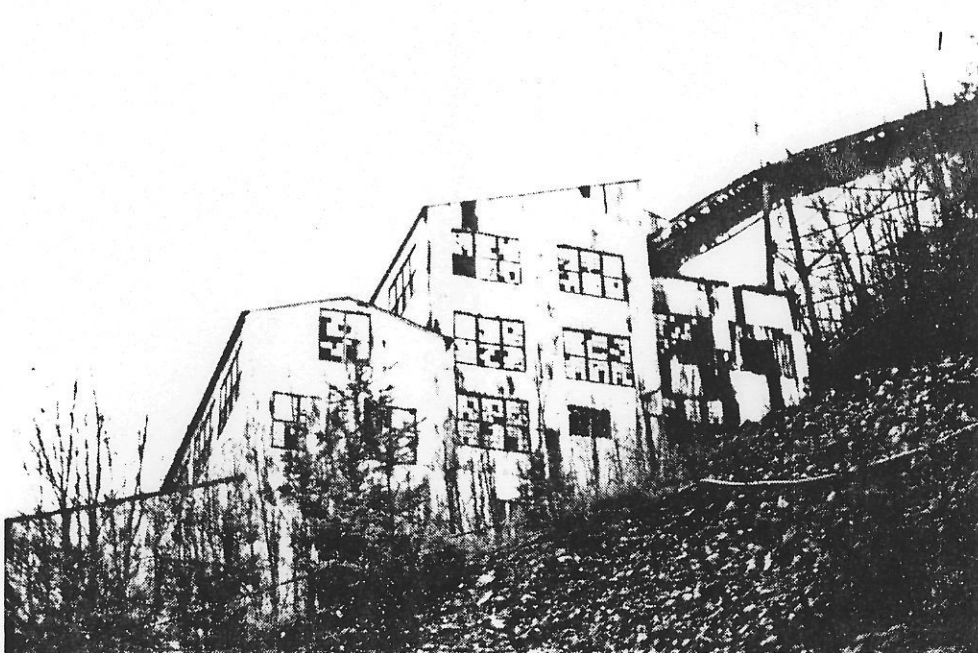
The exterior does not show any sign of major problems giving a false impression of a stable structure. The obvious problems are the missing corrugated metal sheathings, the superficial rusting of the columns, the erosion of the foundation soil near the east annex and the deterioration of the bottom part of the west side structural elements. Fig.1 - Fig.4.

Figure 1. West Facade (no of apparent problems)

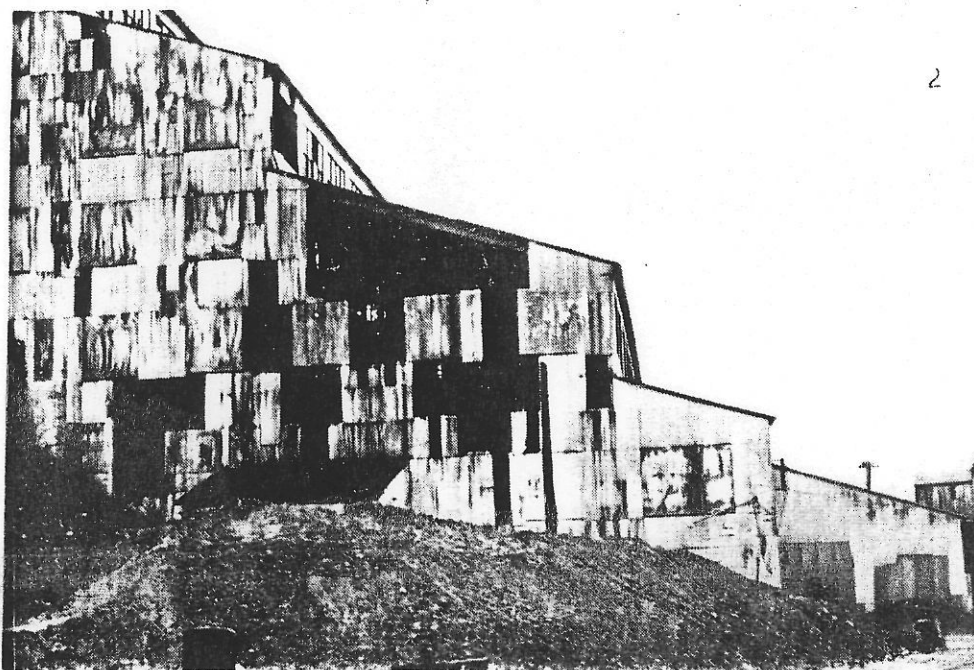
Figure 2. East Facade (No indication of any major problem)

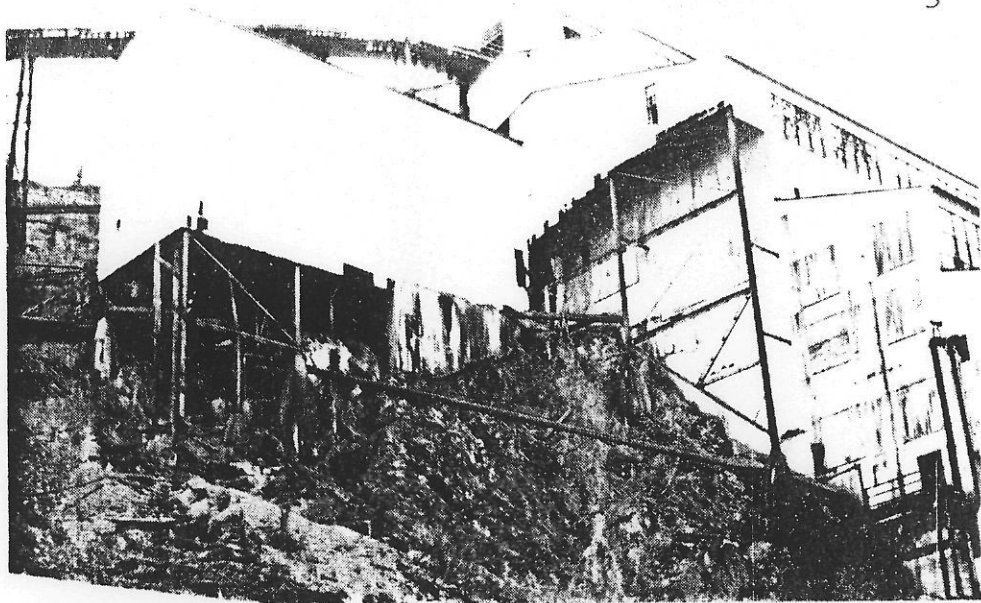
Figure 3. Erosion of Foundation Soil.

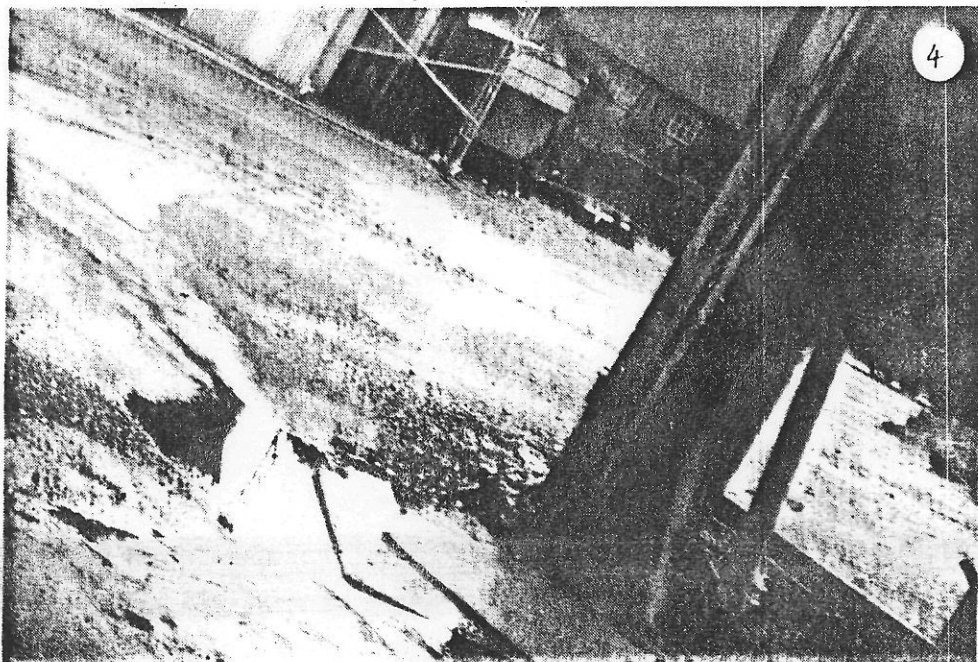
Figure 4. Minor Deterioration of Column Base.

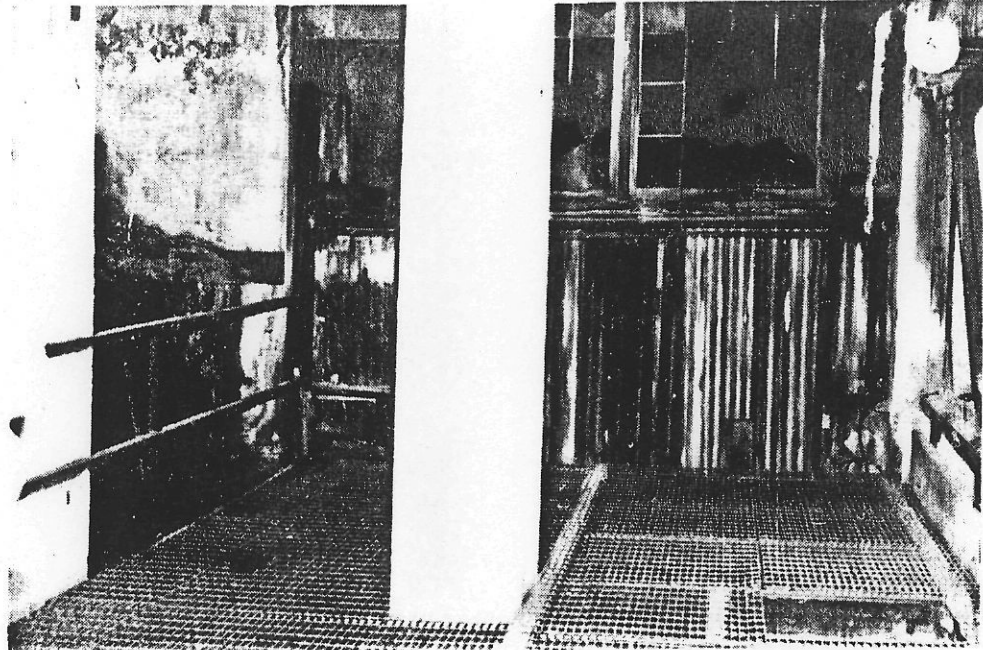
The east side and the upper part of the building seem to be in stable condition. The steel structure however has been affected by superficial rust and minor corrosion. Fig.5 - Fig.8.

Figure 5. Concrete Column and Steel Flooring in Good Condition.

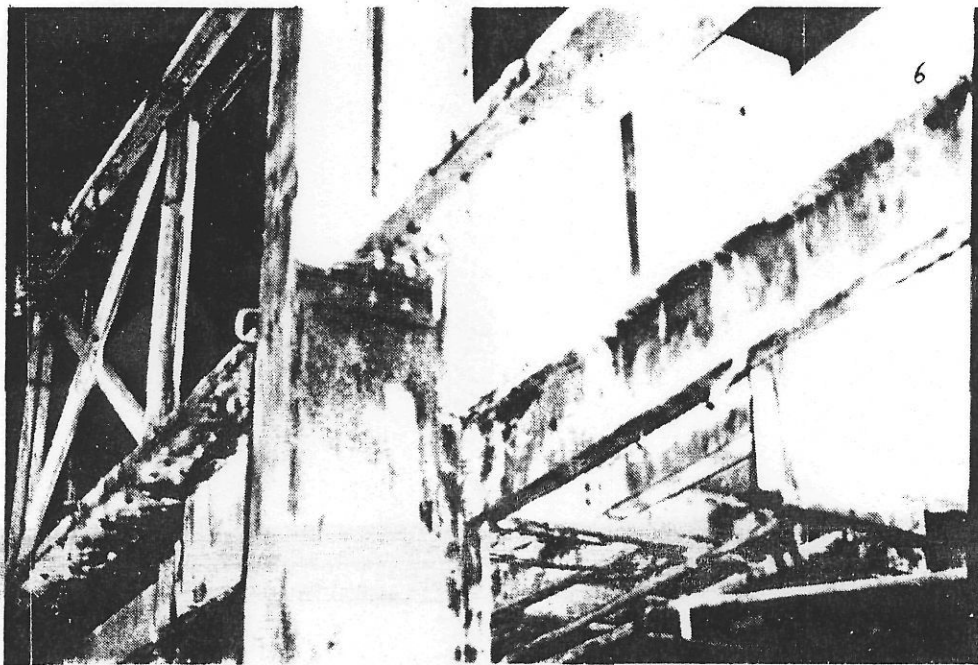
Figure 6. Steel Members Affected By Rust & Minor Corrsion.

. Due to the nature of its structural problems, there is no fast fix solution to freeze the structure in time. The chemical treatment of the steel members to slow down the corrosion process should however be considered as part of the regular maintenance.

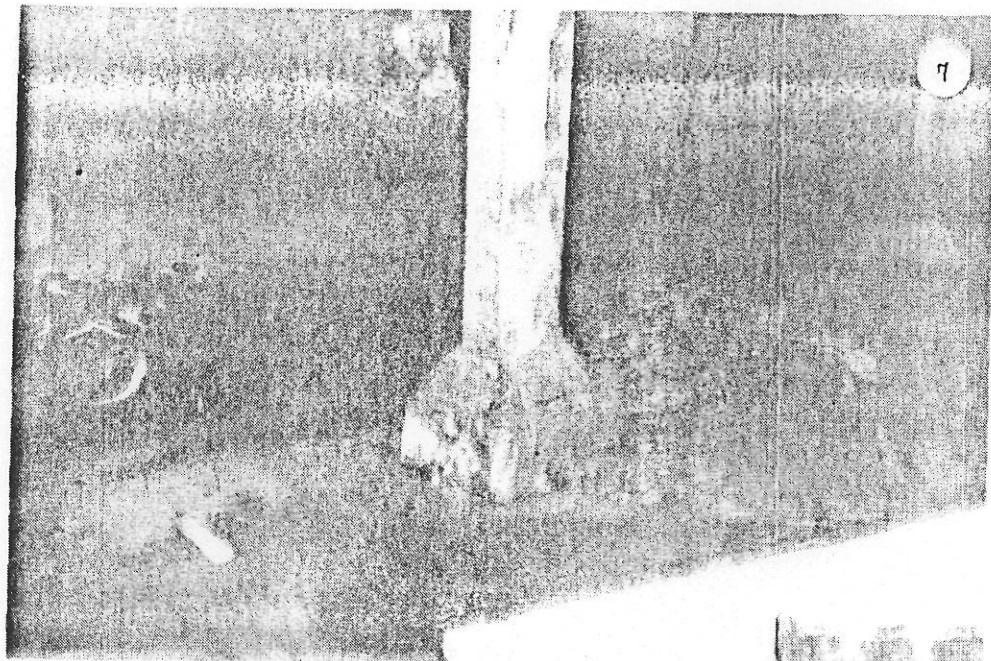
Figure 7. Steel Column and Concrete Base With Rust & Minor Corrosion.

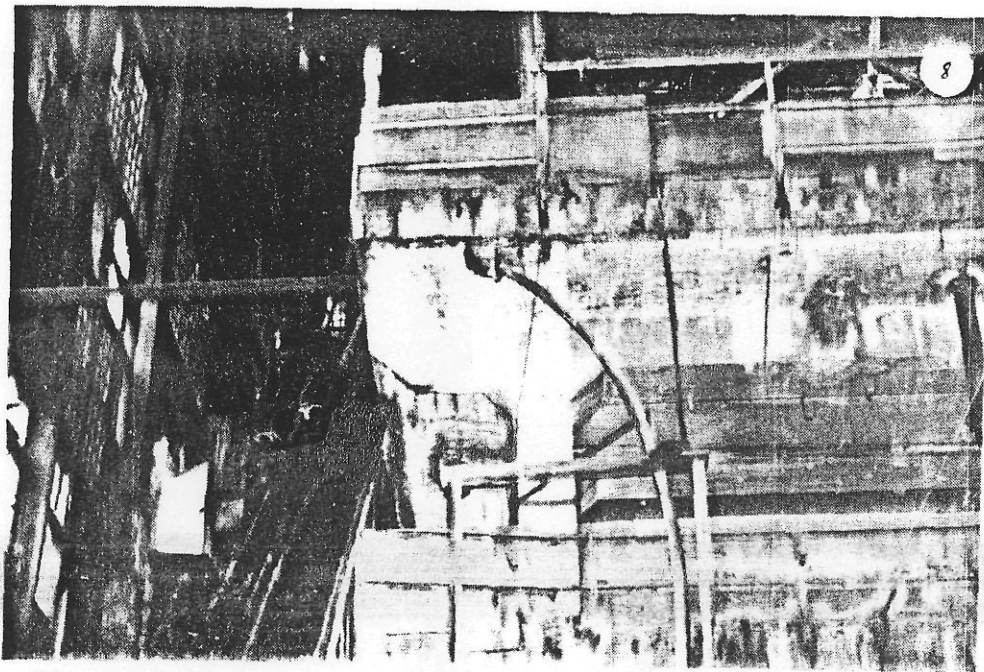
Figure 8. Concrete Elements in Relatively Good Condition.

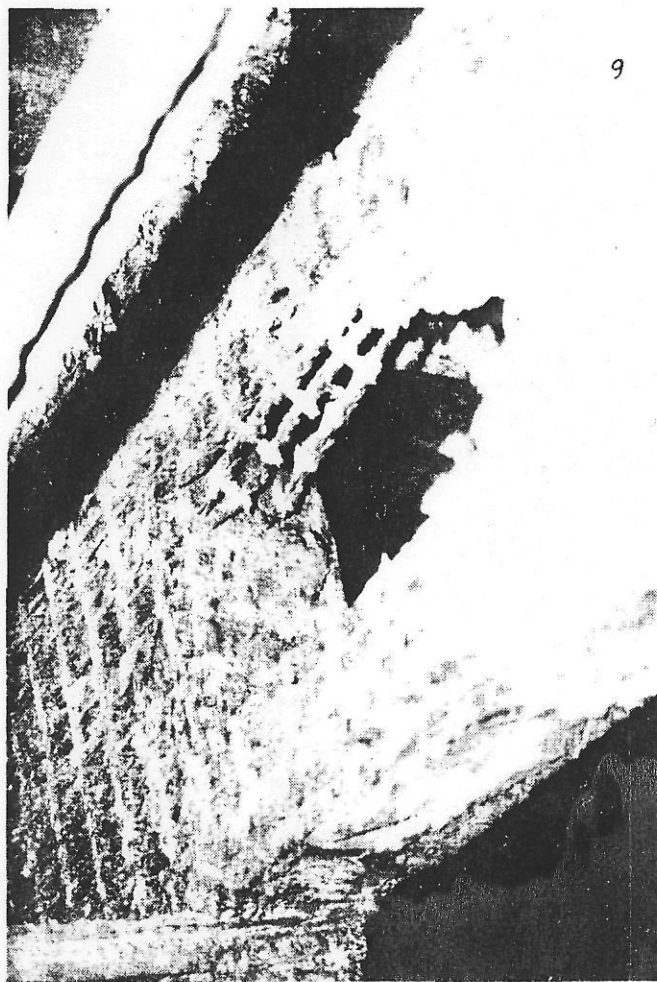
The west side, where the chemically polluted water is running freely, is in poorer condition. Some of the structural elements are completely corroded and basically have lost their structural strength. The concrete elements have also corroded and lost not only their concrete cover but also their reinforcing bars. This area is generally hazardous. Fig.9 - Fig.16.

Figure 9. Badly Corrode Concrete Beam.

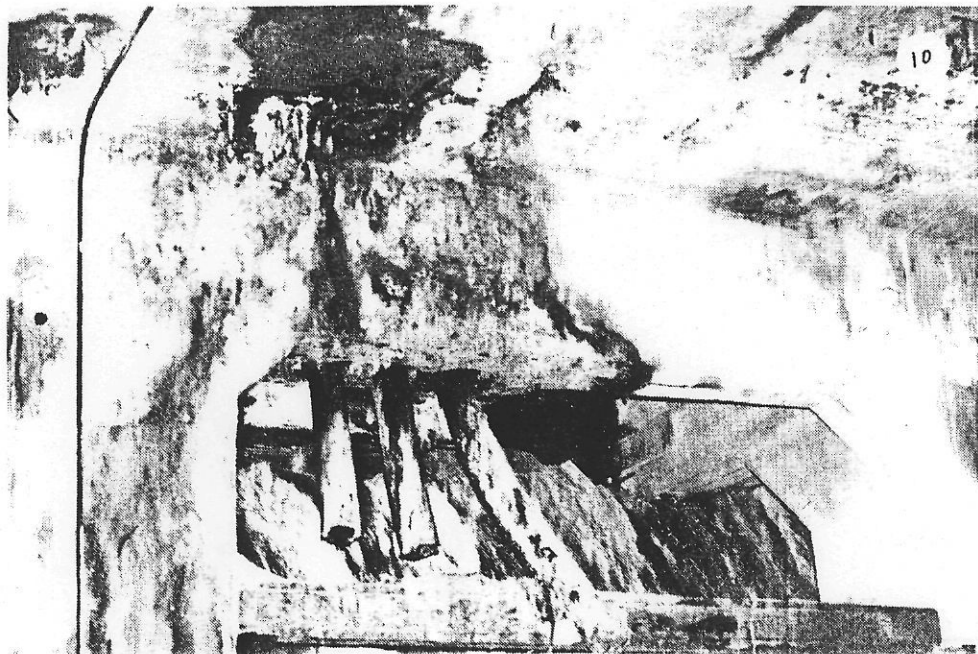
Figure 10. Corroded Concrete Beam.

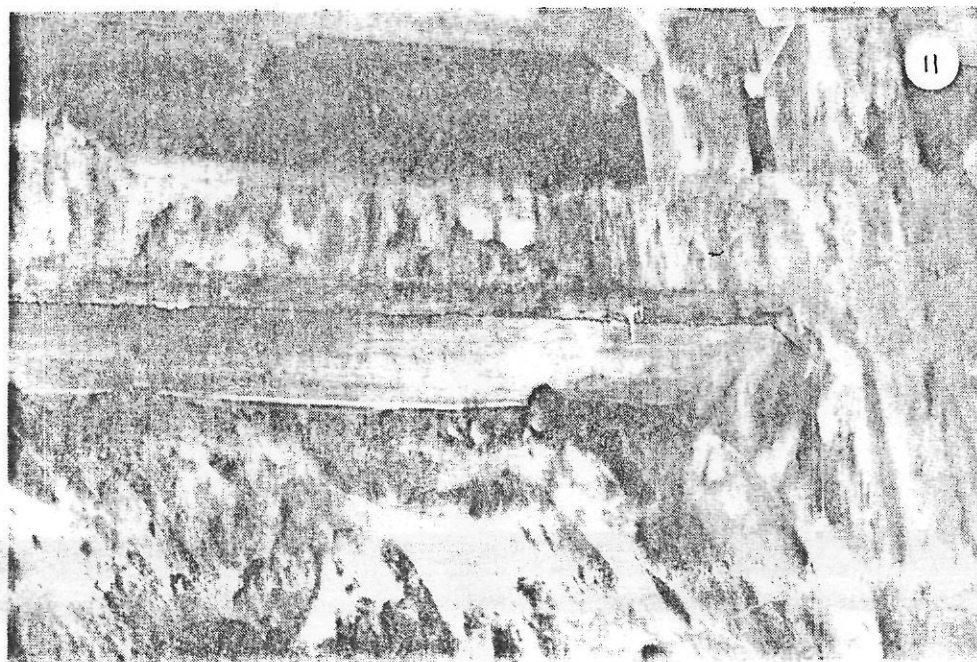
Figure 11. Corroded Concrete Beam.

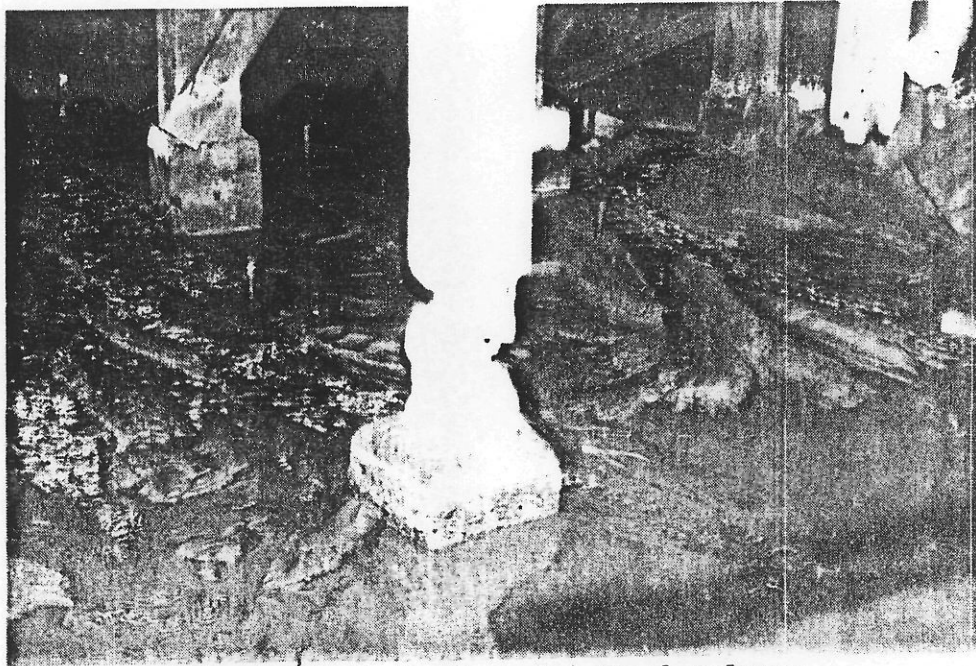
Figure 12. Badly Corroded Steel Columns.

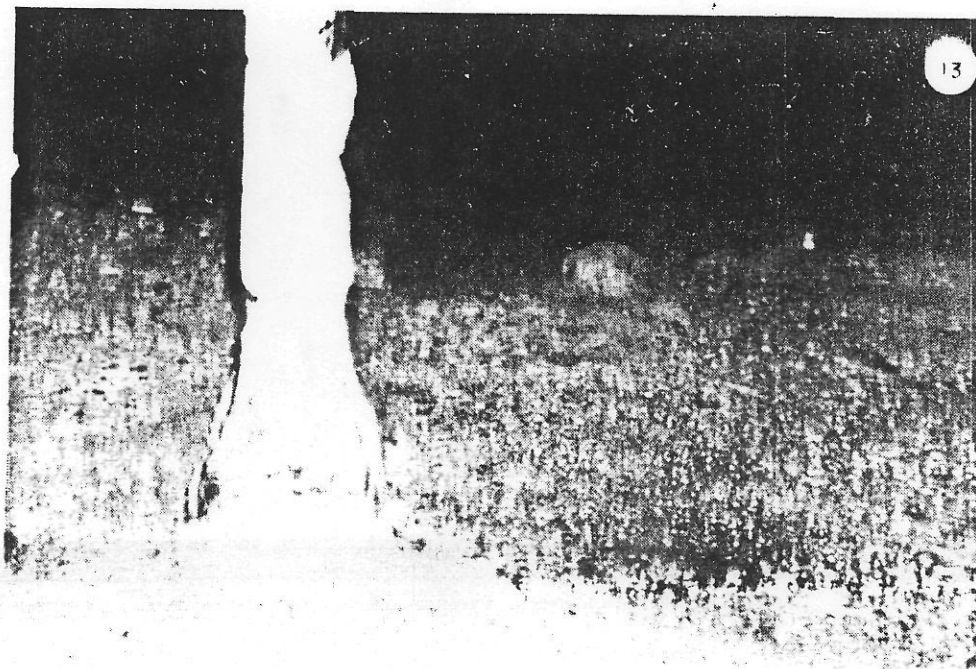
Figure 13. Badly Deteriorated Column.

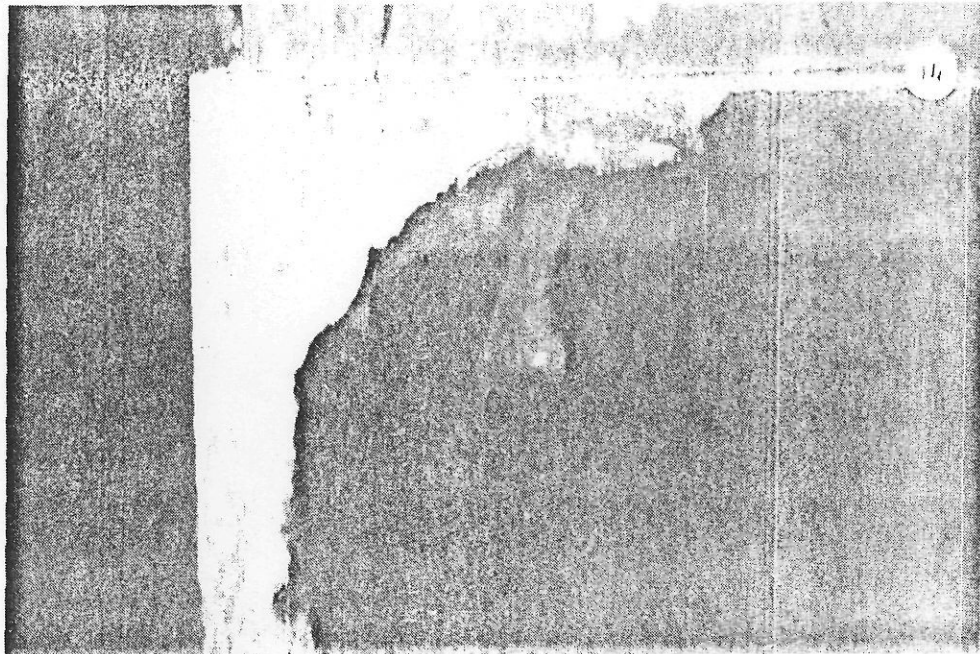
Figure 14. Corroded Steel Support.

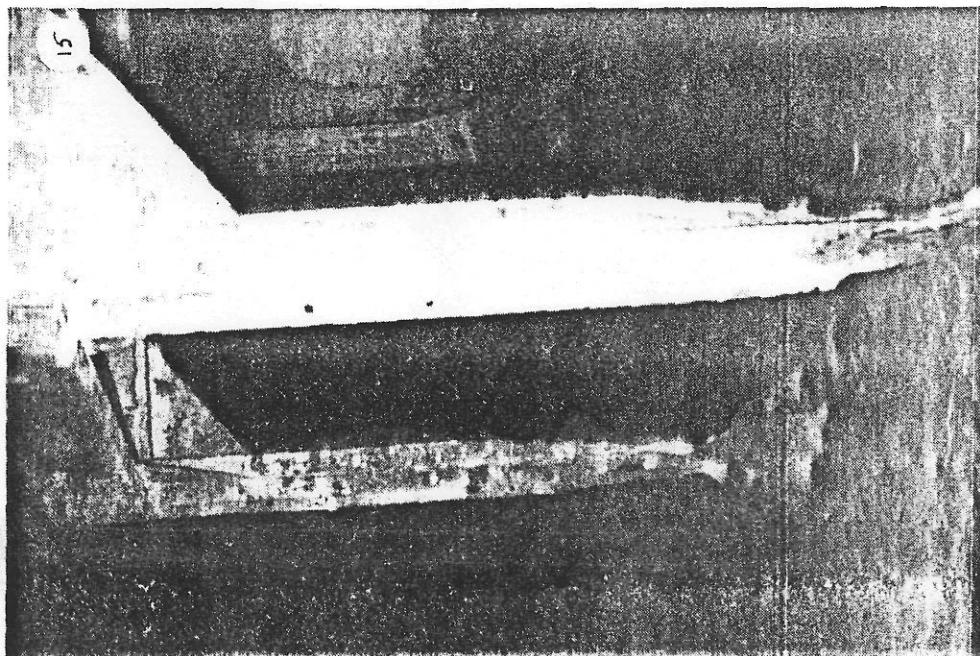
Figure 15. Badly Corroded Columns.

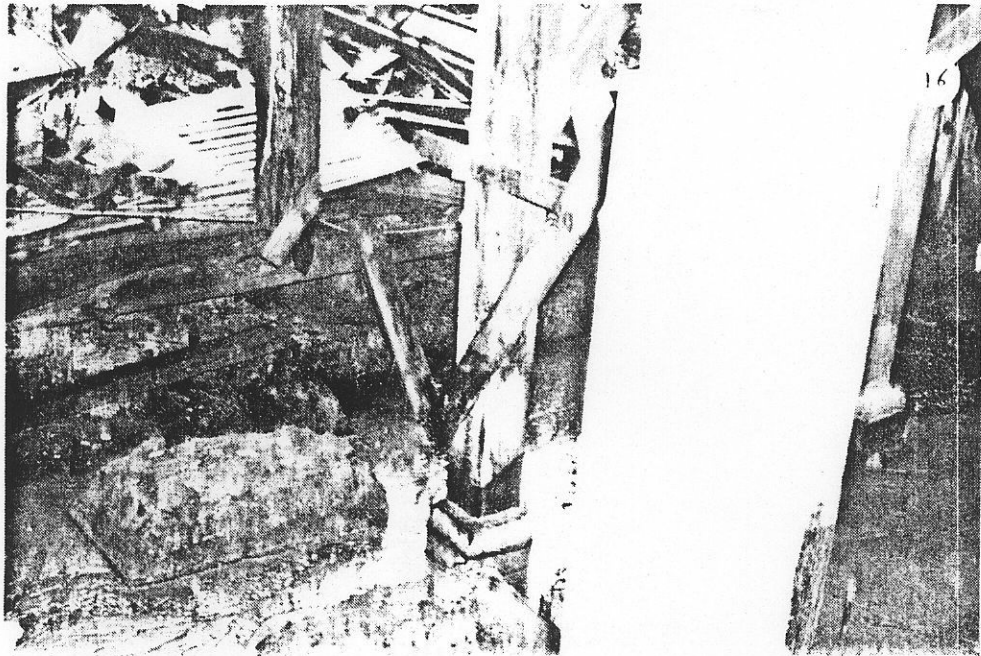
Figure 16. Timber Elements in Relatively Good Condition.

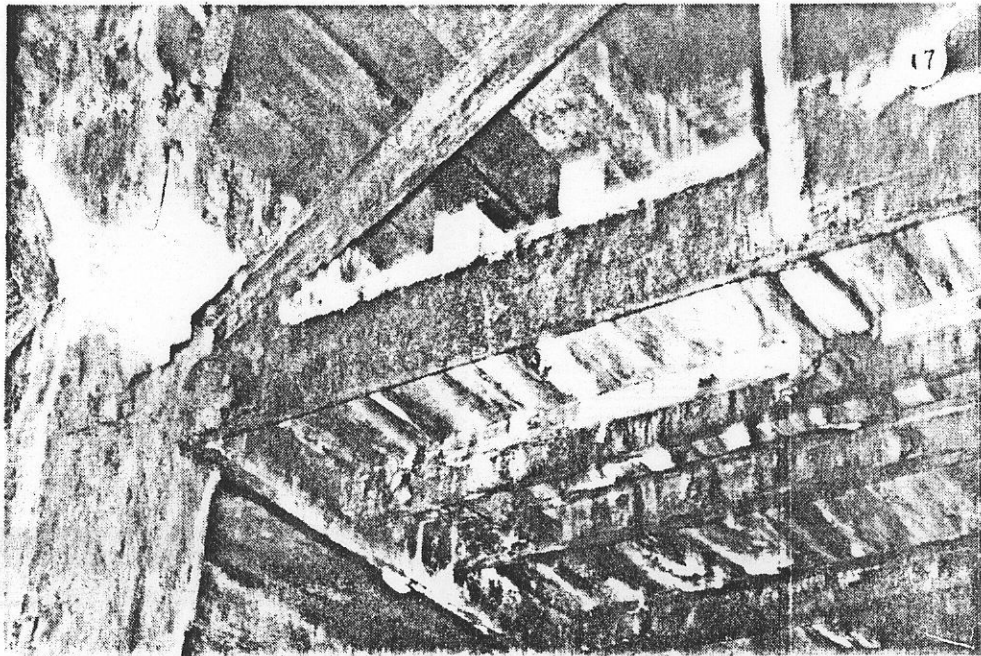
The remaining interior structure has been affected to different degrees by the rust and corrosion. One main bridge in the middle of the ground floor has lost most of its shear strength due the corrosion of the joist webs (fig.17); one of the stairs has lost part of its bottom support to corrosion; several walkaways have lost some parts completely; several columns have superficial rust and corrosion. Fig.18 -Fig.21.

Figure 17. Webs Of Bridge Joists Completely Corroded.

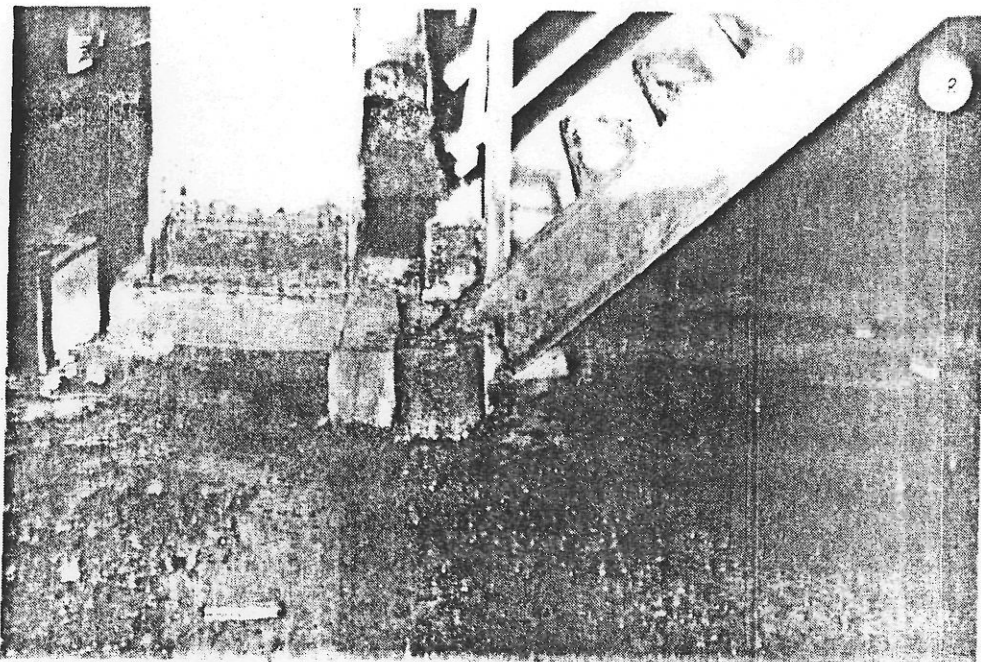
Figure 18. Corroded Stairs Support.

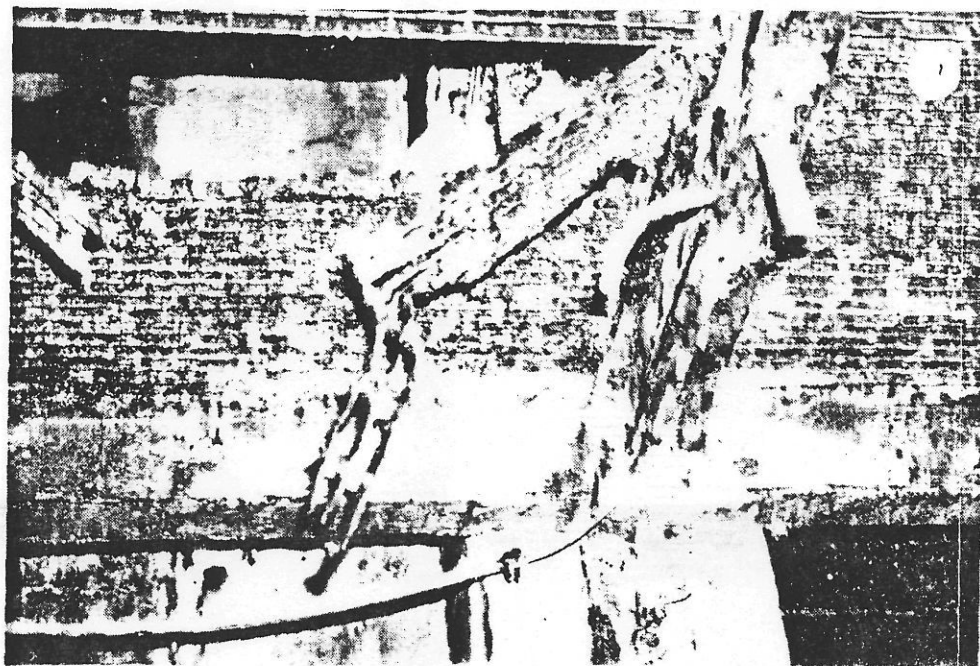
Figure 19. Walkways Completely Corroded.

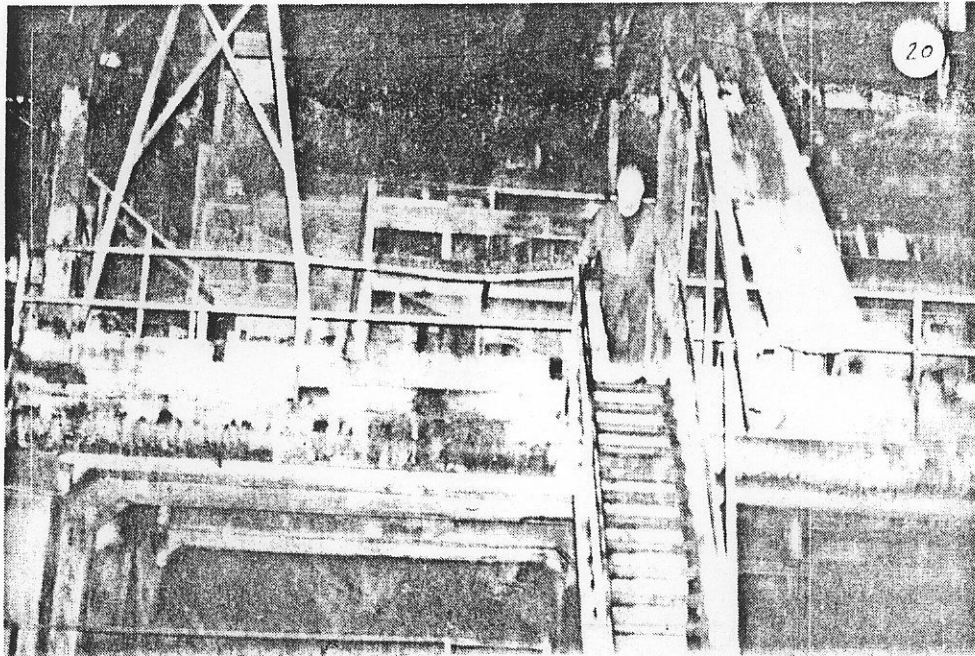
Figure 20. Upper Structure Superficially Rusted.

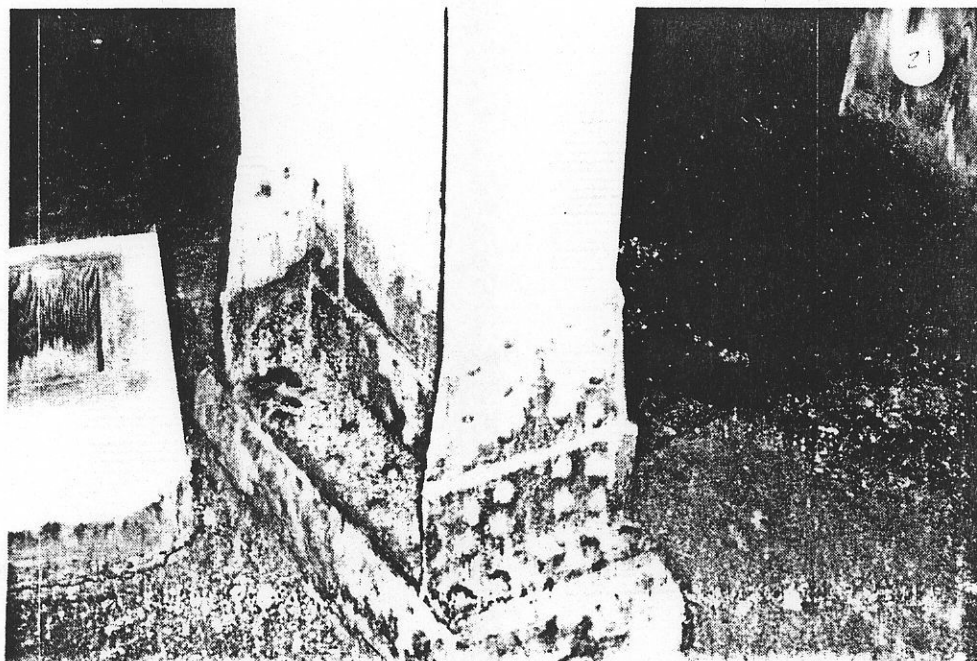
Figure 21. Column Base Superficially Corroded.
