GEOLOGICAL INVESTIGATIONS AT MORAN
IN 1957

By Stuart S. Holland

BRITISH COLUMBIA DEPARTMENT OF MINES

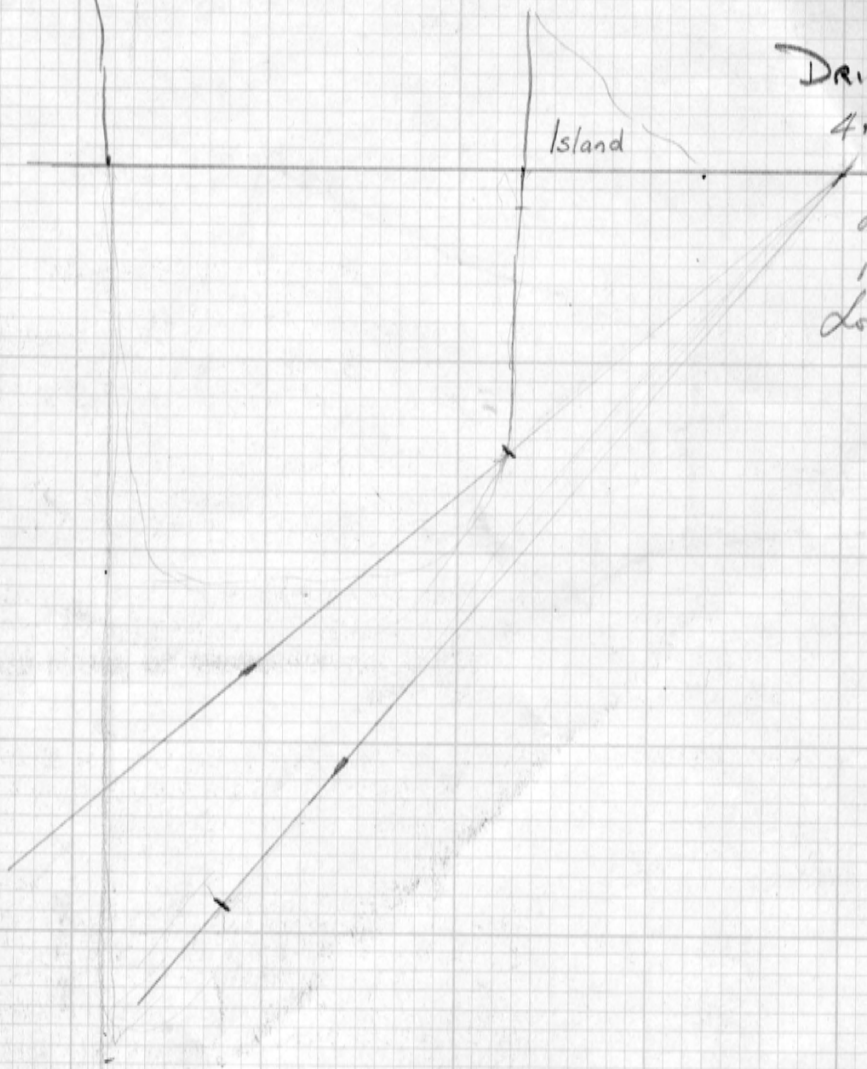
DRILL HOLES
4 & 5.

Two drill holes (Nos. 4 & 5) were collared in rock on the east side of the island and drilled westerly. No. 4 inclined at minus 40 degrees broke out of rock into gravel at 136 feet, indicating a depth to bedrock below present low water level of at least 75 feet. Hole No. 5 inclined at minus 50 degrees was stopped at 300 feet. The end of the hole is 40 feet east of being vertically beneath the west side of the river. The core was examined and no evidence of faulting is apparent. Nevertheless, it is still possible for a westerly dipping fault to lie between the island and the west abutment. Information regarding this point could be secured by deepening No. 5 drill hole about 60 feet and drilling a vertical hole on the west bank to a depth of 275 below present water level. At present, however, the chance of a fault lying in the channel between the island and the west abutment appears less than was previously thought from geological observation.

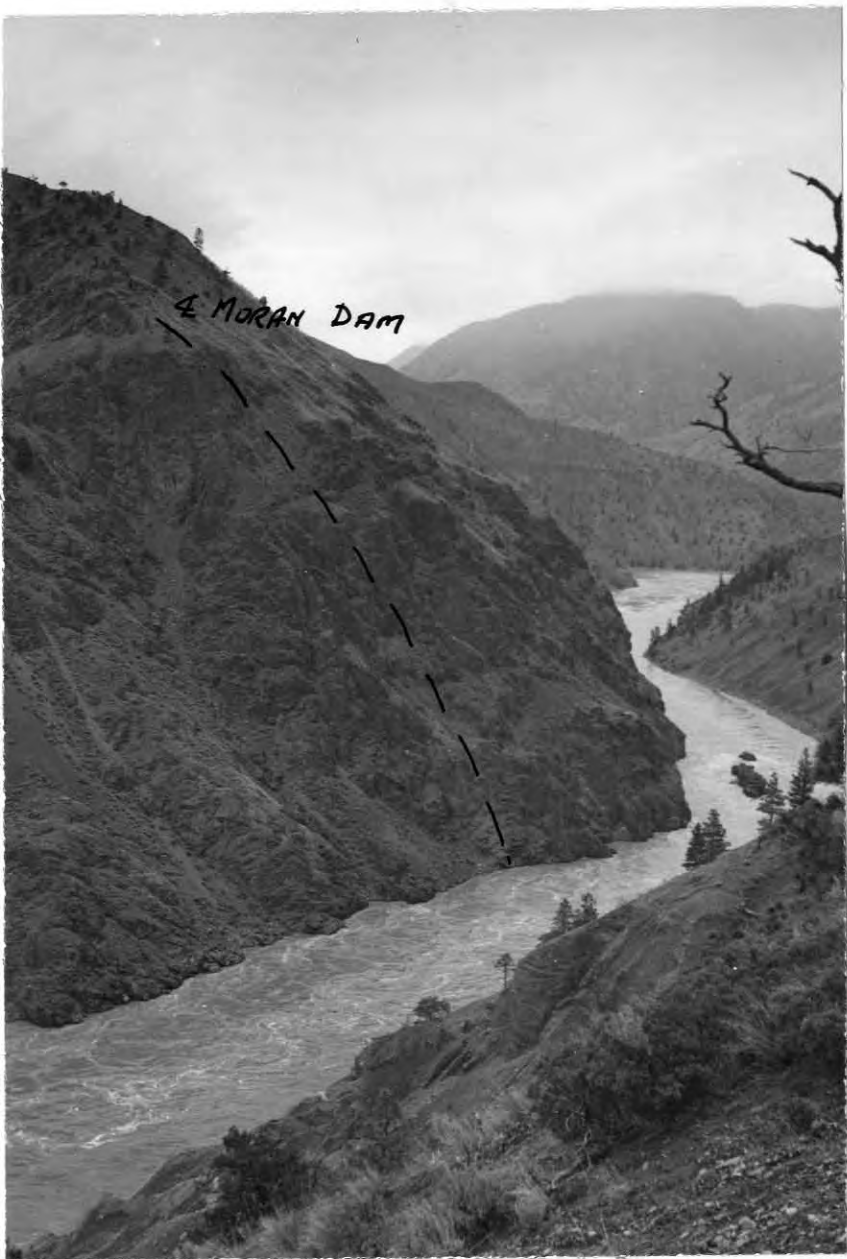
Plate III A.--West abutment at Moran damsite.

Bedrock outcrops on the west side of the river for about 1,900 feet downstream from the centreline of the proposed dam (see Plate III A). Farther downstream from that point to beyond McKay Creek bedrock up to an altitude of 1,700 feet is overlain by horizontally bedded silts (see Plate IV B). These unconsolidated sediments lie as a veneer over the bedrock and effectively hide its position. The position of bedrock in this area can only be determined by drilling. The surface topography in several places indicates that the silts have slumped. Consequently the entire silt-covered area must be considered to be potentially if not actually unstable ground.

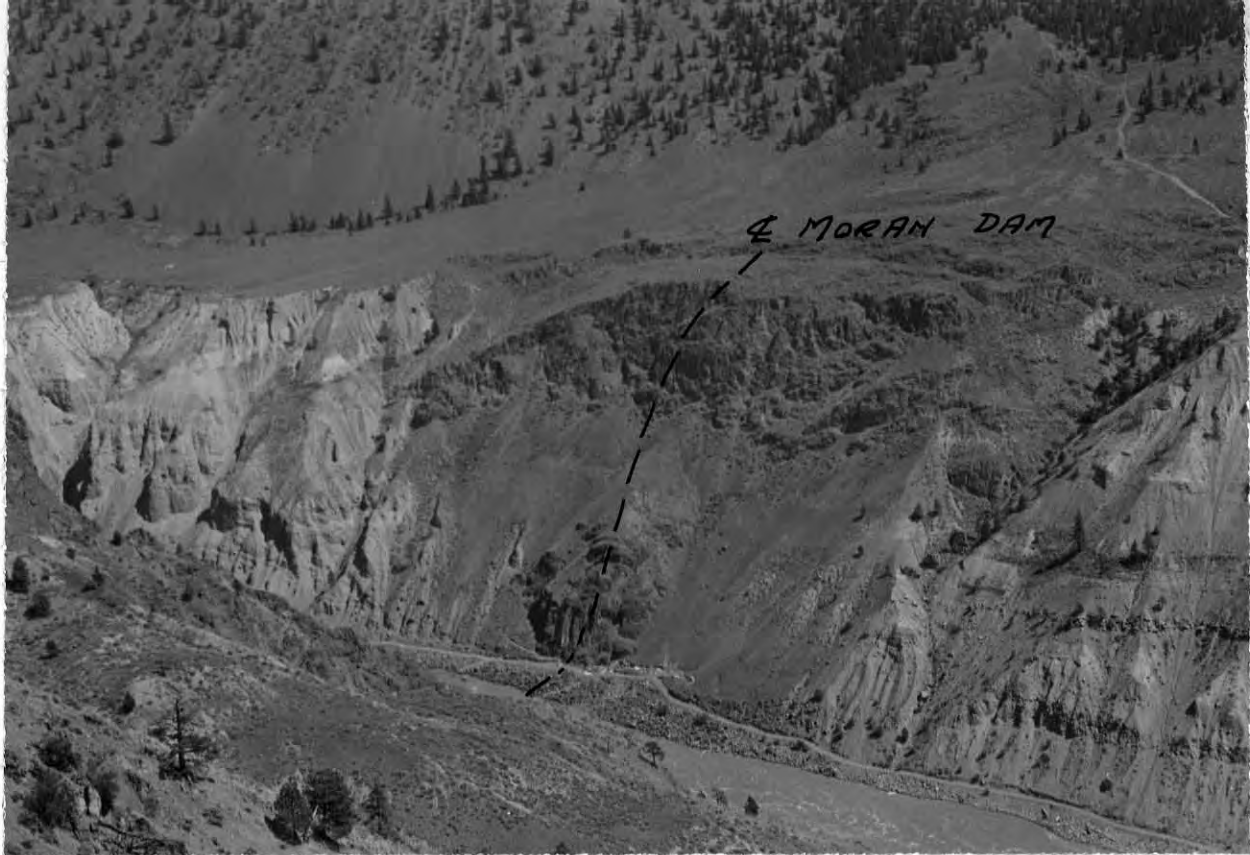
Plate IV A.--East abutment at Moran damsite - with old drilling camp in centre foreground.

On the east side of the river, bedrock is exposed at river level only on the centreline of the proposed dam (see Plate IV A). Upstream and downstream for several thousand feet bedrock is overlain up to an altitude of 1,200 feet by coarse bouldery gravel which stands in bluffs and pinnacles along the river. The gravel in turn lies beneath a veneer of silts. There is no indication of the contour of bedrock beneath the gravels and silts so that the position of bedrock at any point will have to be determined by drilling. However, it is certain that no buried channel of the Fraser River lies in the bank to the east of the east abutment at the damsite.

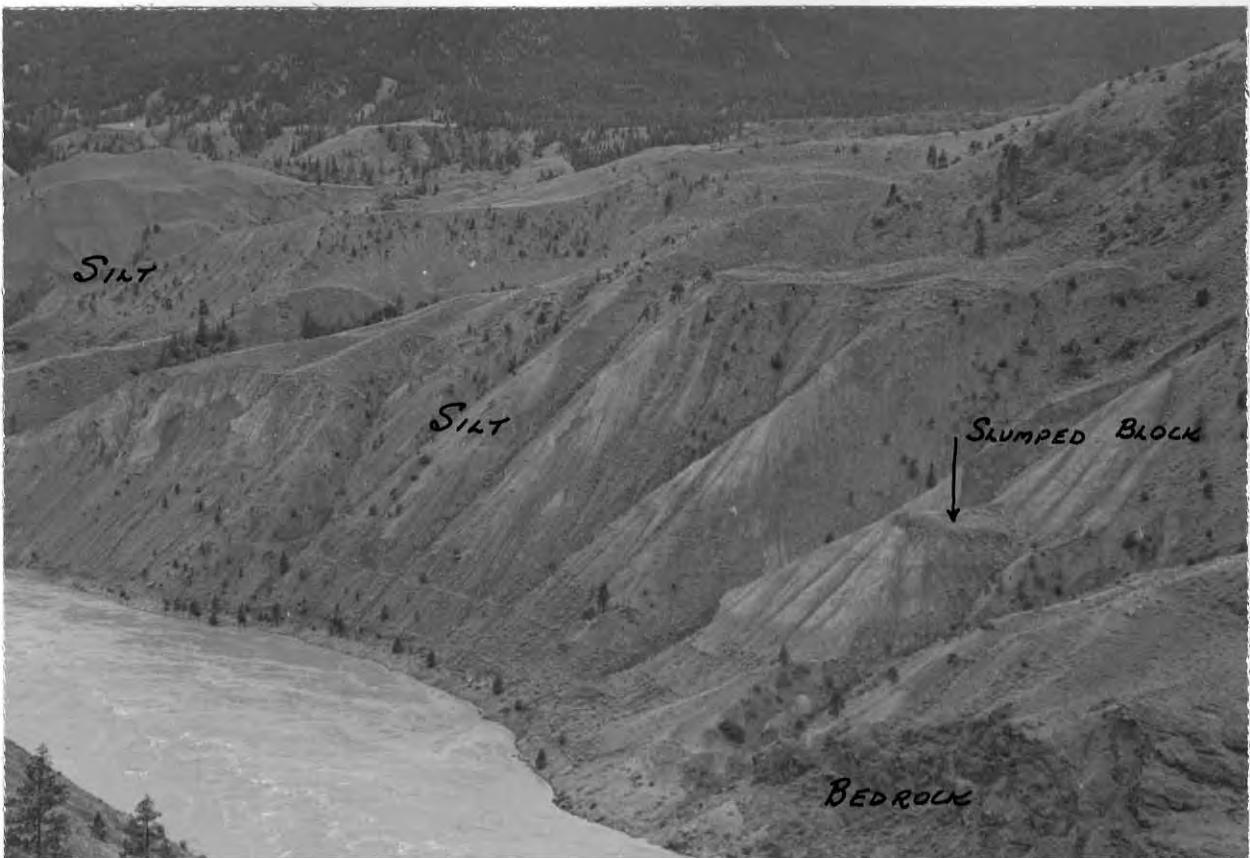
Plate IV B.--Laminated silt overlying bedrock downstream on west side at Moran.

Bedrock 1,000 feet downstream from the centreline of the dam on the west side is overlain by horizontally bedded silts which extend downstream past the mouth of McKay Creek and which rise to an elevation of 1,500 feet and more. These unconsolidated sediments lying as a veneer over the solid bedrock have a variable depth and horizontal extent which change with the outline of bedrock and with the present topographic surface. It is possible only to guess their actual thickness at specific points. The surface topography at several places indicates that this material has slumped, and consequently the entire silt-covered area must be considered to be potentially if not actually unstable ground.

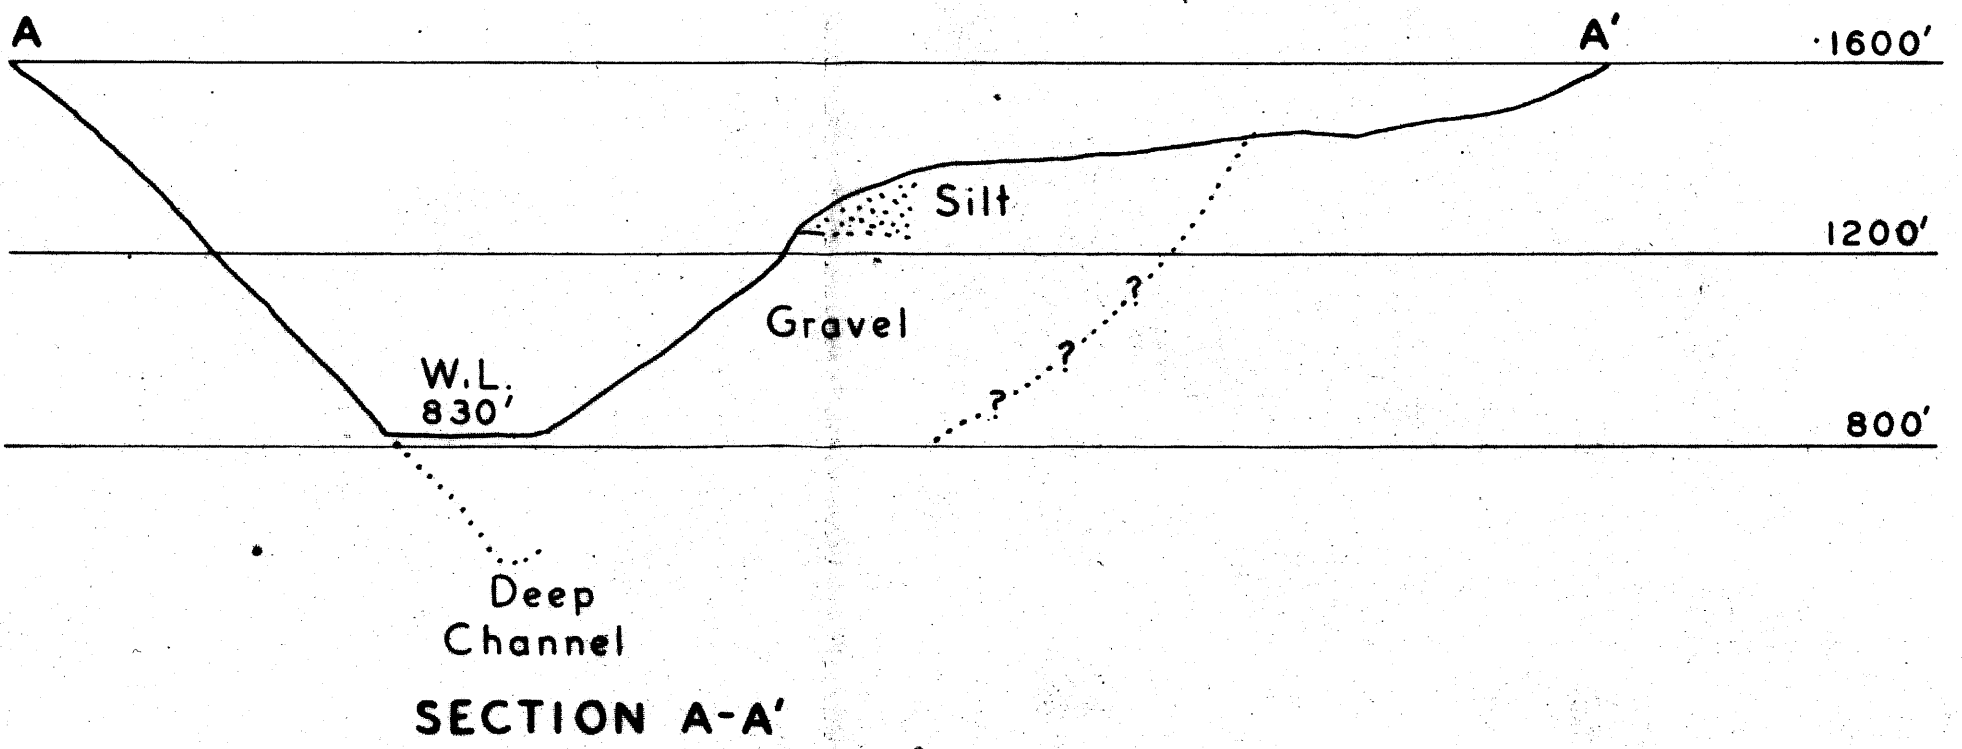
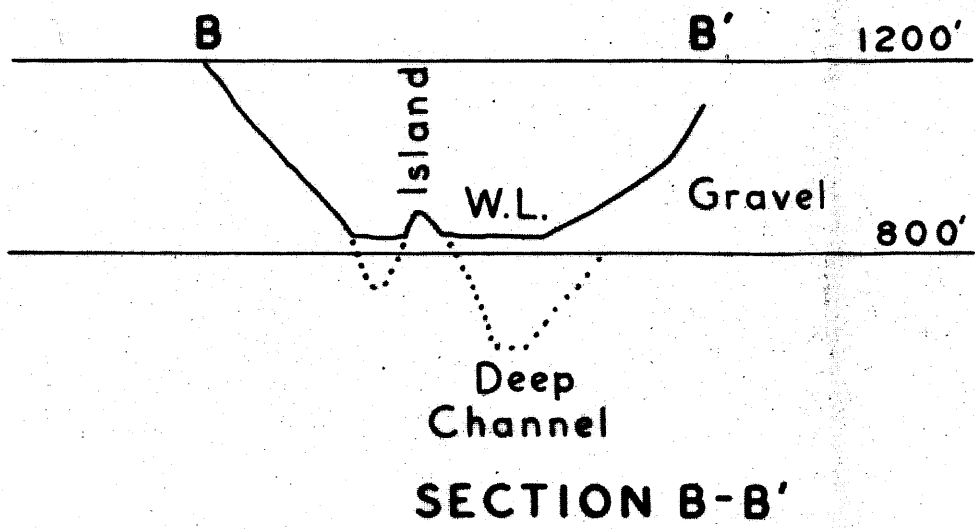
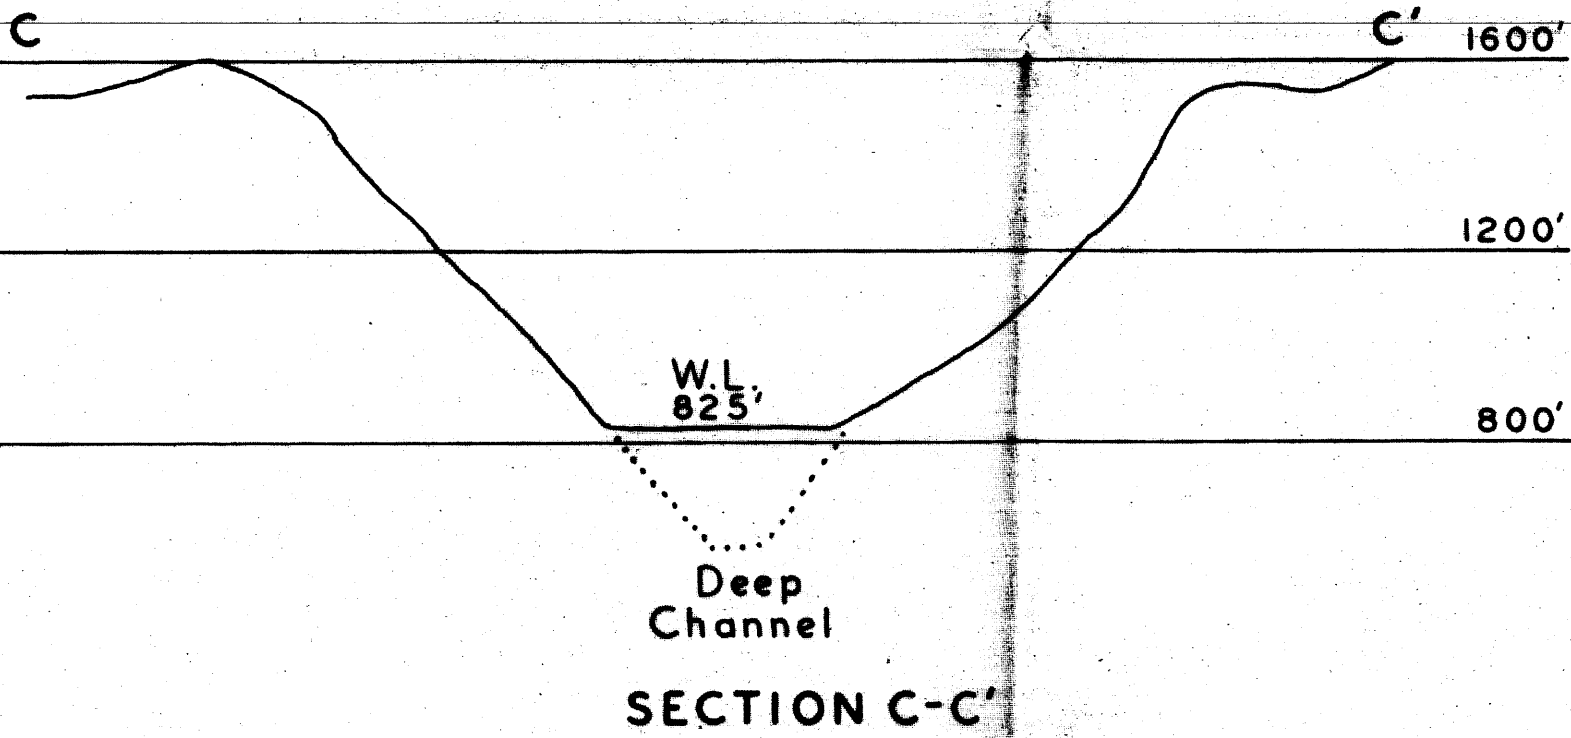
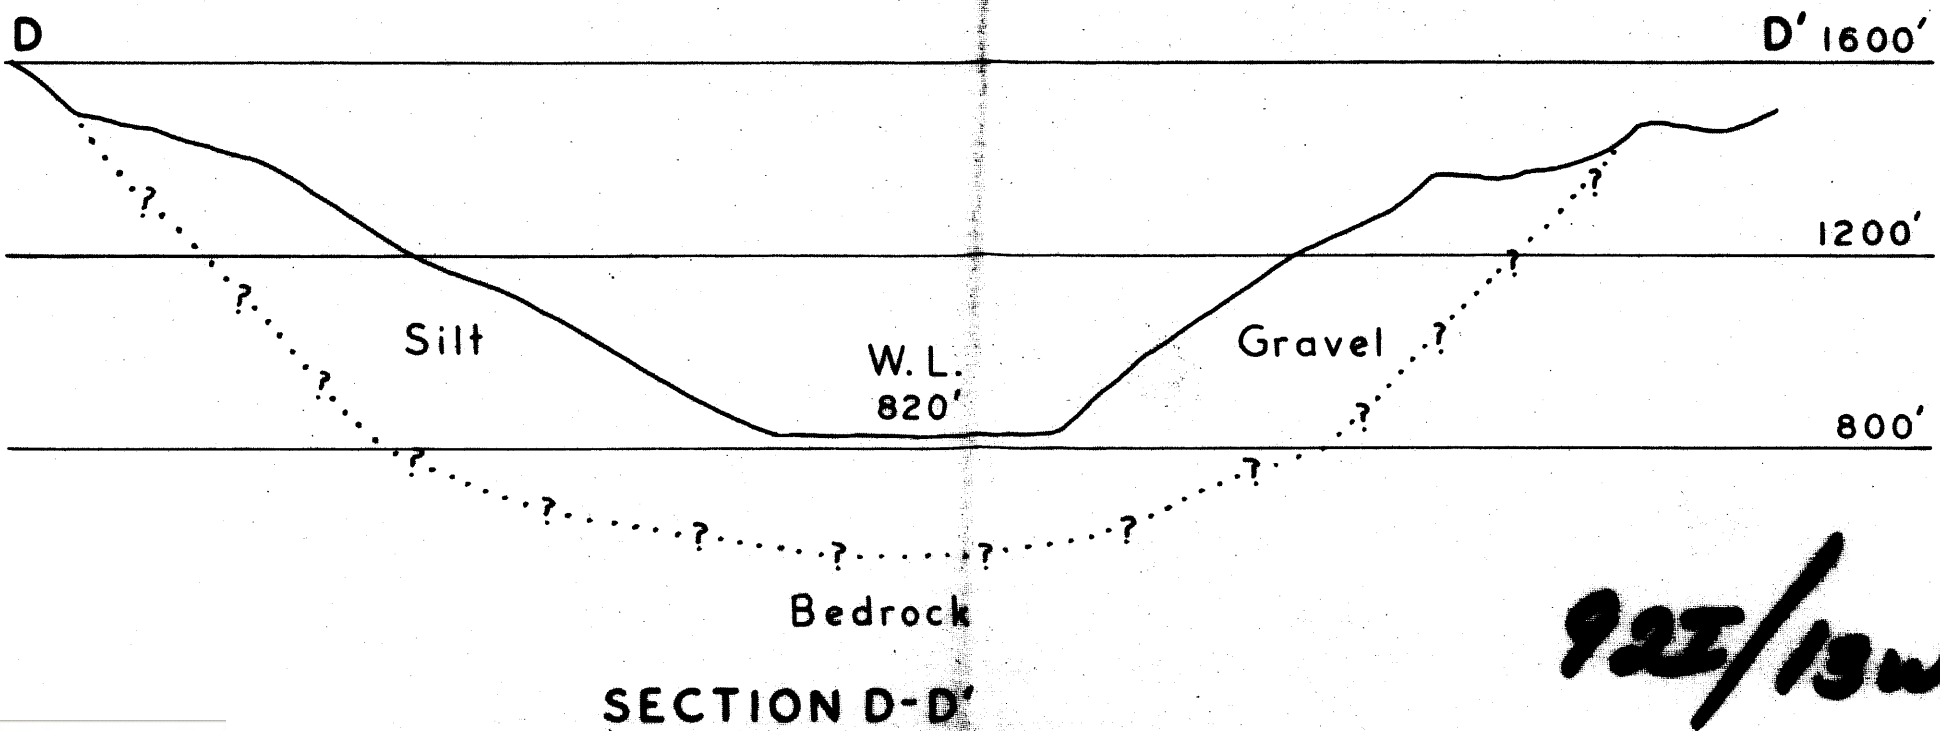
Interpretive cross-sections (see Figure 2) drawn at intervals along the river show the changing relations of bedrock and unconsolidated material, and the inferred position and depth of the deep channel.
