REPORT OF  
EXAMINATION OF THE  
GOLD TOP GROUP  
OF MINING CLAIMS  
SALMON RIVER, B. C.

By  
Charles C. Starr,  
August 20, 1939.

## GOLD TOP GROUP

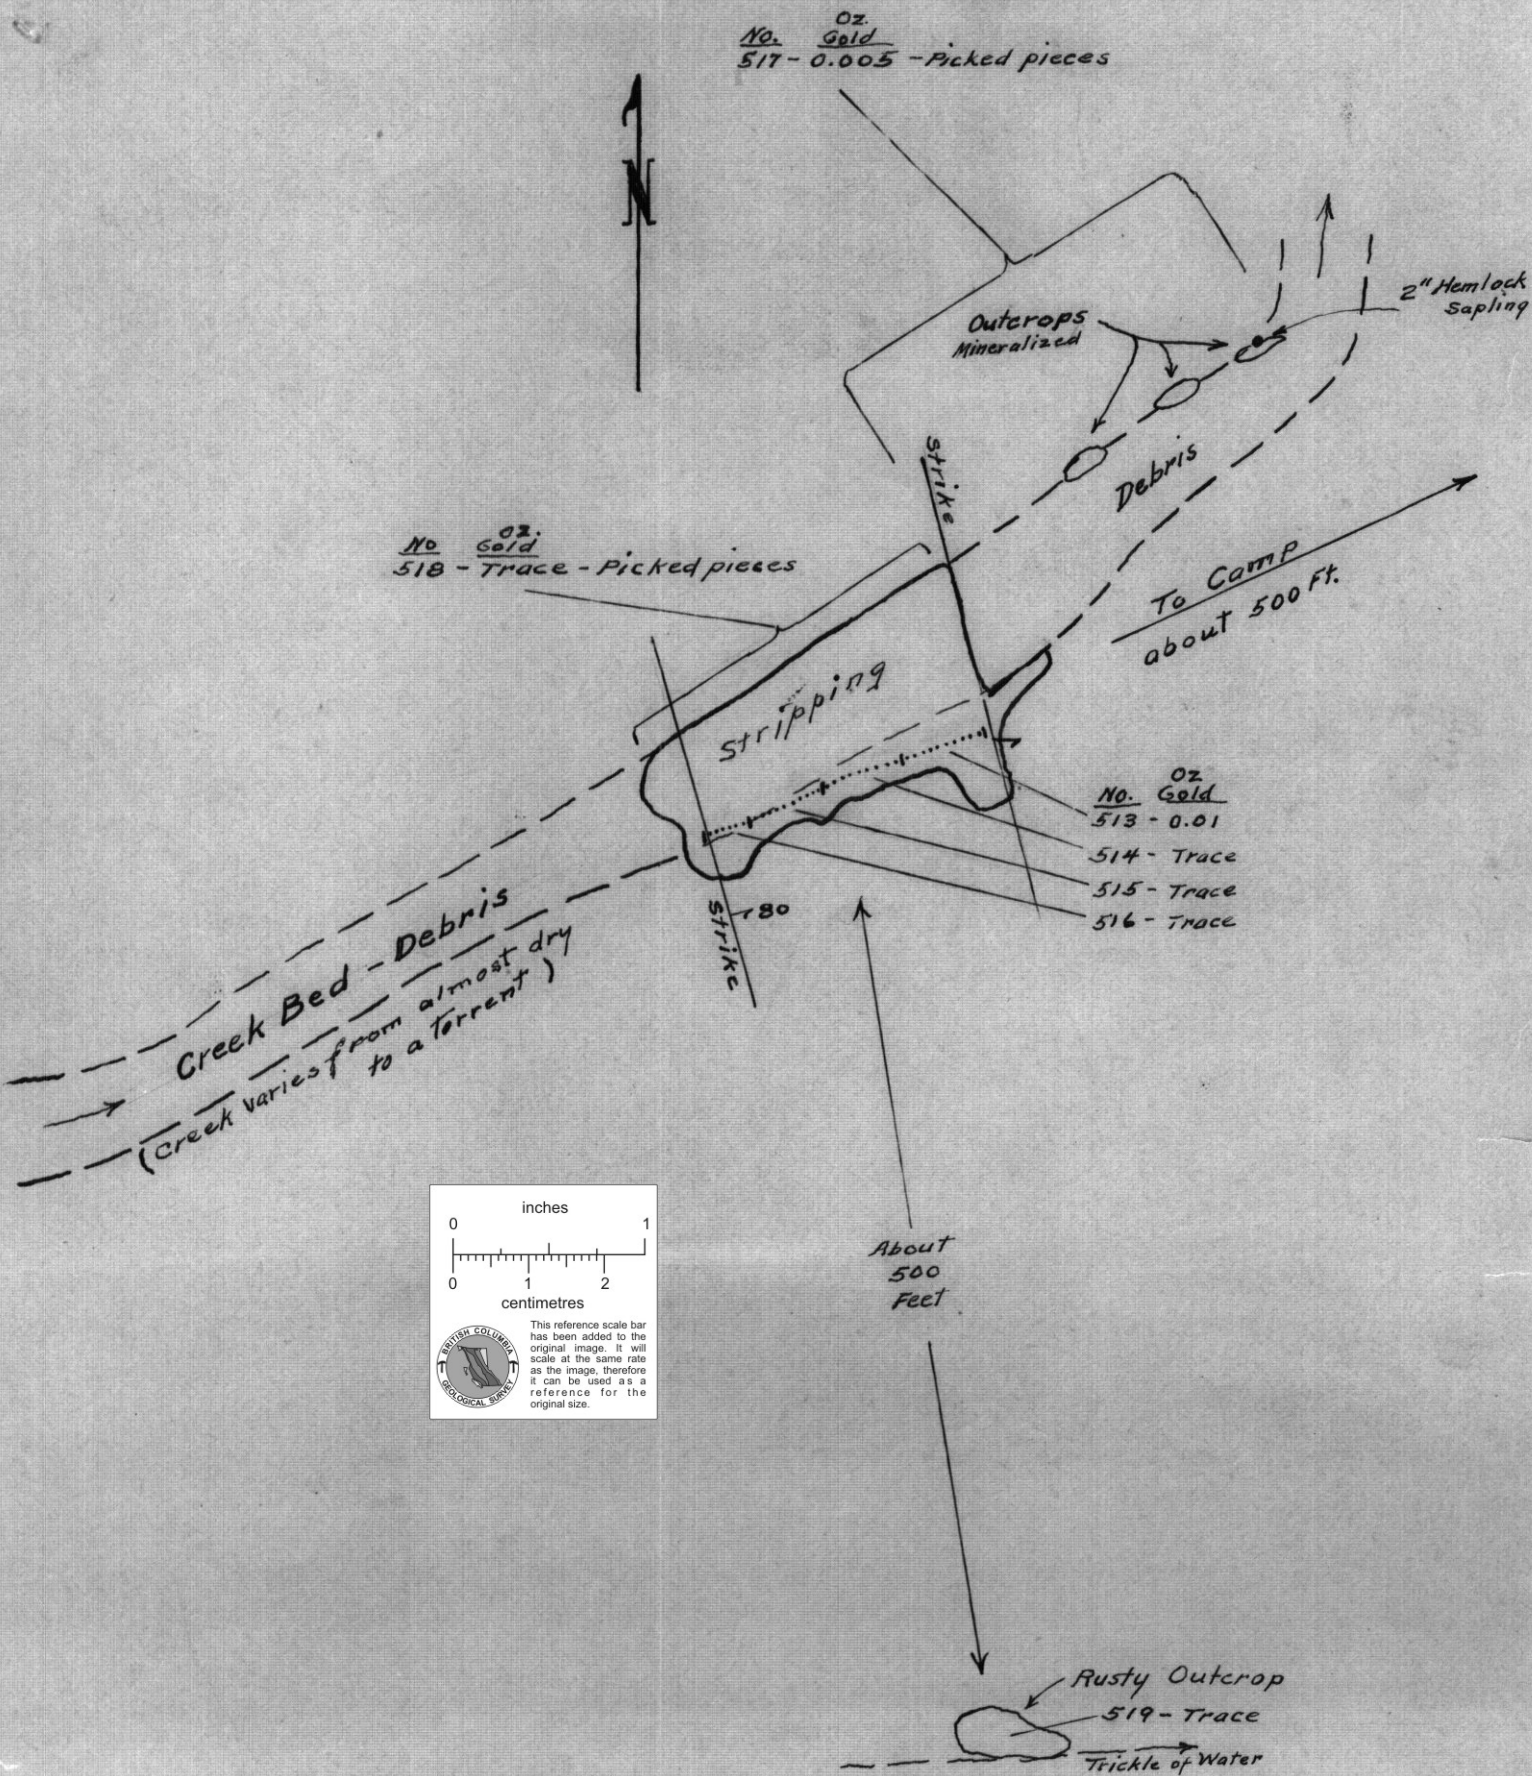
SKETCH OF  
GOLD TOP STRIPPING AND ASSAYS

**SAMPLES:** Seven samples were taken during the examination; Nos. 513 to 516, across the stripped part of the mineralized shear, were taken by continuous chipping across the shear. No. 518 is picked pieces across the best appearing spots throughout the stripped area, and No. 517 is picked pieces from the few outcrops showing east of the stripping. No. 519 is from the rusty outcrop five hundred feet west of the stripping. It was impossible to obtain a fair sample at this point without blasting on account of the hard smooth surface.

No.	Feet Width	Oz. Gold	Oz. Silver	Value
513	9.5	0.01	Trace	\$0.35
514	8.5	Trace	Trace	-
515	8.0	Trace	Trace	-
516	4.5	Trace	Trace	-
517	-	0.005	Trace	0.17
518	-	Trace	Trace	-
519	-	Trace	Trace	-

It is perhaps worthy of note that the best samples herewith (0.01 and 0.005 Oz.) came from the eastern side of the zone, and that the first sample taken by the discoverer, said to assay about \$6, is reported to have been taken between the east part of the stripping and the "2 inch hemlock sapling" some forty feet east. This area is now covered with gravel which has washed down the creek. Possibly it would be advisable to strip this area and sample it on the doubtful possibility that the values are better there. Also, it might be well to strip a narrow width across the rusty outcrop five hundred feet south, and put in a few shots to break the surface. This work, while probably justified, is a long gamble.
