AN ANALYSIS OF A SLIDE  
AT THE COTTONWOOD BRIDGE

AN ANALYSIS OF A SLIDE  
AT THE COTTONWOOD BRIDGE  
ON THE PACIFIC GREAT EASTERN RAILWAY

Hugh Nasmith

May 1954

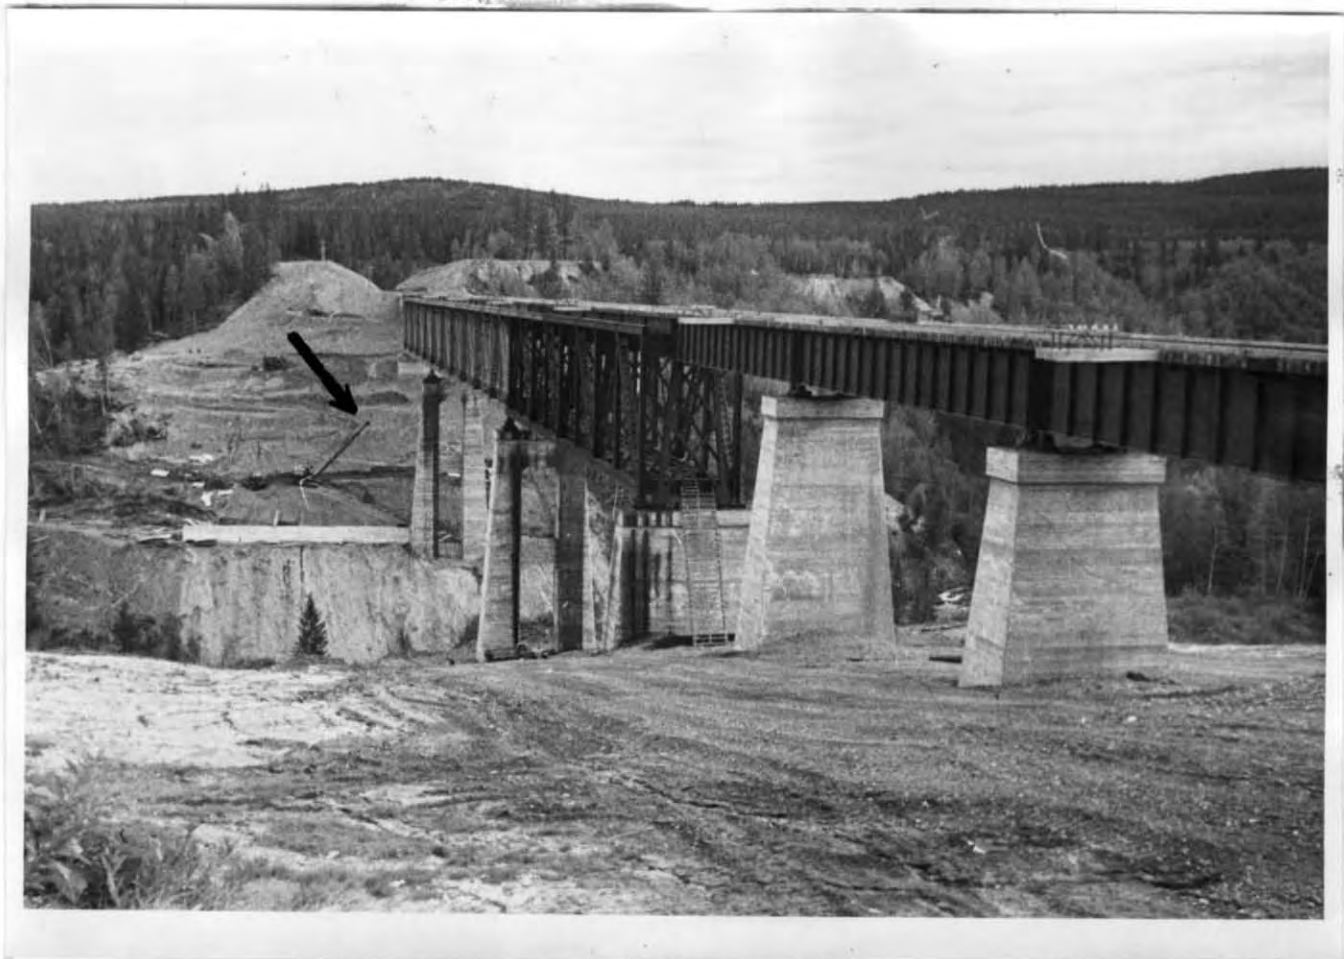
Cottonwood Bridge of the P.G.E. Railway looking north across the canyon of the Cottonwood River. Arrow indicates the general area of the slide on the north bank. (Photo by M.S. Hedley)

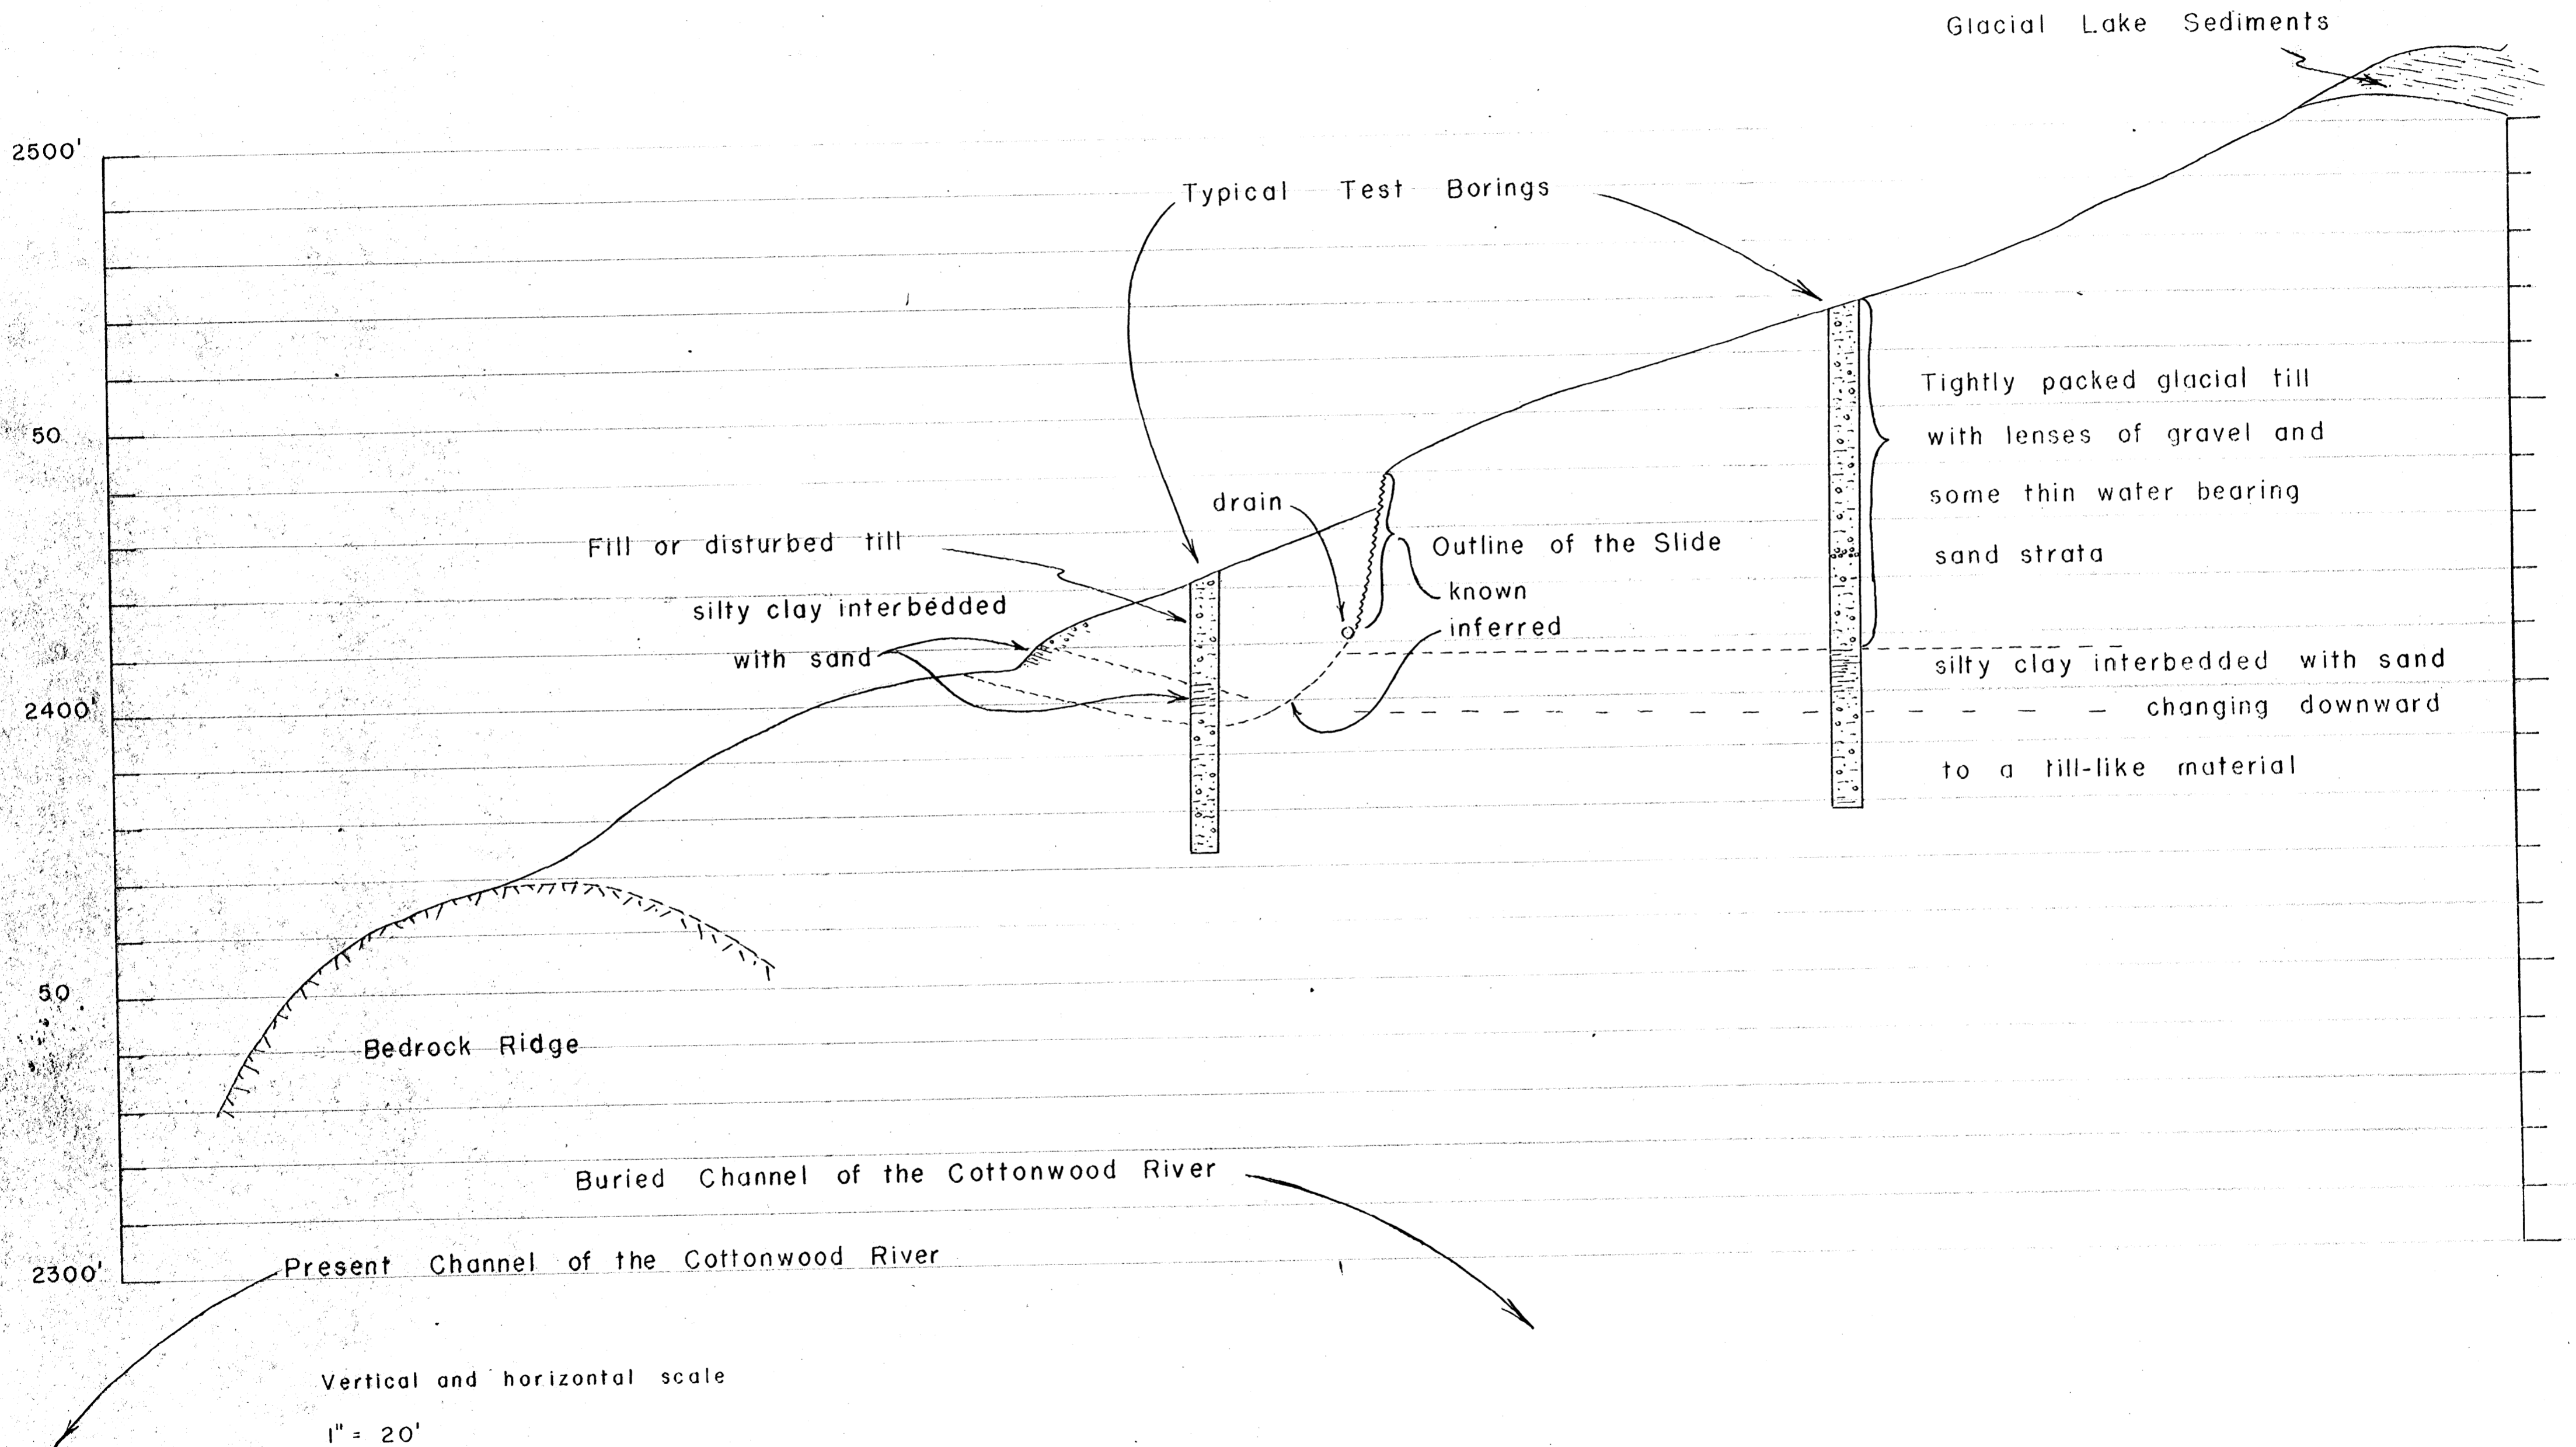
Figure 2 is a section through the area of the slide drawn along the center line of the bridge as shown on Figure 1, and showing significant information revealed by the test drilling together with graphic logs of two typical test borings. At the left of the section the Cottonwood River flows in a narrow postglacial canyon excavated in bedrock. The bedrock wall on the north side of the river rises sharply to an elevation of 2370' and then apparently slopes down to the north. The configuration of bedrock in the river channel upstream and downstream from the canyon, combined with the evidence from test drilling, clearly indicates that an interglacial or pre-glacial channel of the Cottonwood River lies immediately north of the present channel. The approximate location of this buried channel is shown dotted in red on Figure 1.

was known. Drilling in the slide area indicated fairly clearly that the ground below elevation 2390 was undisturbed by the slide, and the exposures on the slope suggested that the plane of failure had intersected the ground surface not lower than 2400'. From this information it is possible to draw the probable outline of the slide on Figure 2 with some assurance.

Within the slide area the drill holes intersected the upper surface of the silty clay layer at a lower elevation than it appeared at the surface. This indicated, as shown in Figure 2, that the silty clay layer within the slide was tipped back into the slope. In the undisturbed ground outside the slide the silty clay horizon is essentially horizontal. Therefore it is clear that the downward and outward movement of the slide was accompanied by a backward rotation of the slumped block.

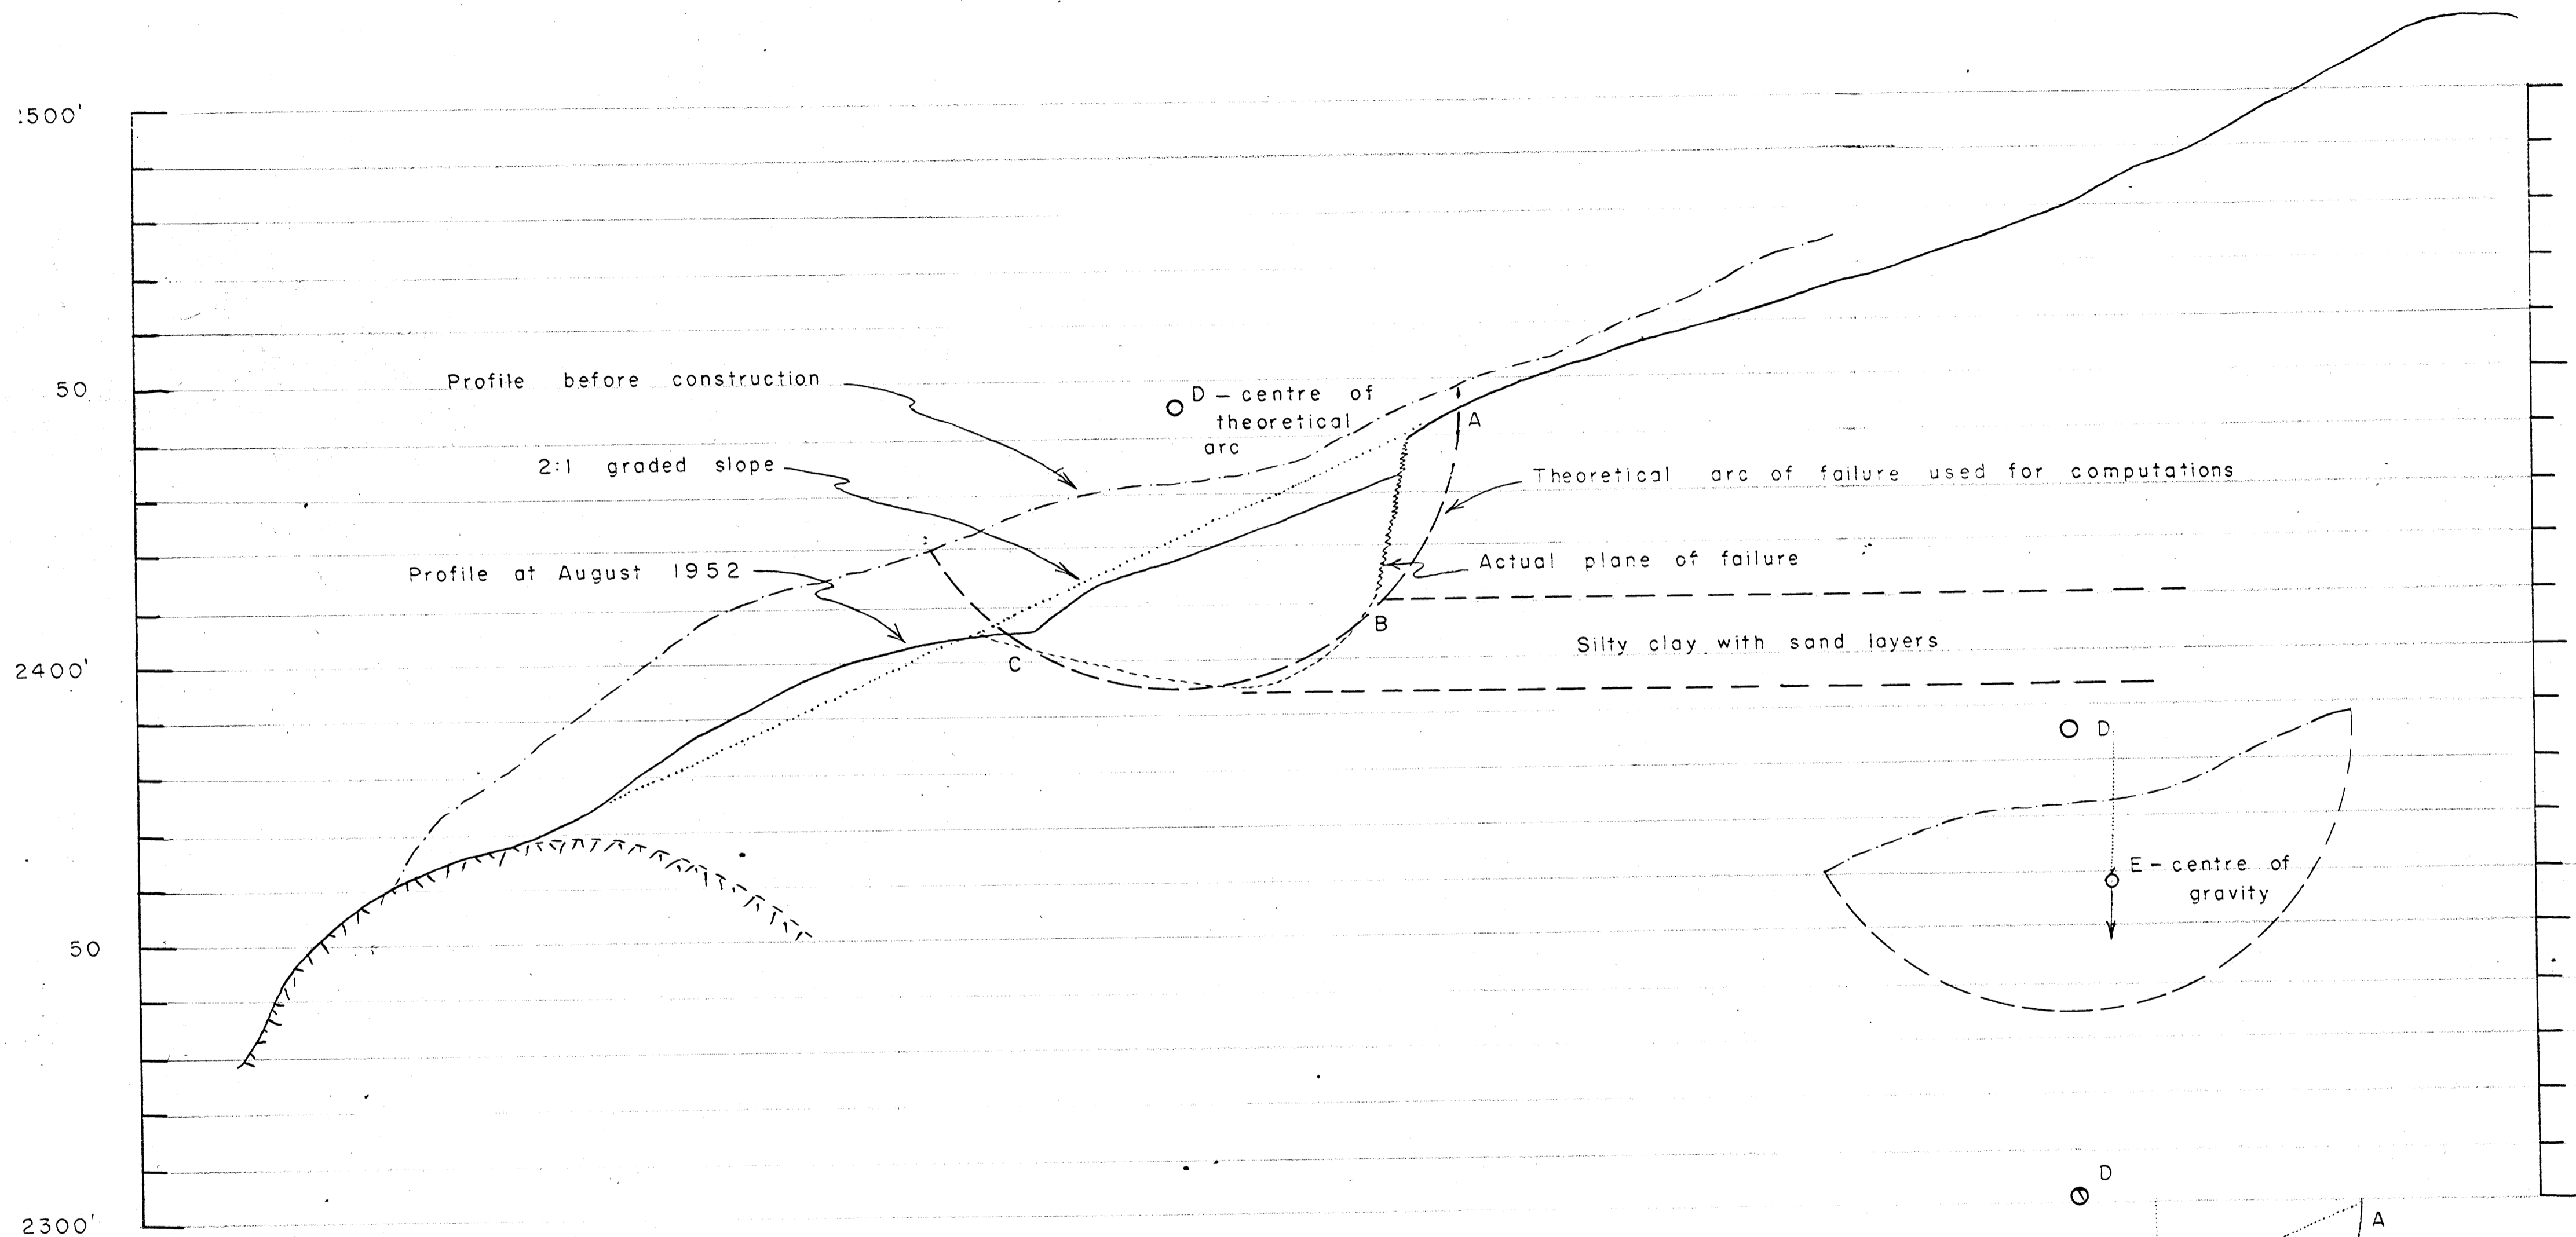
On Figure 3, which is the same section as Figure 2, the original undisturbed profile of the slope is shown as a dashed line. When the excavation for the foundation of the pier which stands on the rock ridge was made, some of the material upslope sloughed into the excavation, and the slope was accordingly graded to a uniform 2 to 1 slope as shown by the dotted line.

The headwall of the slumped block was clearly visible at the surface. Thus in Figure 3 one point on the plane of failure of the slide is defined. In the course of early efforts to check the slide a trench had been excavated and a drain put in along the headwall of the slide. The position and elevation of this drain was recorded so that a second point

The curved form of the inferred plane of failure and the indication of a backward rotation of the slumped block suggest that computations based on a circular arc of failure such as proposed by various soil mechanics authorities\* would be justified. Figure 3 shows the slope and the inferred outline of the slide in section. The circular arc A B C has

its centre at D and is as good a fit to the inferred plane of failure as can be obtained. Several other circular arcs which nearly fitted the plane of failure were tried and computed, and they gave essentially similar results.

The segment bounded by the arc A B C and the 2 to 1 slope of the ground surface at the time of failure has an area of approximately 1990 square feet. Considering a section one foot thick with an average density of 120 pounds per cubic foot this segment has a weight of 238,800 pounds which may be considered to act through the centre of gravity of the segment at E. Thus the weight of the segment acts along a vertical line 14.5 feet to the right of the centre D and exerts a turning moment of 3,460,000 ft. lbs ( $238,800 \times 14.5$ ) tending to rotate the segment in a clockwise direction. This turning moment is opposed by a counterclockwise moment made up of the total shearing resistance developed along the arc A B C acting at a distance D A (the radius of the arc) from the centre of the arc D. The length of the arc A B C is 115' and the radius D A is 51'. In order therefore, for the segment to be stable as to sliding along the arc A B C the moment developed by the shearing resistance must be equal to or greater than the moment developed by the weight of the segment. Therefore, average shearing resistance per square foot along A B C  $\times 115 \times 51 \cong 3,460,000$ ; and on the average each square foot along the arc must be capable of developing a shearing resistance equal to or greater than 590 pounds.

Similar computations were made for a segment of the same circle centred at D bounded by the original ground surface instead of the surface graded to a 2 to 1 slope. This represents the conditions which prevailed along the theoretical arc of failure before construction was begun, conditions under which the undisturbed slope had evidently remained stable for many years prior to construction. These computations indicate that prior to construction an average shearing force of 380 pounds per square foot had to be developed along the theoretical arc of failure in order to prevent sliding. Thus, as a result of grading the slope, the shearing force along the plane which actually failed was increased by about 55%. It is thought that this large percentagewise increase in shearing stress was an important

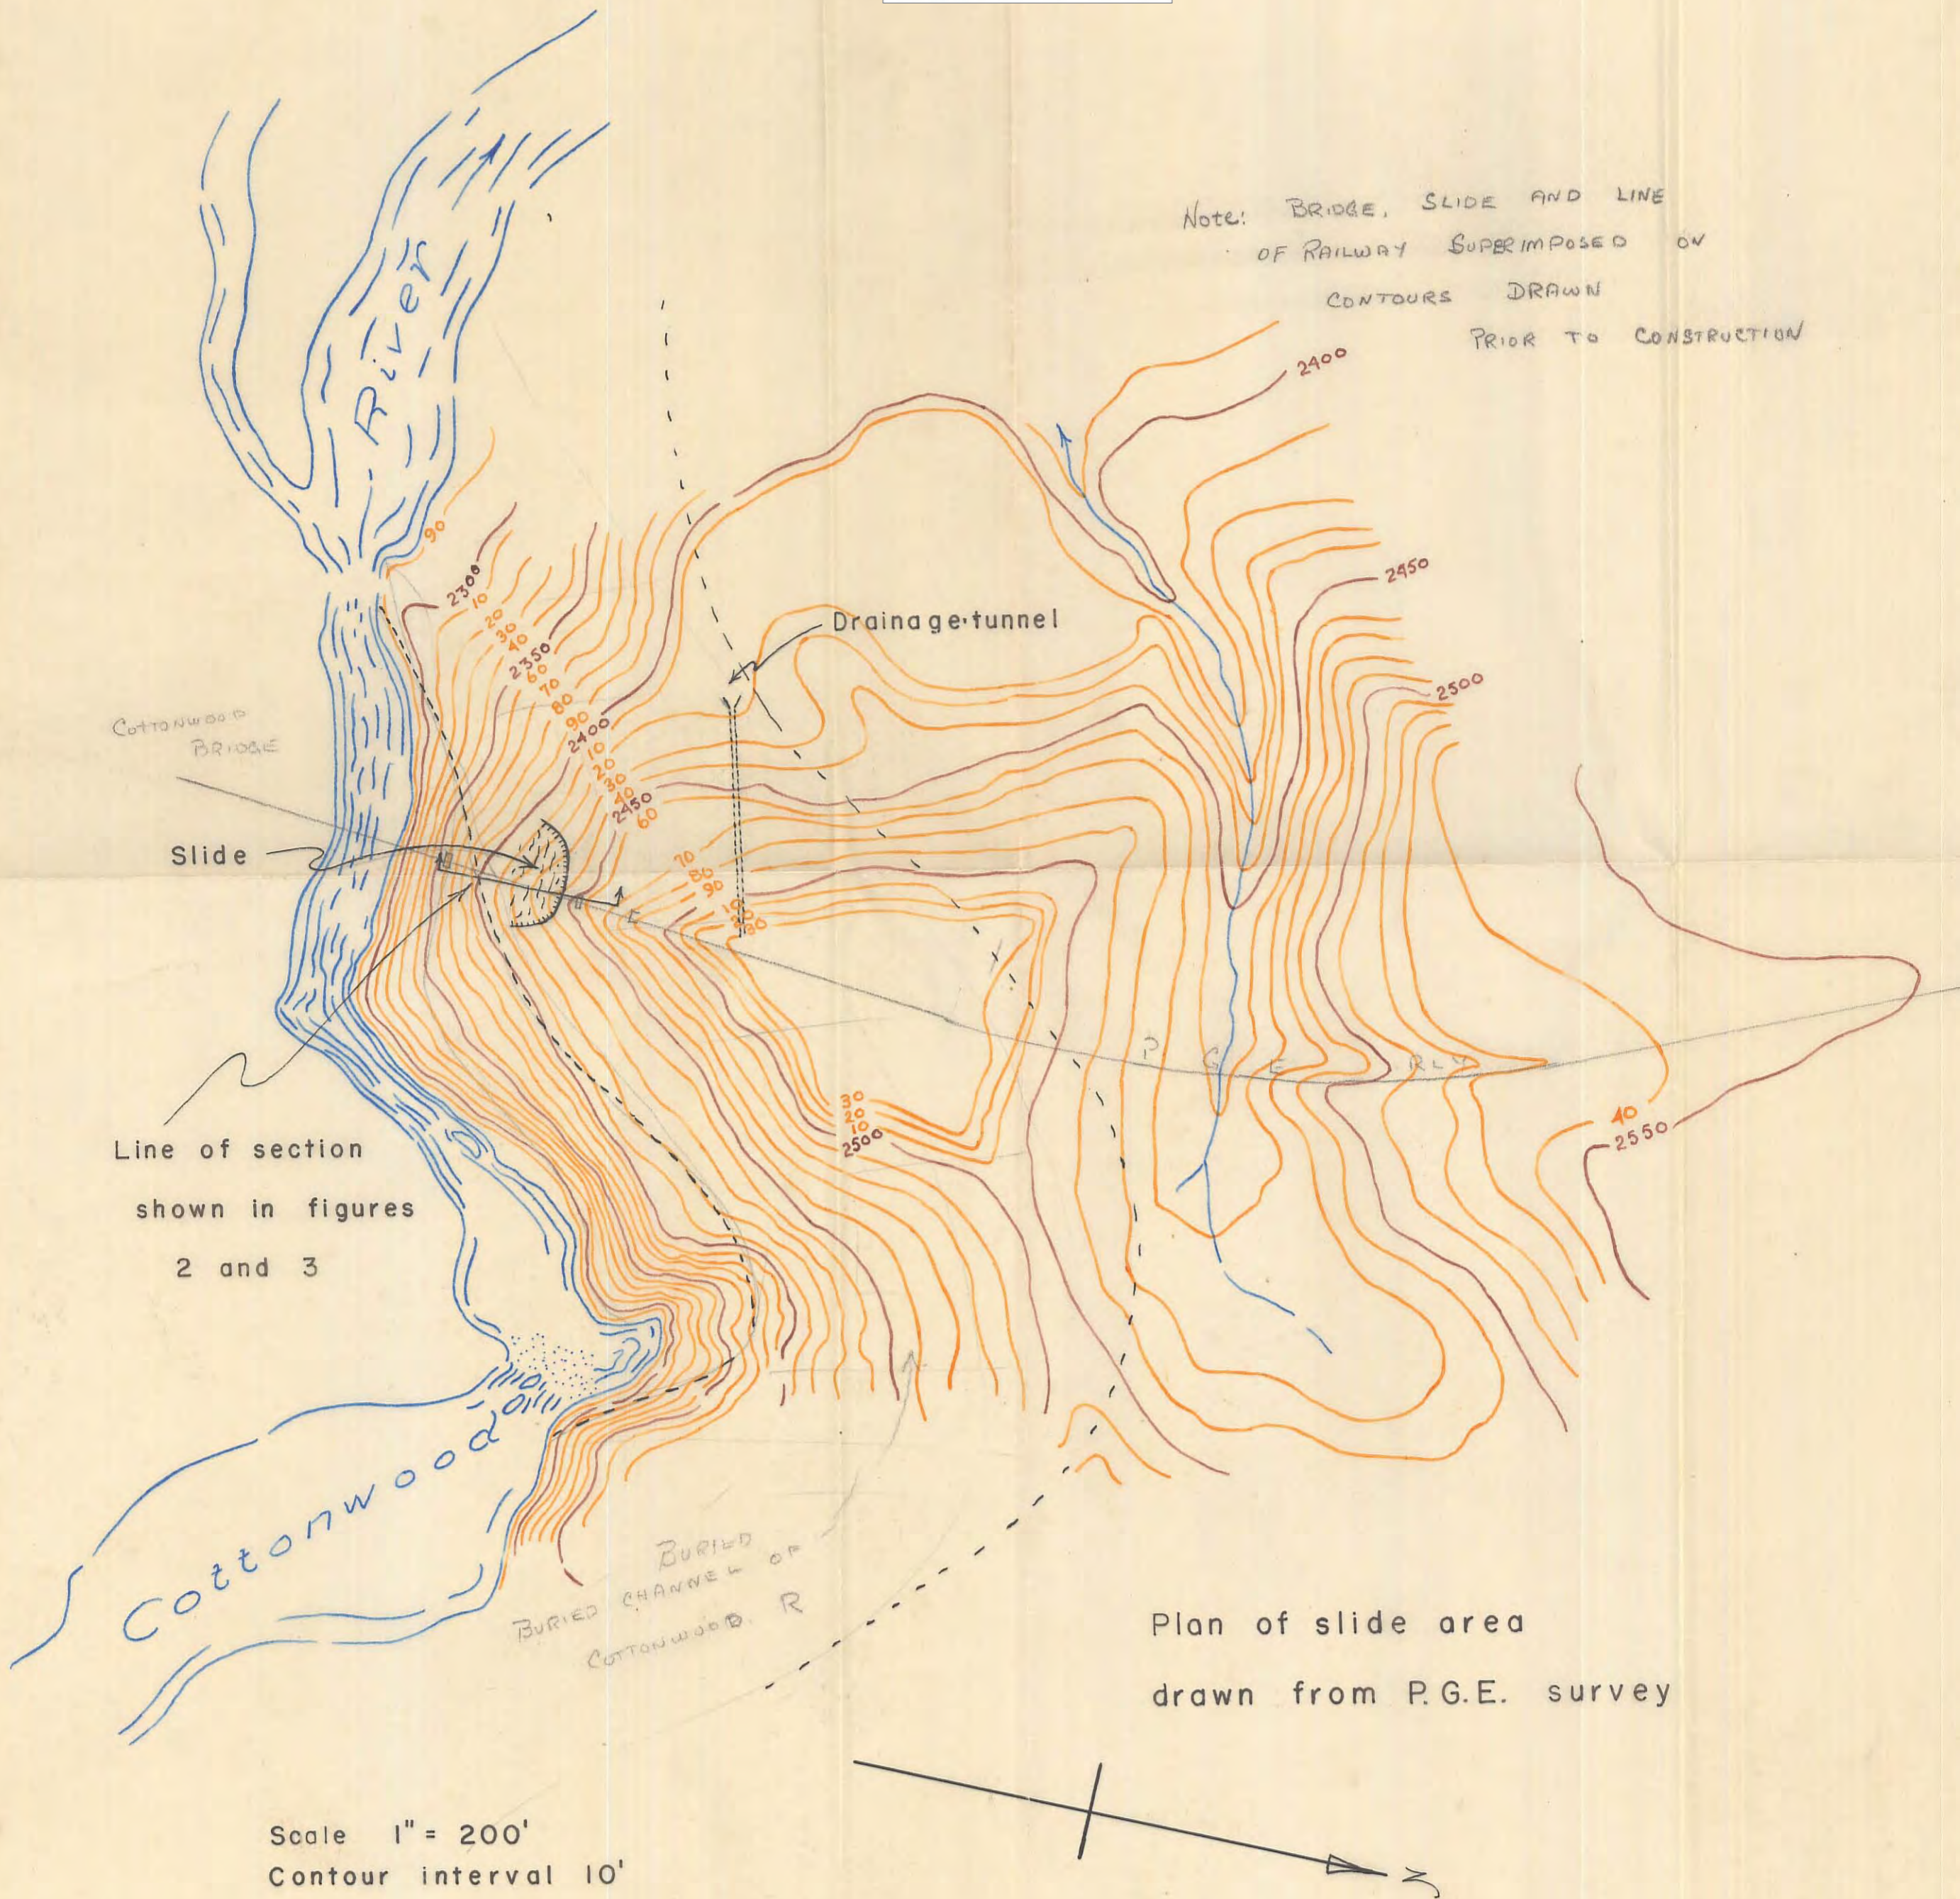
Figure 1

As can be seen from Figure 1, the obvious place where precipitation might percolate into the ground and then move laterally to the area of the slide is the little valley containing an intermittent stream about 1000 feet north of the slide. No test drilling was done in this area so that the character of the material beneath the surface is unknown, but coarse bouldery material is present in the bed of the little stream. Possibly this little valley is underlain by deposit of gravel which can collect and store infiltration from the bed of the stream, and from which the water can flow laterally into any permeable horizons with which it is in contact. The elevation of the bottom of the creek is adequate to account for the greatest hydrostatic head found in any of the drill holes.

Measures to correct the unfavourable ground-water conditions consist of a drainage tunnel in the silty clay layer. It is driven in a northeast direction as shown on Figure 1. A series of vertical holes were drilled from the surface to the tunnel and packed with gravel. These vertical drains are expected to collect seepage from any water bearing strata they pass through, and to carry it to the tunnel which is also packed with free draining material. It is believed that this tunnel and the vertical drains will effectively cut off seepage into the area of the slide from the north as well as reduce any hydrostatic pressure which might develop.
