GRAND CANYON DAMSITE

By W. C. Jones

British Columbia Department of
Mines and Petroleum Resources

February 8, 1962

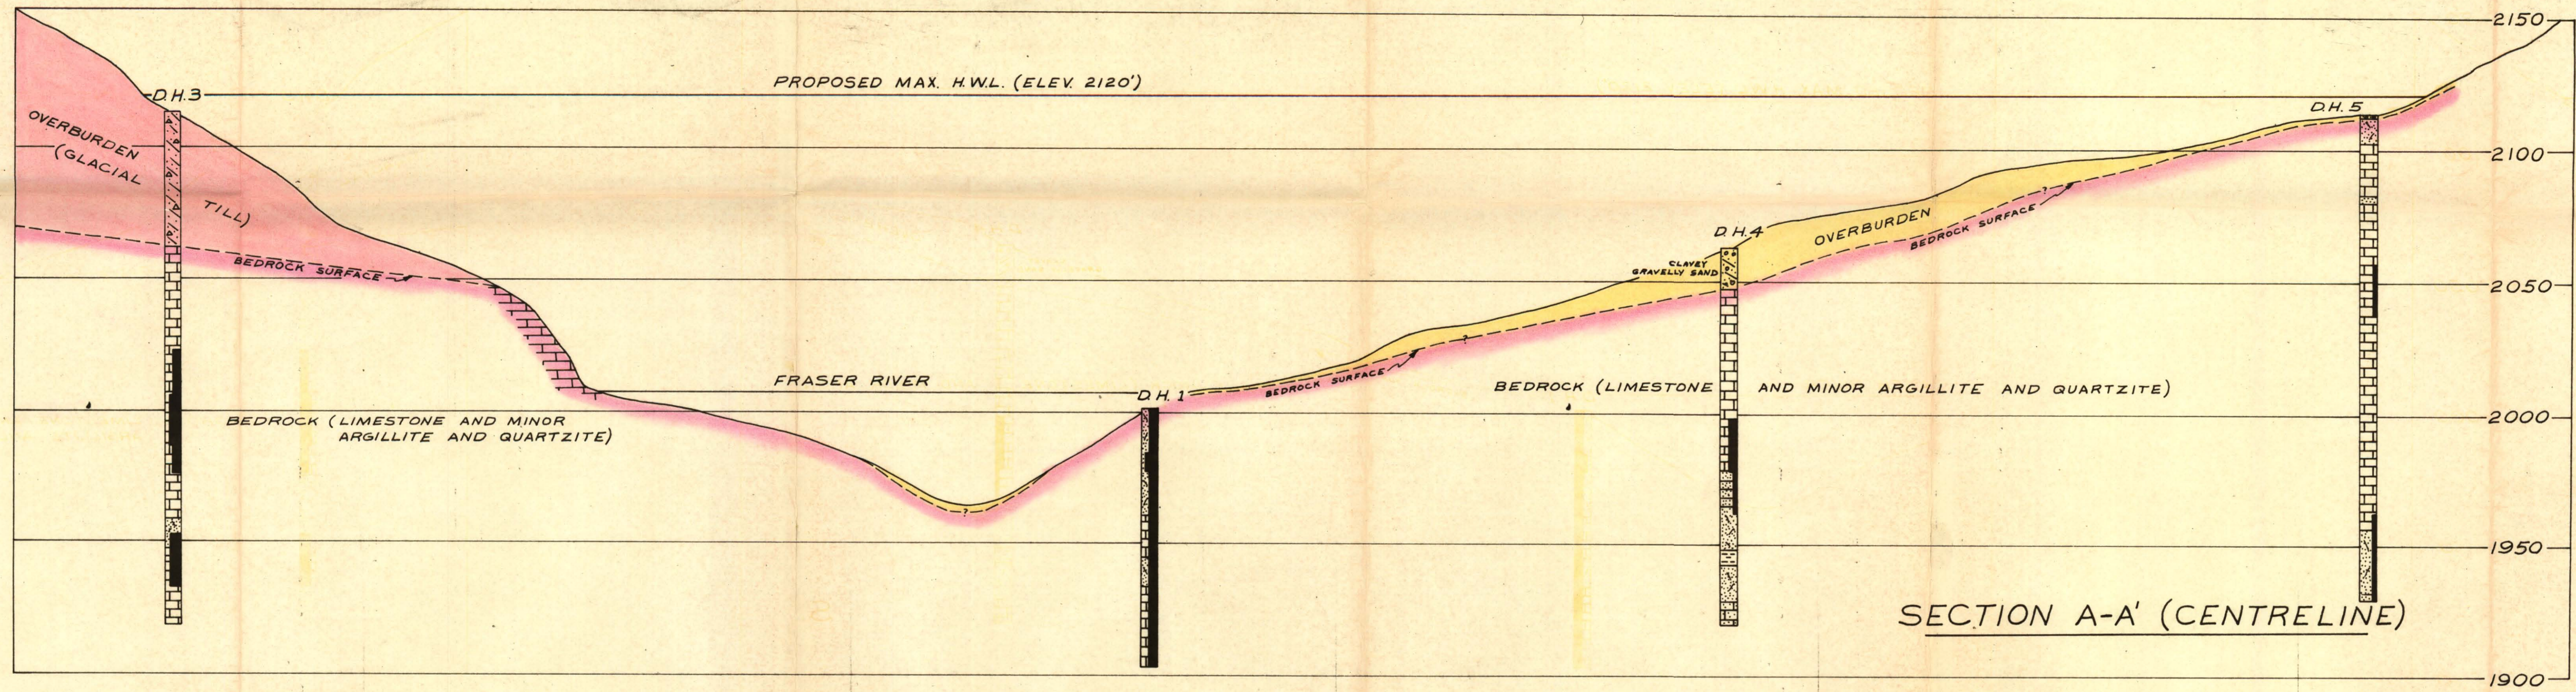
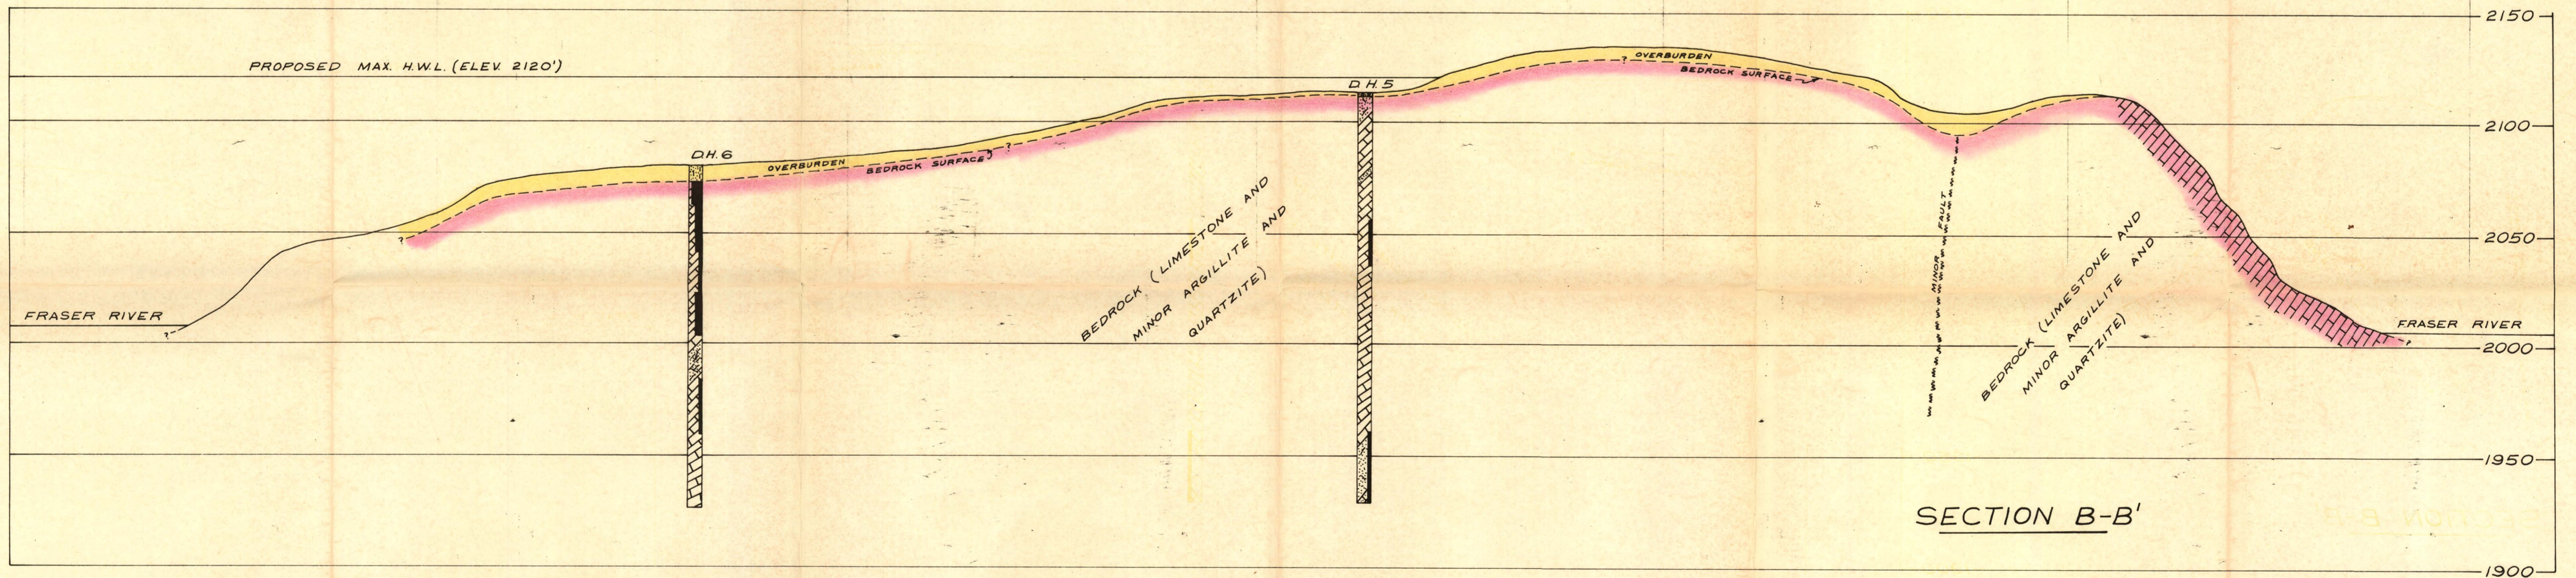
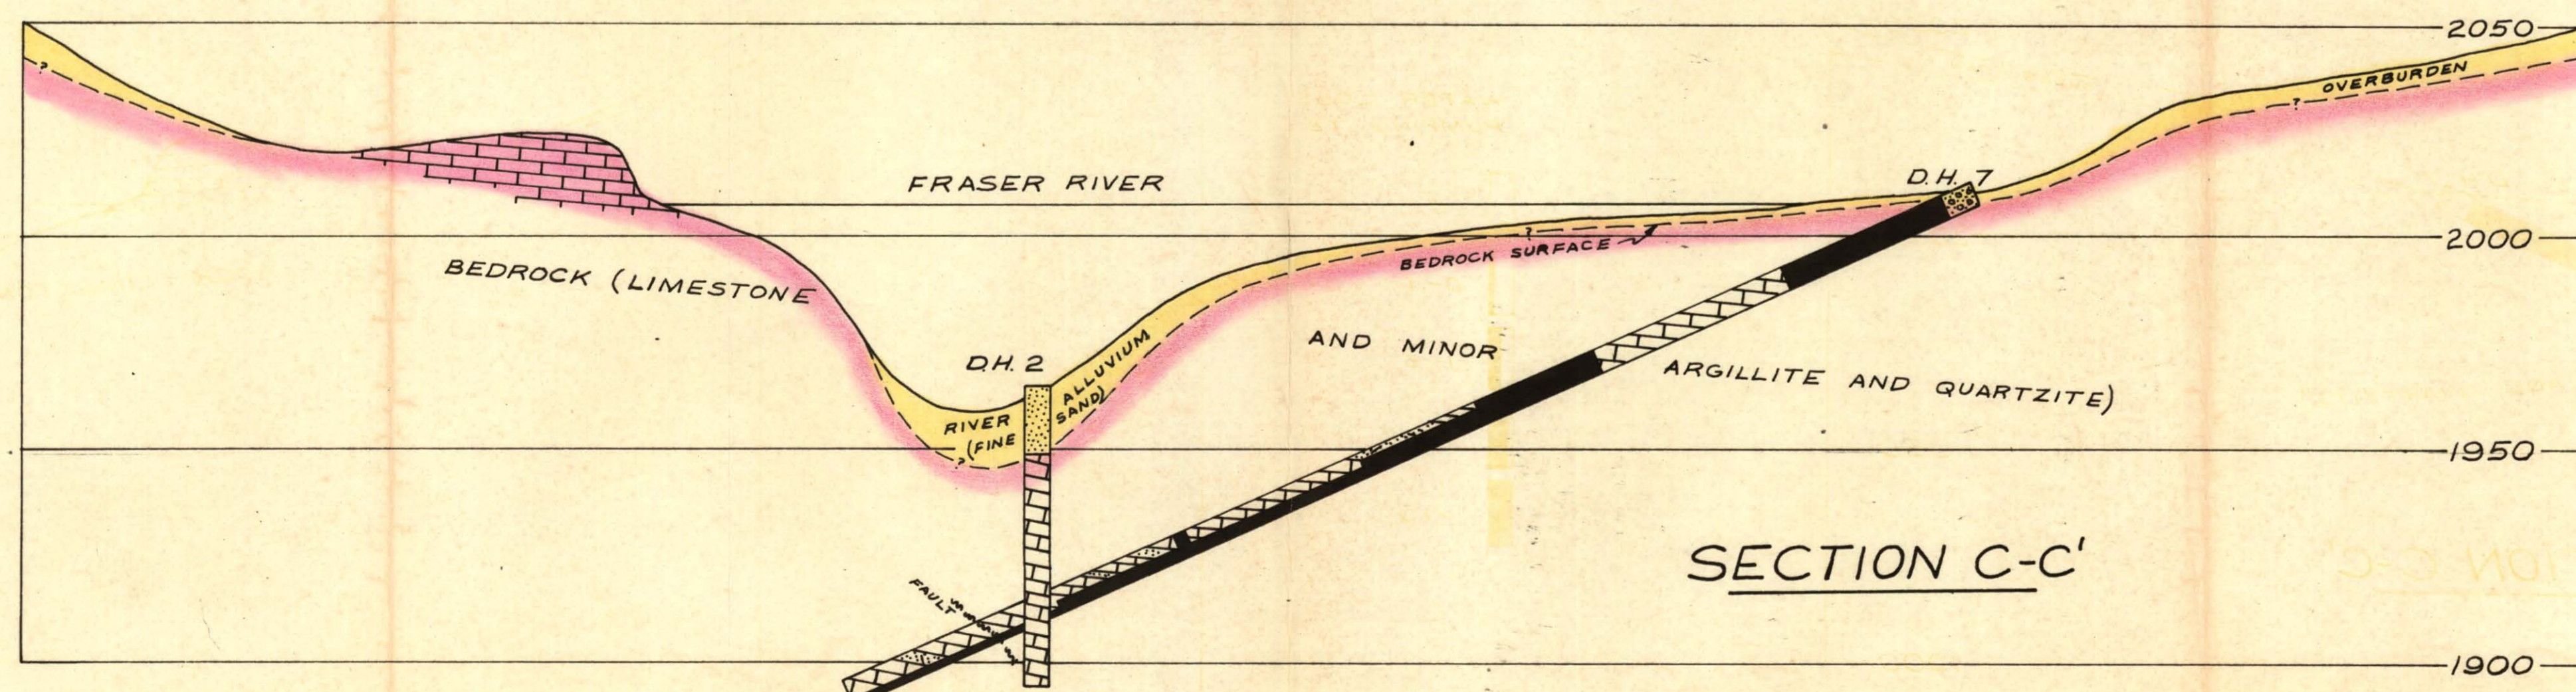
FIG. 2

Recent river alluvium consisting mainly of reworked glacial lake silts and sands overlies bedrock in the present river channel at the site and forms bars in the river upstream and downstream from the site. The bars are locally capped by a thin veneer of coarse, well-rounded gravel. Drill hole 2, put down in the river about 80 feet from the left bank and 150 feet downstream from the proposed centreline (see Section C-C', Fig. 2) encountered 16 feet of loose, fine sand overlying bedrock. It is expected that the river alluvium is probably somewhat shallower at the proposed centreline (see Section A-A', Fig. 2) than in the vicinity of drill hole 2 or in the deep pool which

The three drill holes put down in the river (see Sections A-A' and C-C', Fig. 2) indicate a considerable variance in the water conducting properties of the rock underlying the river bed in this immediate area. Drill hole 1 and the upper half of the angle hole 7, drilled near the right bank and under the right part of the river channel respectively, recorded generally high water losses during pumping tests, apparently mainly through open joints, whereas drill hole 2 and the lower section of drill hole 7, drilled near the central and left part of the river channel, recorded no to low water losses during pumping tests. Although several small faults and one relatively wide fault (drill hole 7, -252 feet to -258 feet) were encountered in these holes, the faults are apparently mainly filled with clay gouge and do not appear to offer open channels for the passage of water. No cavernous areas were detected in any of the limy rocks penetrated by these holes.

Except for sections of rock penetrated by drill hole 3, put down on the left bank, the three holes drilled into the proposed abutment areas (see drill holes 3, 4, and 5, Section A-A', Fig. 2) recorded no or, locally over short sections, low water losses during pumping tests although relatively severely fractured

The chief problem associated with the soils at the site is the depth and extent of the glacial till in the left abutment area. The bedrock surface is approximately 70 feet lower than the proposed dam crest at drill hole 3 (see Section A-A', Fig. 2) and appears to slope toward the river at about 7 degrees below horizontal in this immediate area. A steep cliff composed of the same formation as that exposed at the site occurs about 2,000 feet northwest of drill hole 3. Until further pre-construction drilling is done on the flat immediately above and to the west of drill hole 3, it must be assumed that the bedrock surface under this flat is at the same general elevation as encountered in drill hole 3 or rises very gradually to the base of the cliff mentioned above. As previously stated, till was encountered in several of

type of grouting cannot be accurately determined with the information presently at hand. The depth of the primary grout curtain required under the heel or core wall of the dam is also difficult to predict but the drilling done to date suggests that it may need only be shallow in the abutments but possibly about 70 to 80 feet deep under the river section.
