REPORT ON**TAILINGS DAM INSPECTION
CAROLIN MINES
HOPE, BRITISH COLUMBIA**

Athabaska Gold Resources Limited
#200 - 1185 West Georgia Street
Vancouver, B.C.
V6E 4E6

October 27, 1995

952-1483

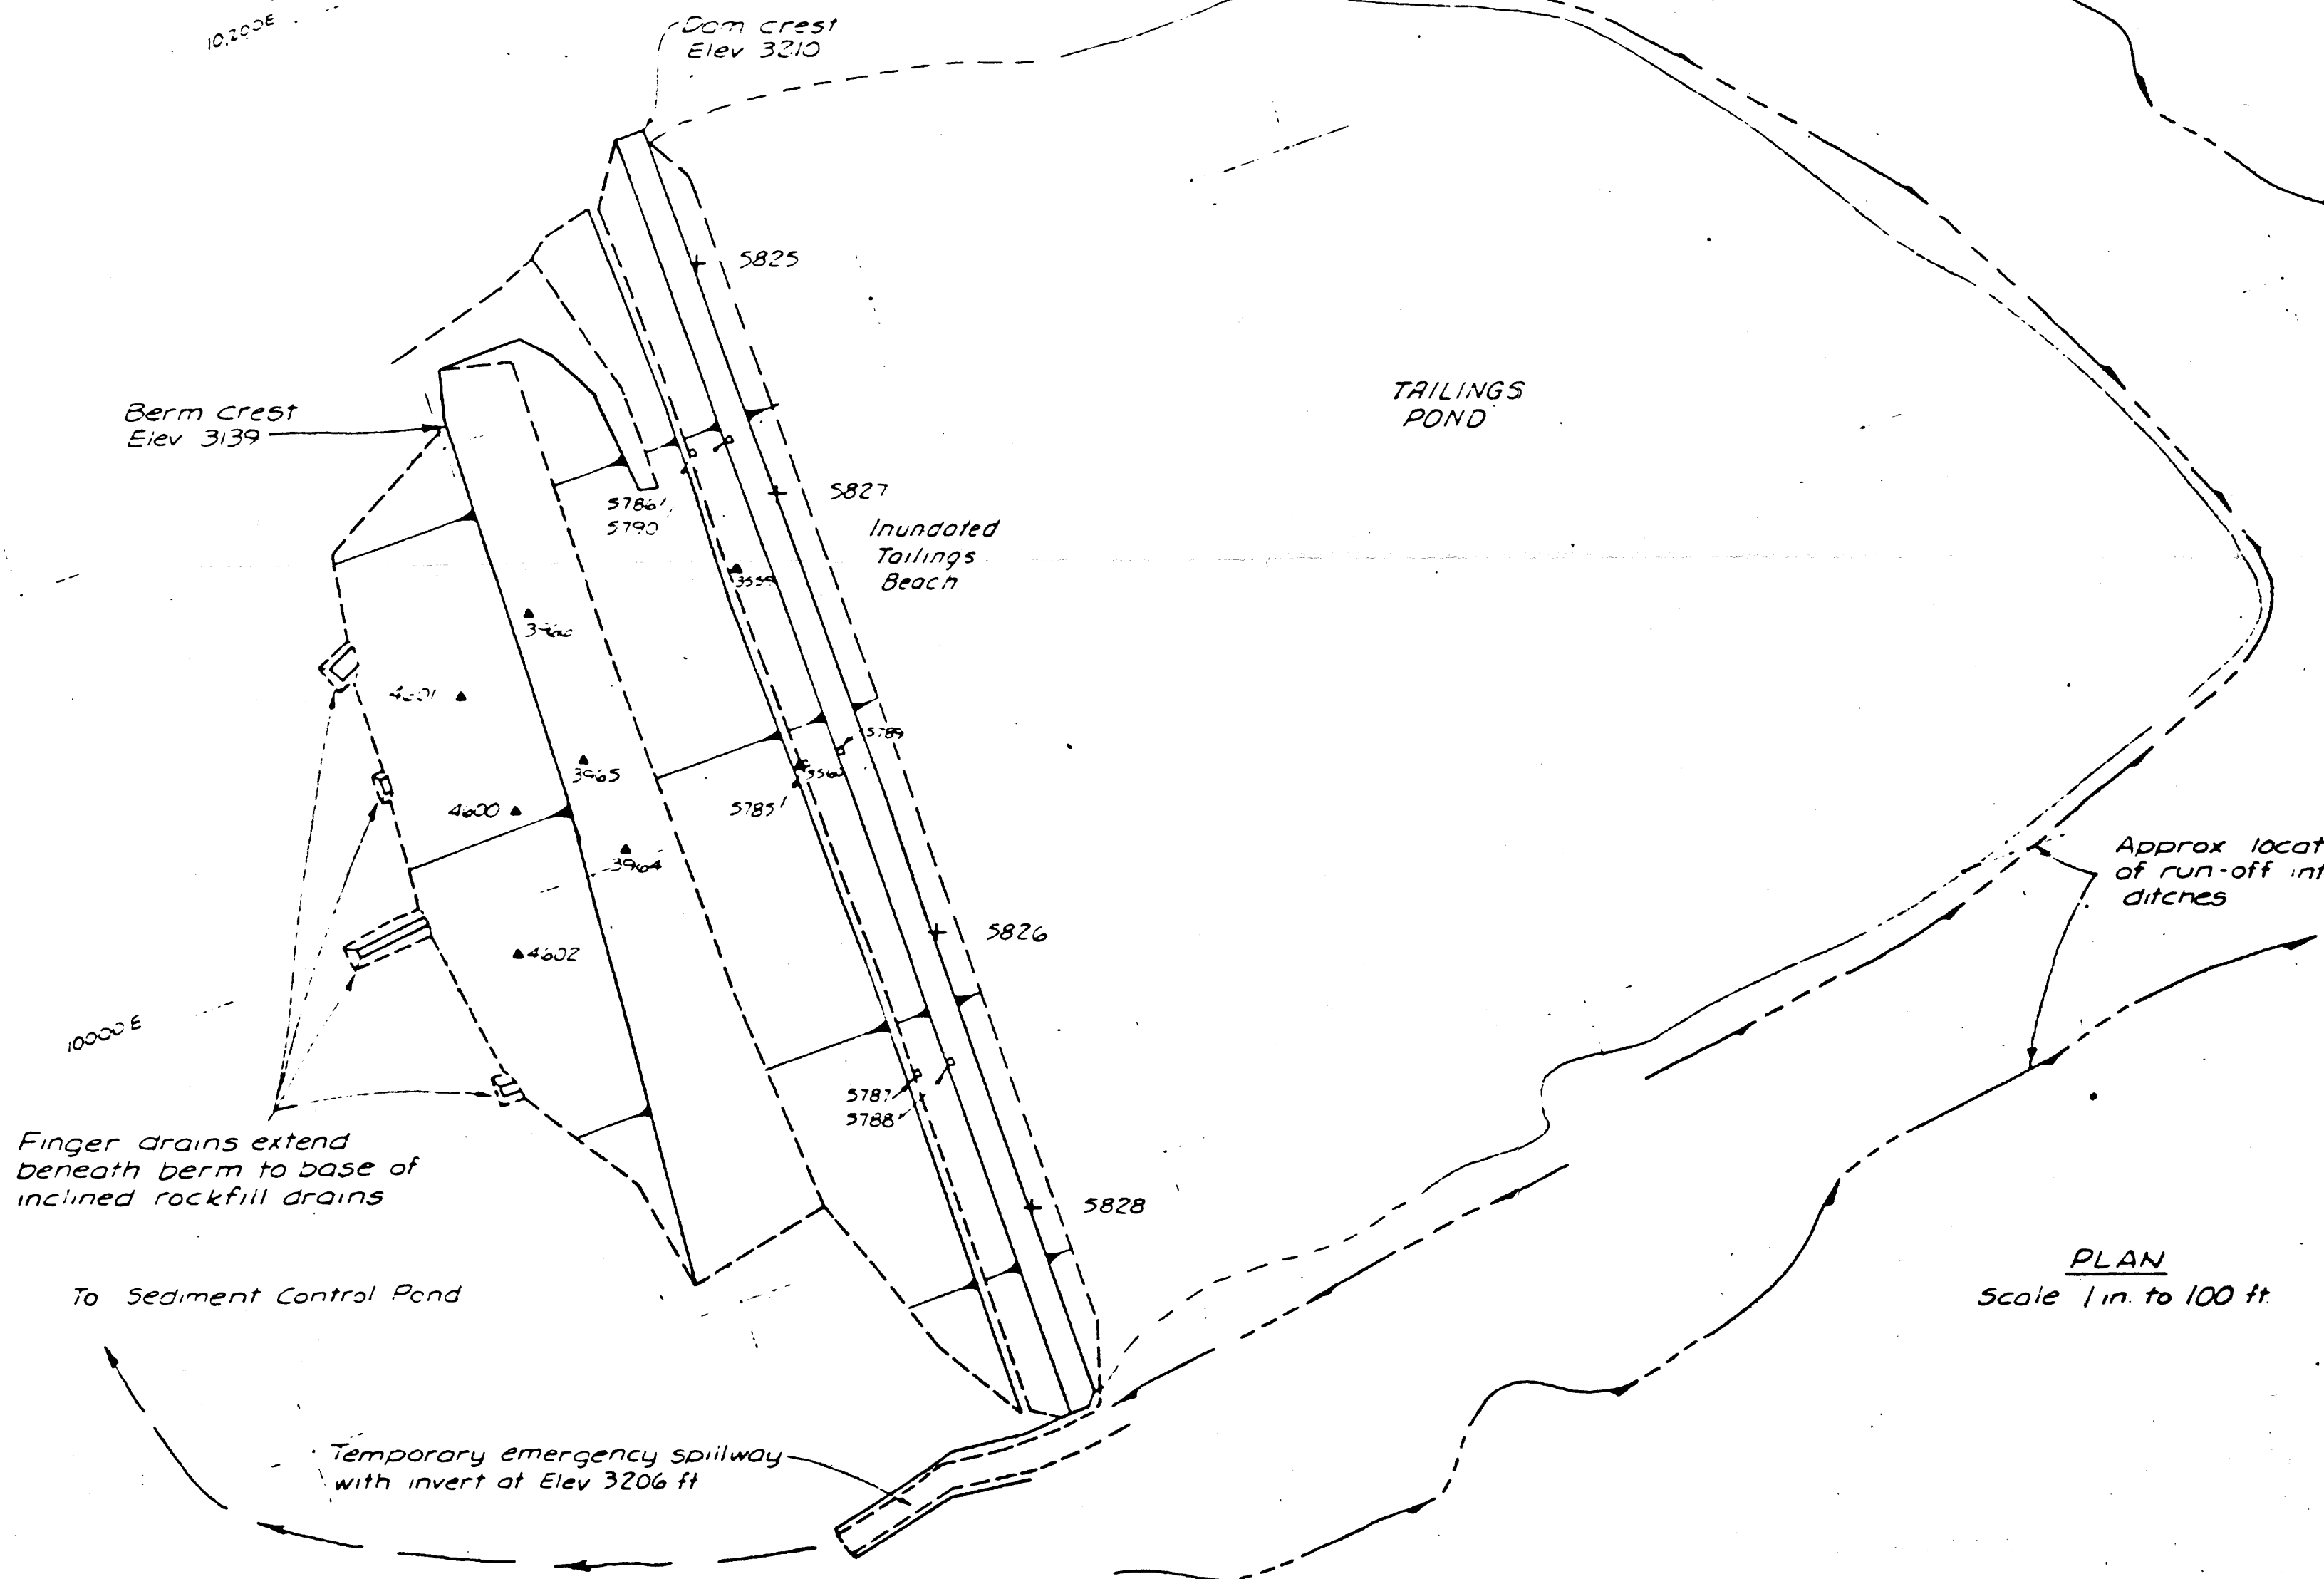
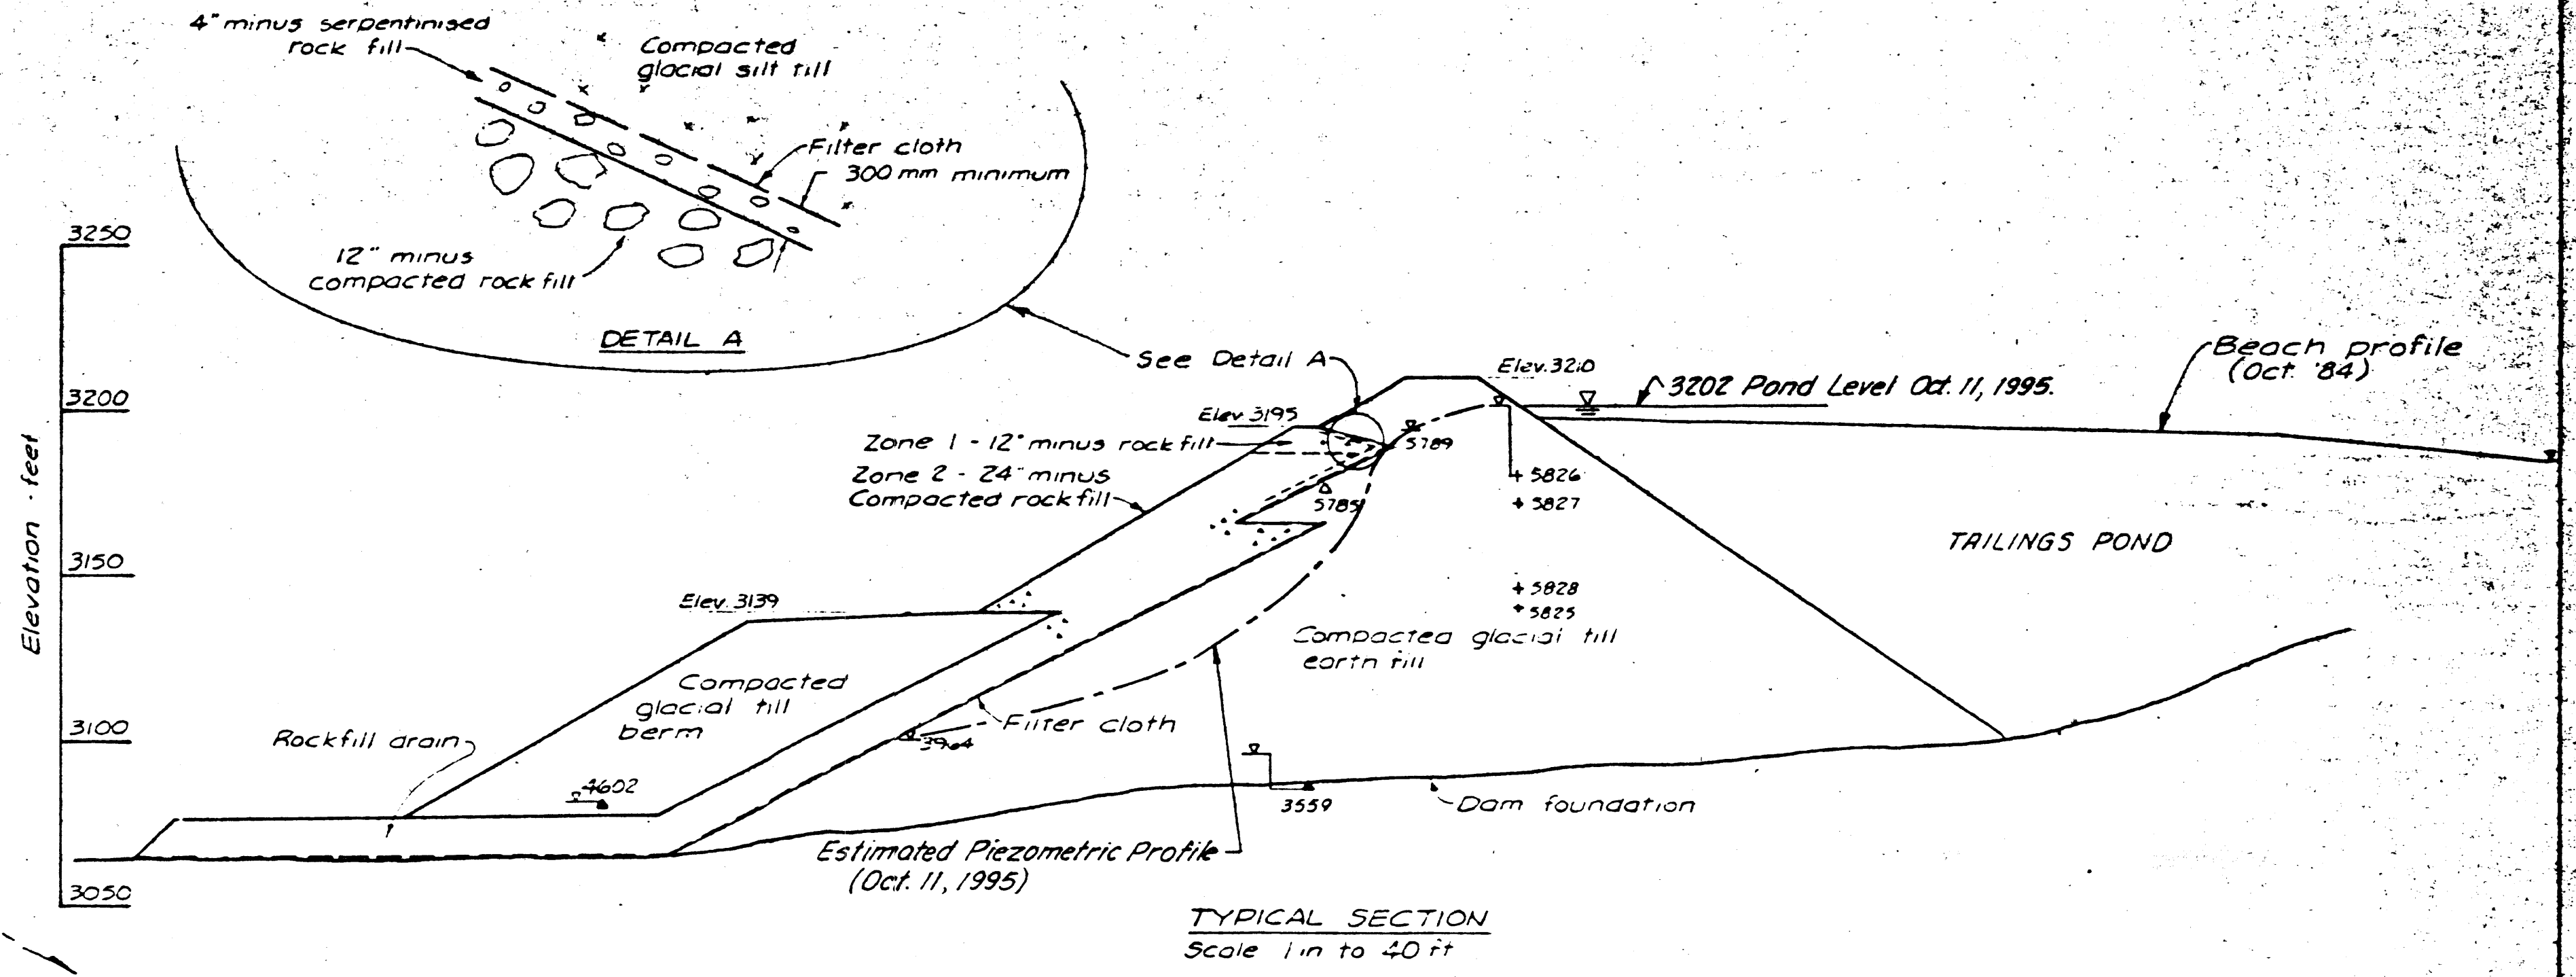
CAROLIN MINES LTD.			
Golder Associates			
CAROLIN MINES TAILINGS DAM COMPLETION OF FIRST PHASE STAGE II DAM			
drawn	R.D.	checked	AW
date	OCT. '95	project	052-1483
figure	3	revised	F.E.

- The mill effectively ceased operation during 1984 and the final tailings solids beach level is as shown on Figure 3.
- The water storage level behind the dam ranged from 3,190 to 3,203 feet during the period 1984 to 1987 as water quality affected discharge. From mid 1987 to 1989 the pond level was controlled by pumped and siphoned discharge, and was maintained near elevation 3,187 feet.

No mill operation has taken place during the period from 1989 to 1995, and therefore the tailings solids stored remain the same as in 1984 and as shown on Figure 3. The beach is currently inundated but ranges from elevation 3,194 to 3,199.5 feet at its intercept with the upstream dam slope.

The piezometer readings and phreatic surface are considered indicative of full pond storage to elevation 3,206 feet. The results indicate that seepage is discharging through the upper core section into the upper rock drain. This indicates a high phreatic surface in the central section of the dam core. Additional piezometers are required to replace those destroyed, in the central section of the dam, in order to provide a reliable appraisal.

There is presently insufficient piezometric detail to fully define the seepage conditions within the dam. This has resulted because of the destruction of piezometer leads on the dam crest. We recommend that four additional piezometers be installed at this time from the dam crest. This work would be undertaken by means of a percussion drill rig using casing and drilling fluid. The piezometers would be installed to replace piezometers numbered 5825, 5827 and 5828.
