672868

W. R. Bacon, P. ENG.

October 19th, 1970.

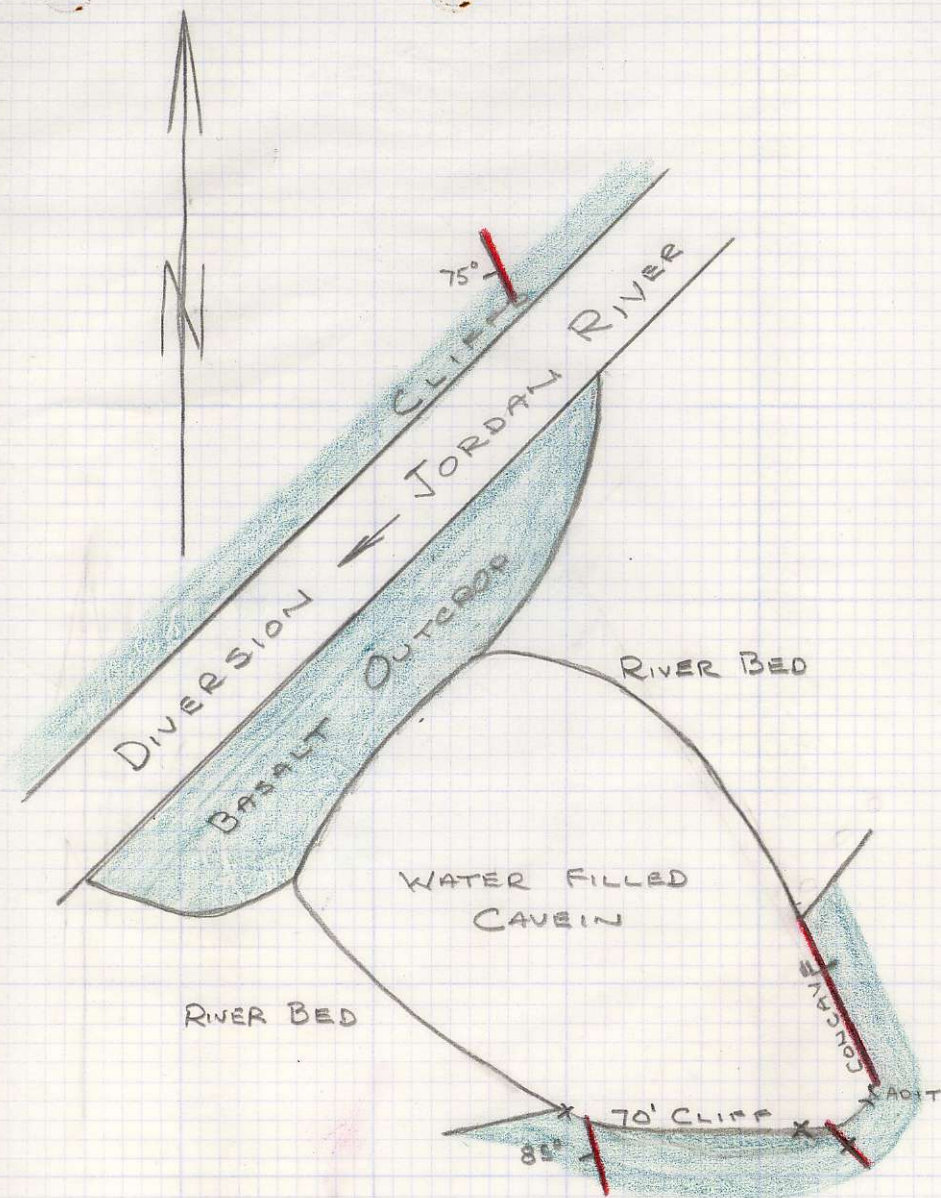
"Three steeply dipping shears stand out prominently in the cliffs and are noted in the accompanying sketch. All strike northwesterly and are marked by slickensides, i.e. planes of movement.

Because of the fracturing and the shearing, the rock bordering the cavein on the south must be classified as incompetent."
