MINNOVA INC.

DATE: April 7, 1992  
TO: Ian Pirie  
COPIES TO: Agreement File.  
FROM: Dave Heberlein.  
SUBJECT: Wolf Property Environmental Audit.

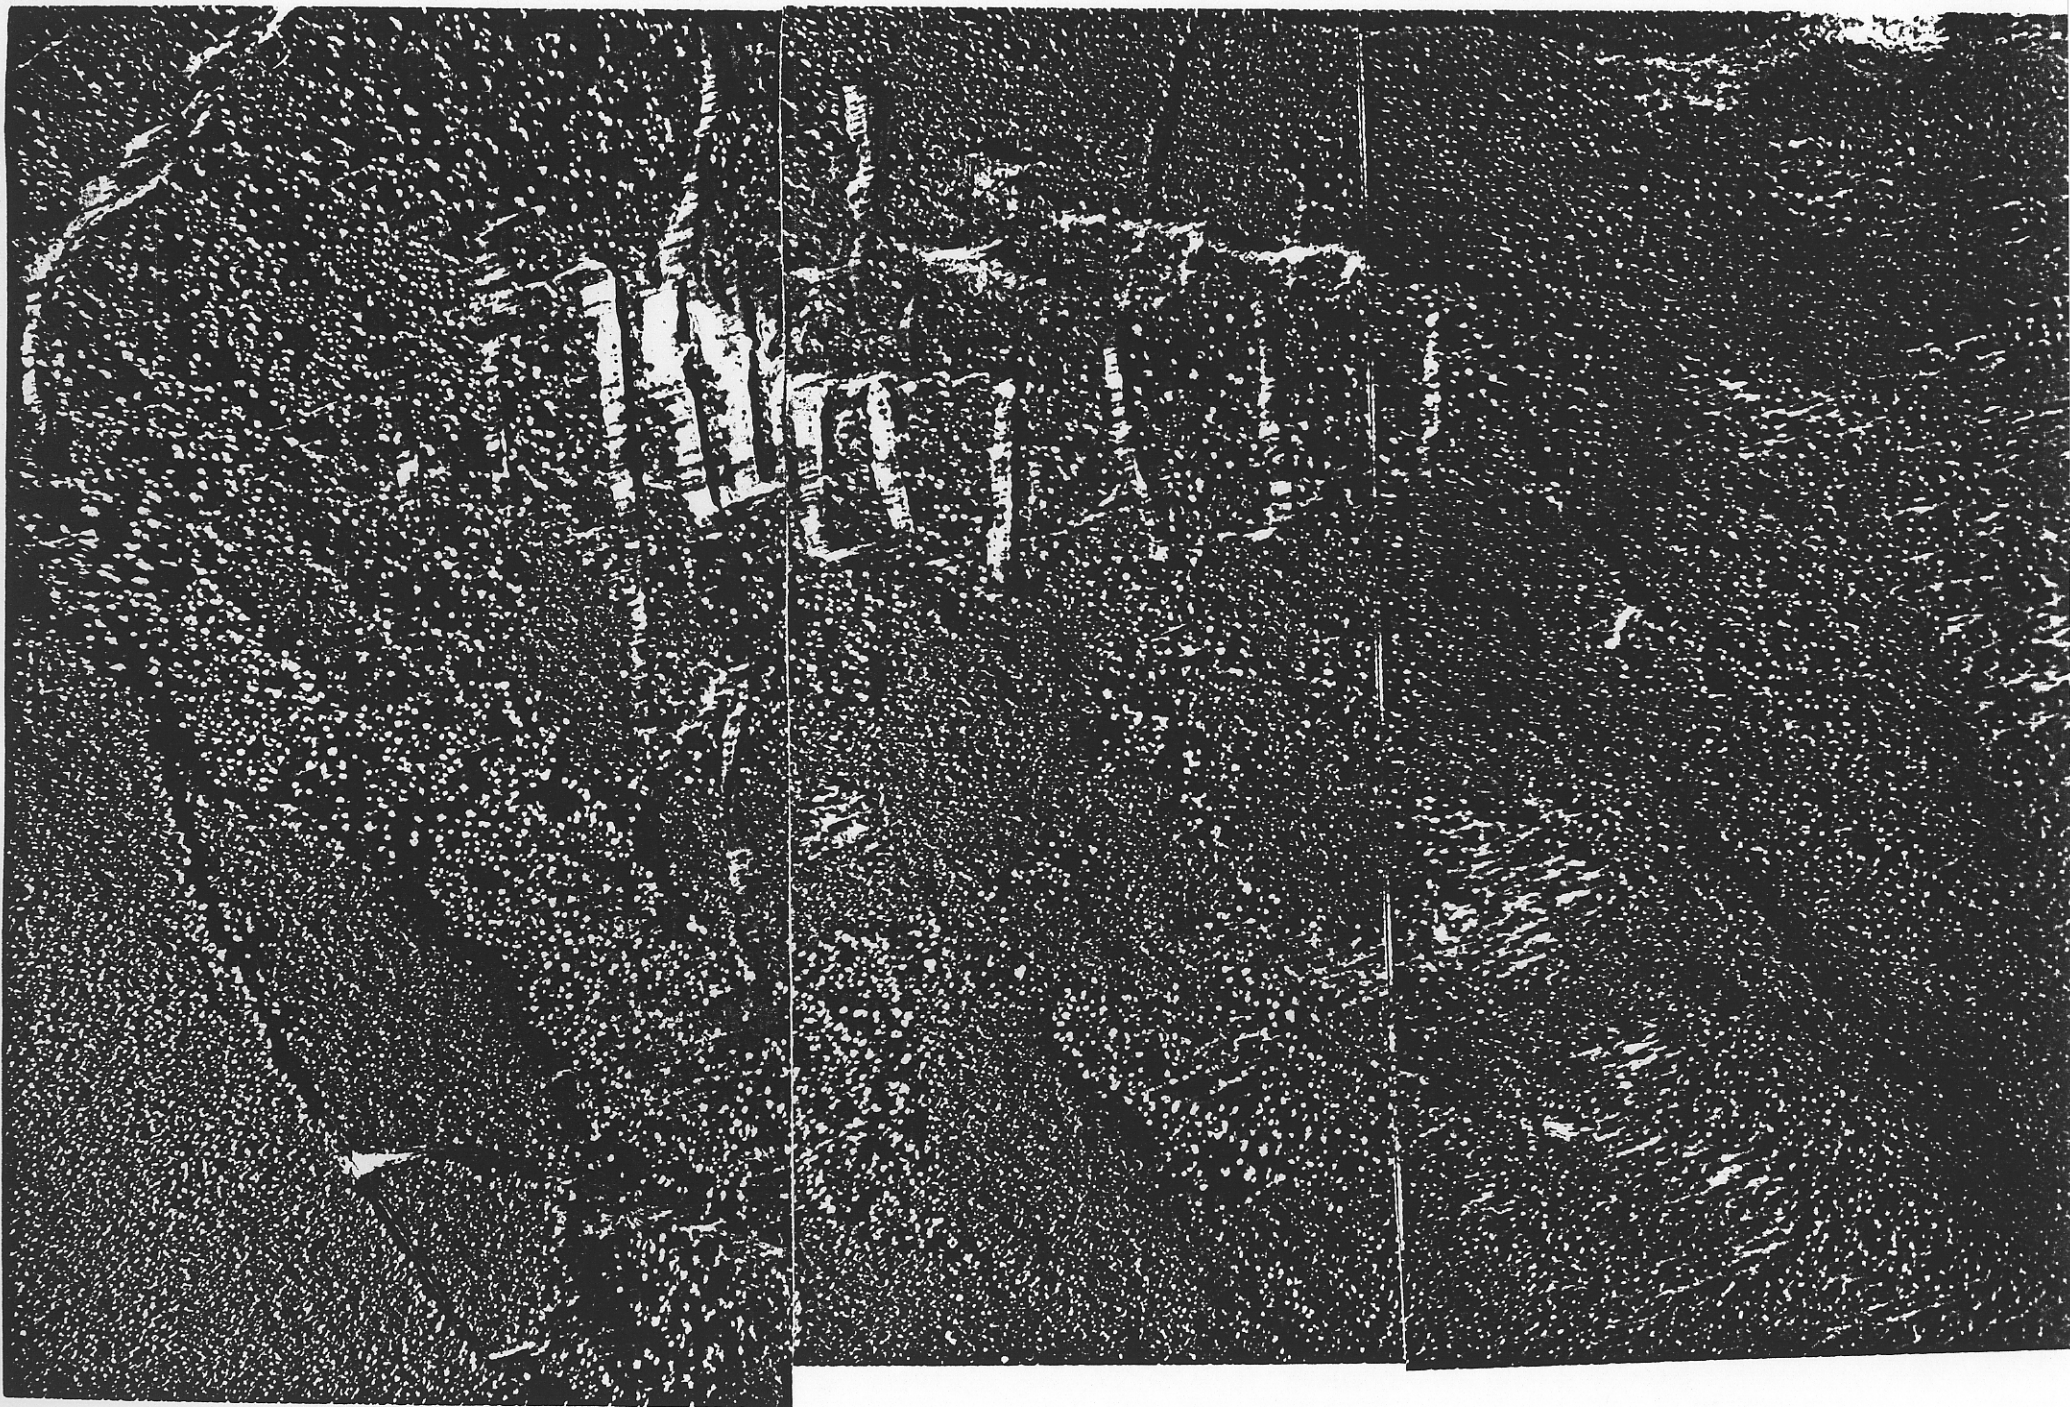
RIDGE ZONE - TRENCHES FROM AIR.

Although the amount of trenching work done at the Ridge Zone is extensive, it does not seem to pose any environmental problems. As far as we can determine, the work exceeds the requirements of the Guidelines for Mineral Exploration and conforms with the Forestry Regulations on cutting and timber disposal. Trees felled during the trenching program were either recovered or buried in the road beds.

Reclamation of the roads and old trenches can be done at the same time as our own reclamation program.

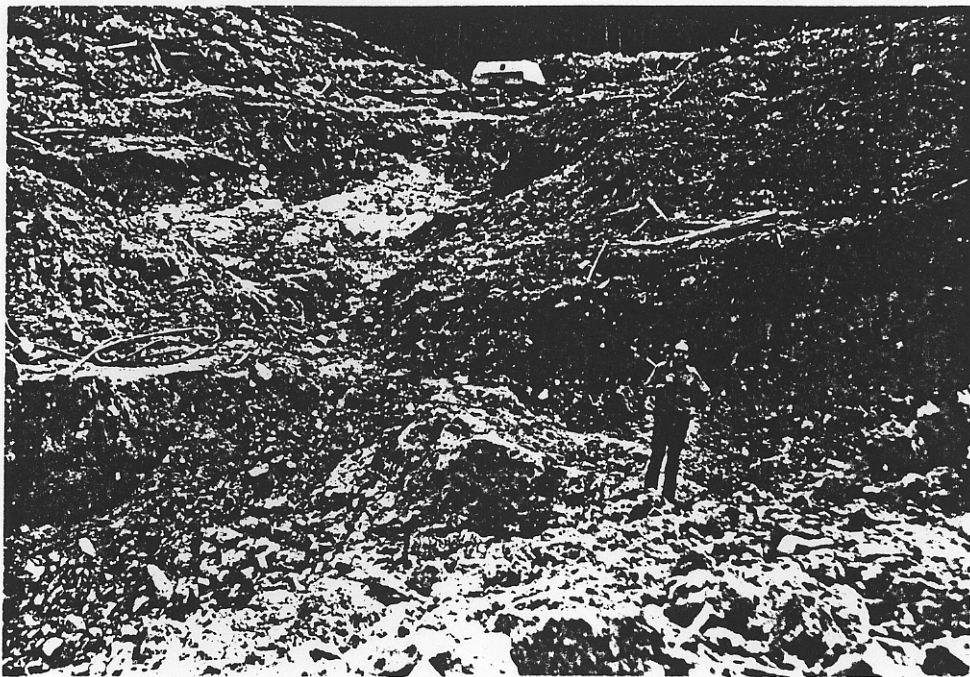
RIDGE ZONE - TRENCH 3

The trenches remain open but have sloughed in to varying degrees. As the trenches are open at both ends, there is no potential for wildlife to get stuck or for ponding of runoff. The potential for acid generation is also very low; total sulphide contents typically average trace, but occasionally reach 0.5% to 1%.

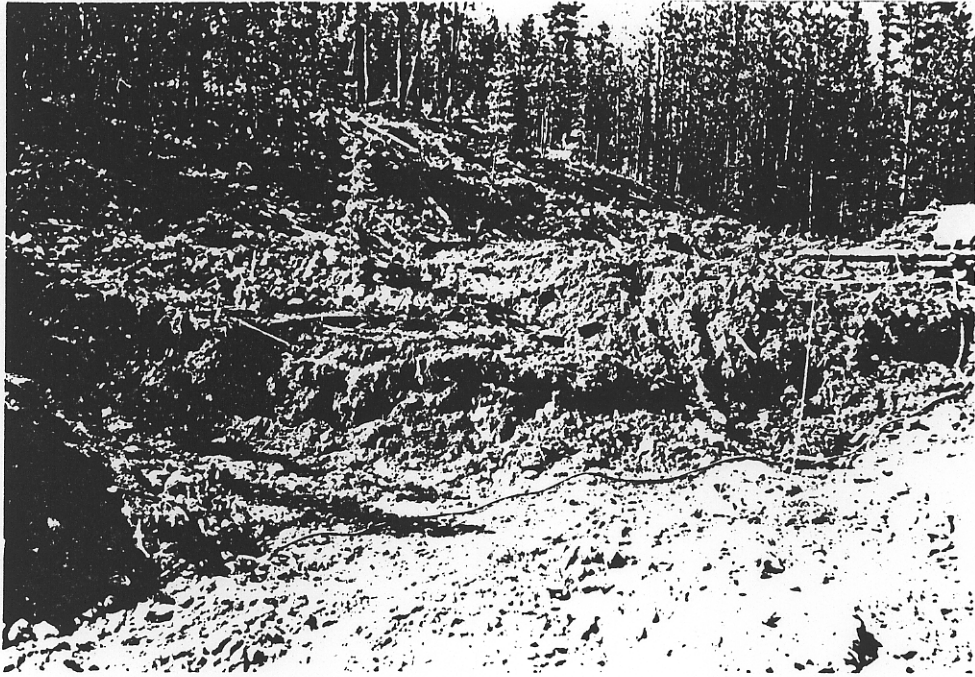
RIDGE ZONE - TRENCH 2. (RIO TRENCHES  
IN BACKGROUND)
