Dusty Mac Reclamation

PROPERTY: DUSTY MAC (PN 627)

REPORT OF INSPECTOR OF MIN

Name of Property: DUSTY MAC **Reclamation Permit No. MX-GEN-89**
Location: Osoyoos M.D. 49°20' N 119°32' E 82P/5E
2 km E of Okanagan Falls
Manager: Idle at time of inspection.
Address: Minnova Inc.
3rd Floor - 311 Water Street
Vancouver, B. C.
V6B 1B8
Persons Contacted: Idle at time of Inspection.
Type of Mining: Mineral Exploration
Date of Inspection: July 21, 1992

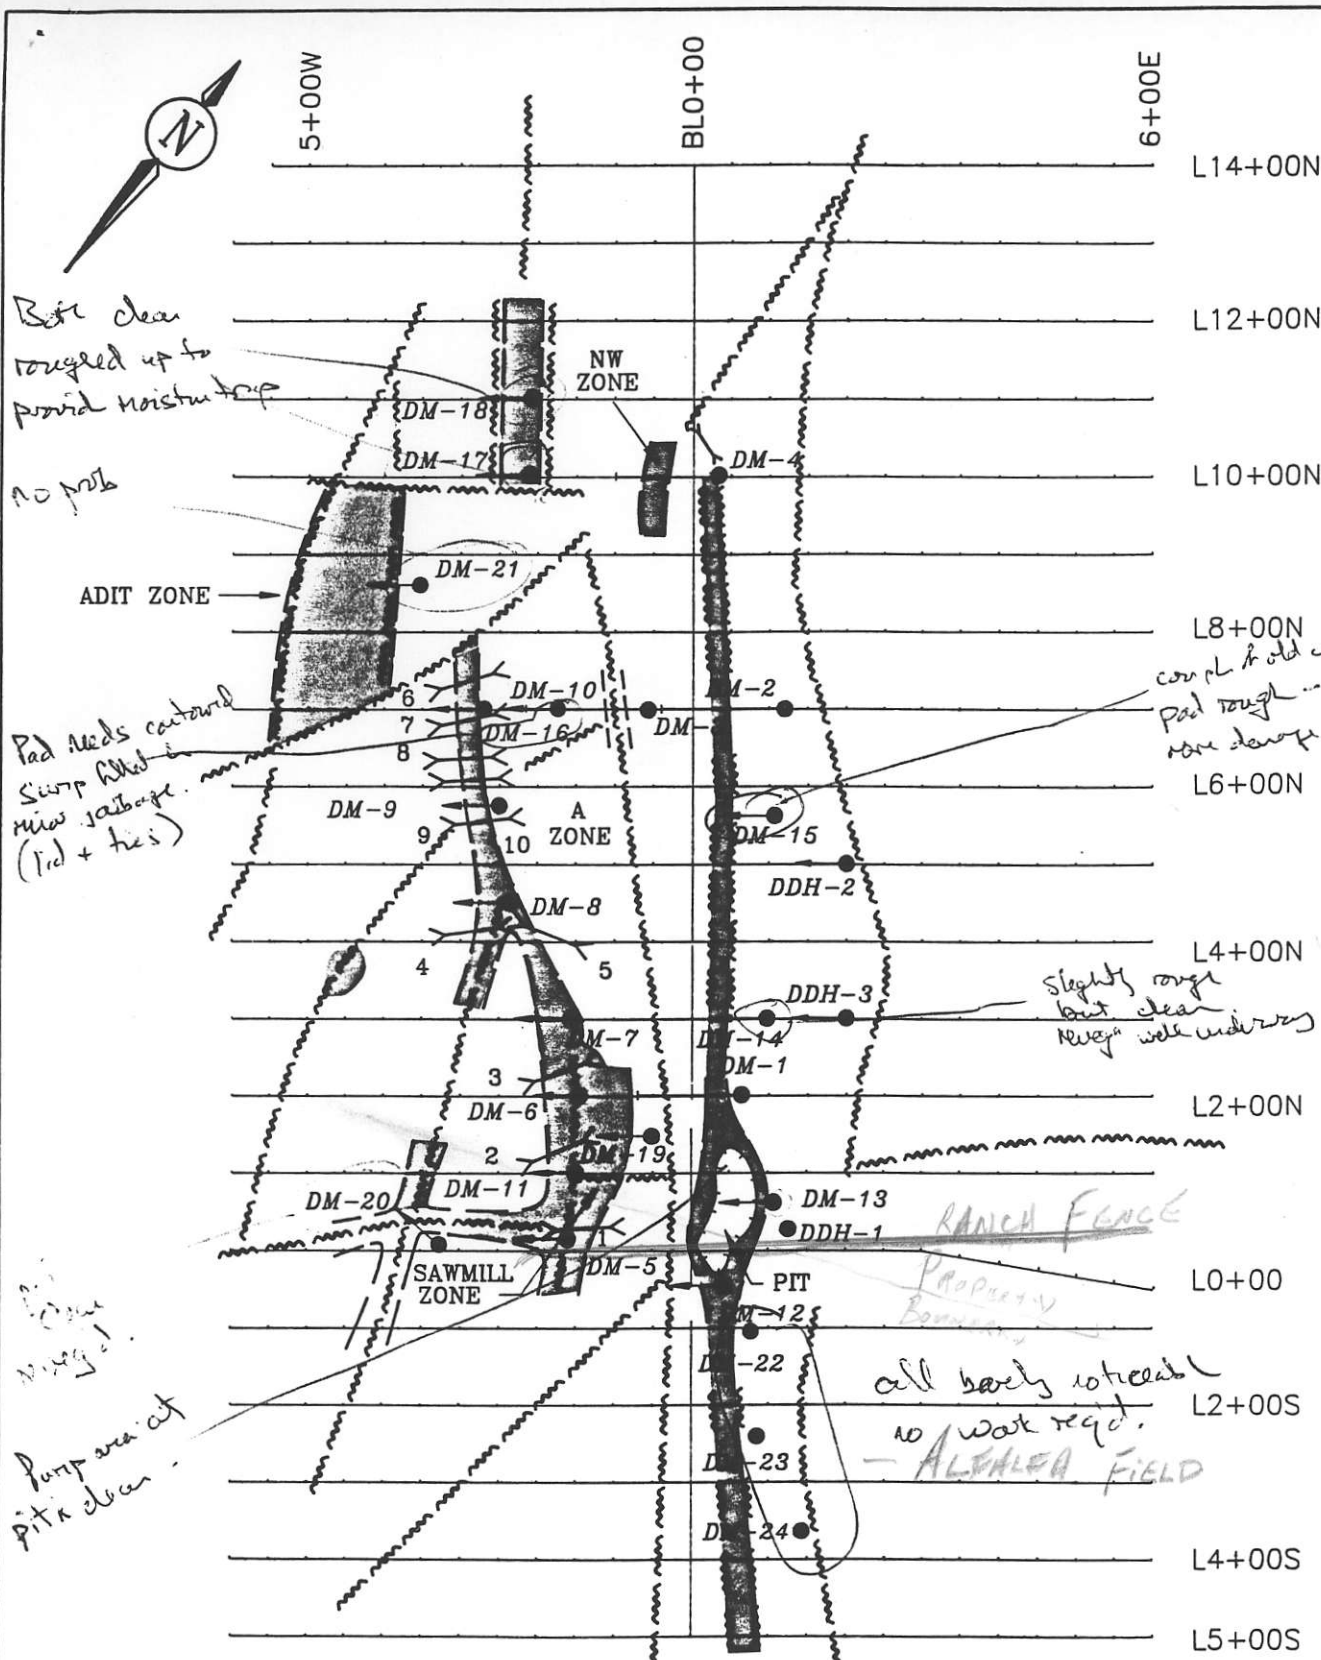
DUSTY MAC PROPERTY
 STRUCTURE & MINERALIZATION
 WITH DRILL HOLE LOCATIONS

DM-17/18 area. Clear but rough around ~~the~~ pad ~~at~~. Would cause more damage than repair to walk in is cat. Already well reseeded. No damage to cattle.

DM-16 Pad should be cartowed - sump filled in - Small backhoe - 10m
Garbage has been cleared.

DM-15 Garbage cleared - could be smoother but would destroy existing reseed.

DM-14 as DM-15.

DM-22-24 all OK.

Trenches all reclaimed.

Did not see DM-19.

One day, need small tired backhoe for a morning to do 16 a smooth 17, 18 (poss 14, 15?). Also have 19 checked and done if required.
