Support at Cassiar Underground Mine

J. JAKUBEC

Cassiar Mine, Cassiar, Canada

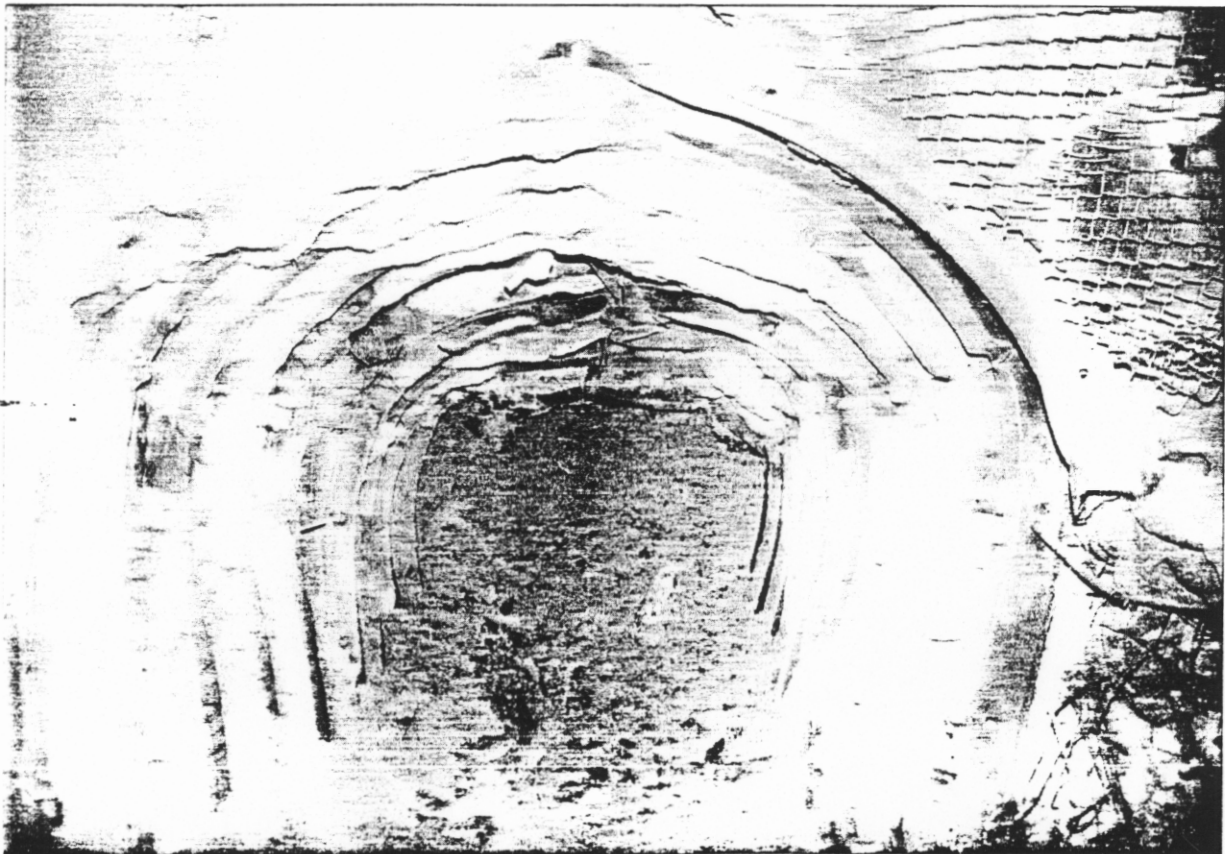
Figure 10. Severe arch deformation on 1350 North

The rigid steel arches themselves have behaved fairly well. It was surprising that the arches functioned well and applied support pressure even after severe deformation (Figure 10). Part of the success was the interlocking of the arch structure with the top plates and connection bars, which prevented disintegration of the arch unit. The weakest point was the anchoring system. Arches were installed on the top of the concrete floor, so that no concrete was placed after the arches had been erected, which could block the legs from moving into the drift. The bottom channels were not bolted to the floor, and the cable grips, on which the whole anchoring system relied, failed. The combination of poor excavation and excessive pillar deformation often necessitated the slashing of the drift in order to install arches. Once considerable deformation and distortion of the arches had occurred, the connection bars pulled through the arch beam.

Several weak points were observed in the yielding sets that were tested in one drawpoint in Class 5A ground. Firstly, the legs and crowns had been joined with a jointing system consisting of a U-bolt and a flat clamp. This connection failed in the first three sets, where the yields exceeded 75 to 100 mm. Because of the shotcrete, which encases the whole structure, there was no access for the

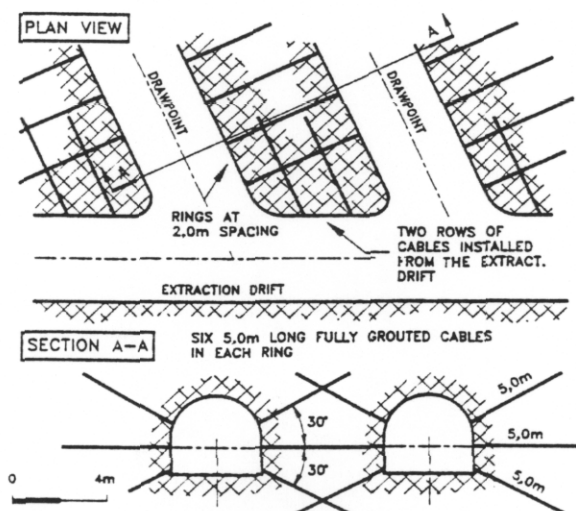
Figure 11. Pillar cable reinforcement

Corner ropes were installed to reinforce the critical part of the pillars. Because the ropes had not been properly tightened to the wall, they applied minimal restraint during the initial pillar relaxation. Shortly after installation, the

shotcrete developed large vertical cracks as a result of initial pillar deformation. Exposed ropes were showing signs of high tension. The corners in which four ropes had been installed retained the pillar well, but the corners with two ropes suffered extensive damage and failure of some of the ropes. As a result of such failures, all the corners were re-supported with four ropes.

Since no damage was observed on the back, repairs were concentrated on the sidewalls. The critical situation of pillar failure was recognized, and large-scale repairs and installation improvements were implemented immediately. All the loose shotcrete was removed, and the exposed rock was re-shotcreted. The bottom area of the walls was reinforced with additional Dywidags connected horizontally with 0,3 by 2,4 m welded straps. A system of 16 mm fully grouted cable bolts was installed through the pillars (Figure 11). There were 3 cables in the ring, and the rings were at a spacing of 2 m. Surface restraint was provided by vertical and horizontal welded straps overlapped at the bolts and tightened with 150 by 150 by 15 mm plates and cable grips (Figure 12). The whole steel structure was encased in shotcrete: firstly, to provide good contact between the straps and wall and, secondly, to protect the support from LHD damage.

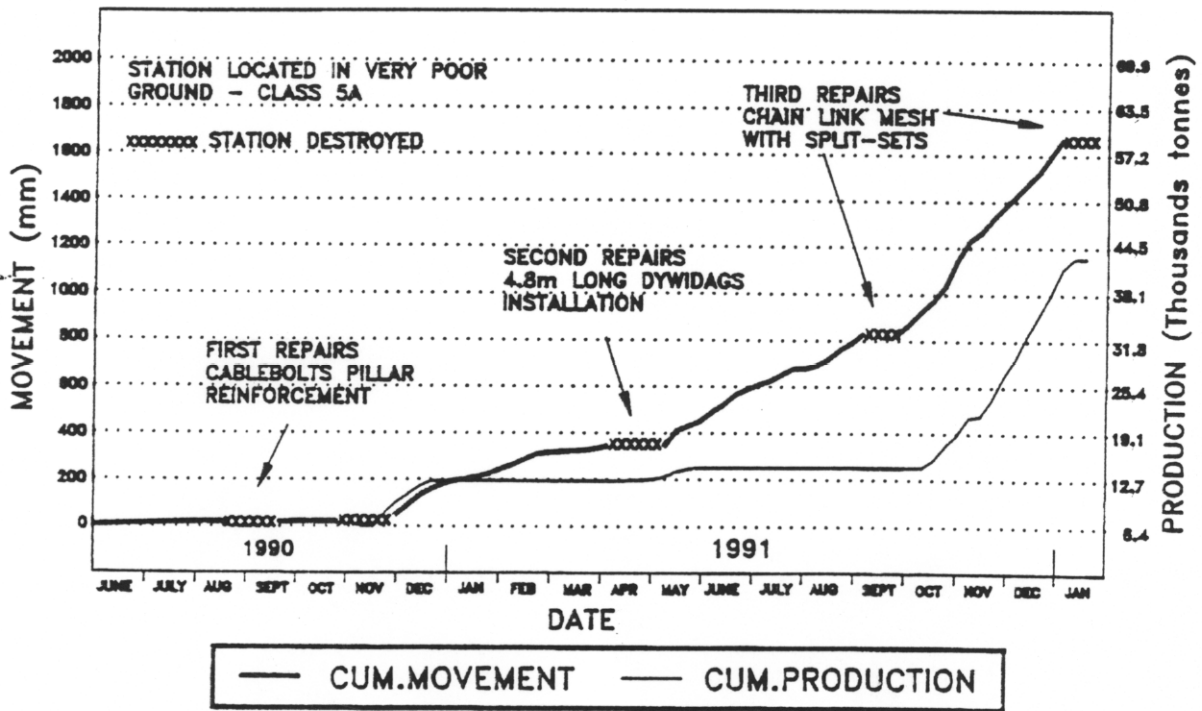
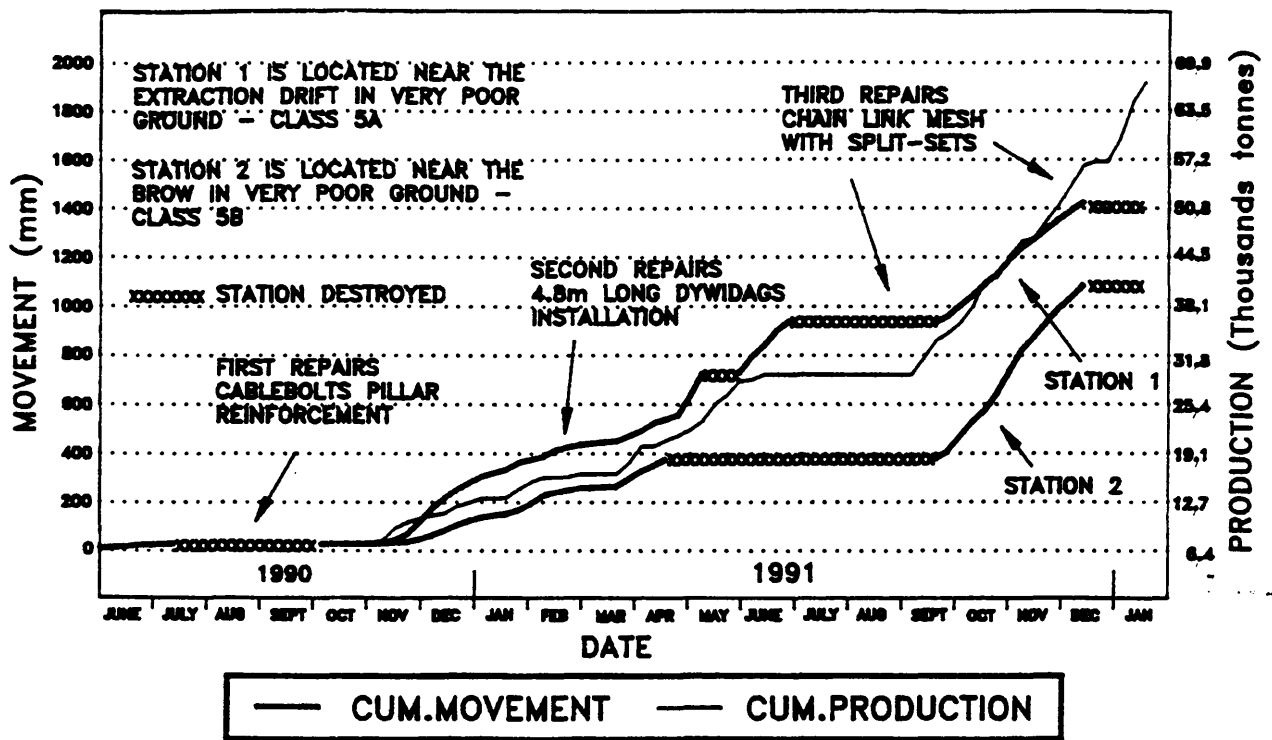
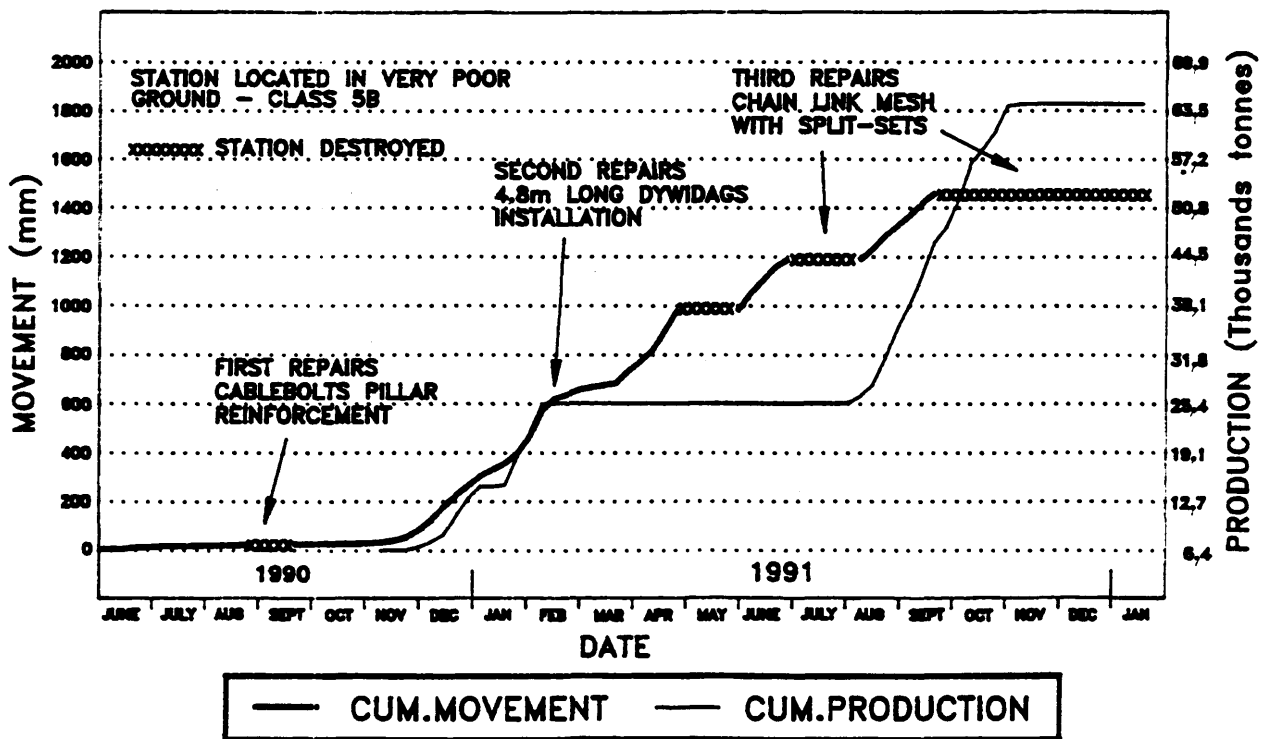
Although the ground support was designed for the 11 to 15-month lifetime of the level, post-support failures of the drift were observed shortly after the excavation of the drawpoint began, and repairs had to be initiated in the early stages of development. Vertical cracks in the shotcrete appeared as a first sign of deformation. They were usually initiated at the bottom of the drift and progressed upwards. Once the cracks had reached 1 to 2 mm in width, the welded-wire mesh failed. Debonding of the shotcrete layers occurred, often close to the floor. Monitoring of the drift closure showed a rate of horizontal closure of approximately 5 to 10 mm per week.

Monitoring of the drift closure was re-established, and the horizontal movement decreased from between 5 and 10 mm per week prior to the installation of cable bolts to almost 0 mm after repairs (Figures 13 to 15). Development of the level continued, and the undercut was excavated and supported.

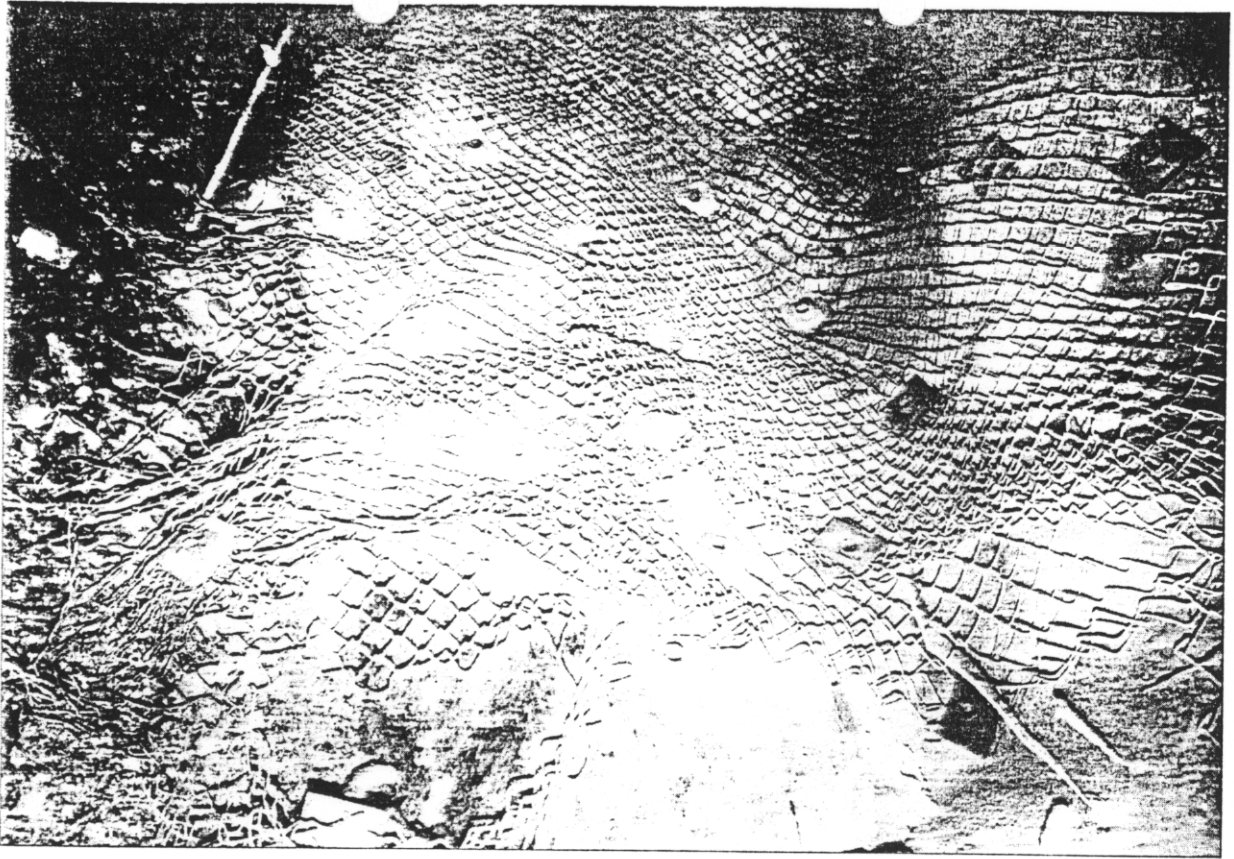
Figure 16. Extensive sidewall damage in drawpoint no. 9, 1350 North

The excessive deformation (Figure 16) and floor lift (Figure 17) in the north has meant that most of the drawpoints have had to be slashed and re-supported.

The low standard of support and repeated slashing gave the pillars additional opportunity to deform. This caused gradual pillar disintegration, and the load-carrying capacity of the pillars was reduced significantly. Plastic flow of the weak rockmass into the openings was observed on many occasions (Figure 16).

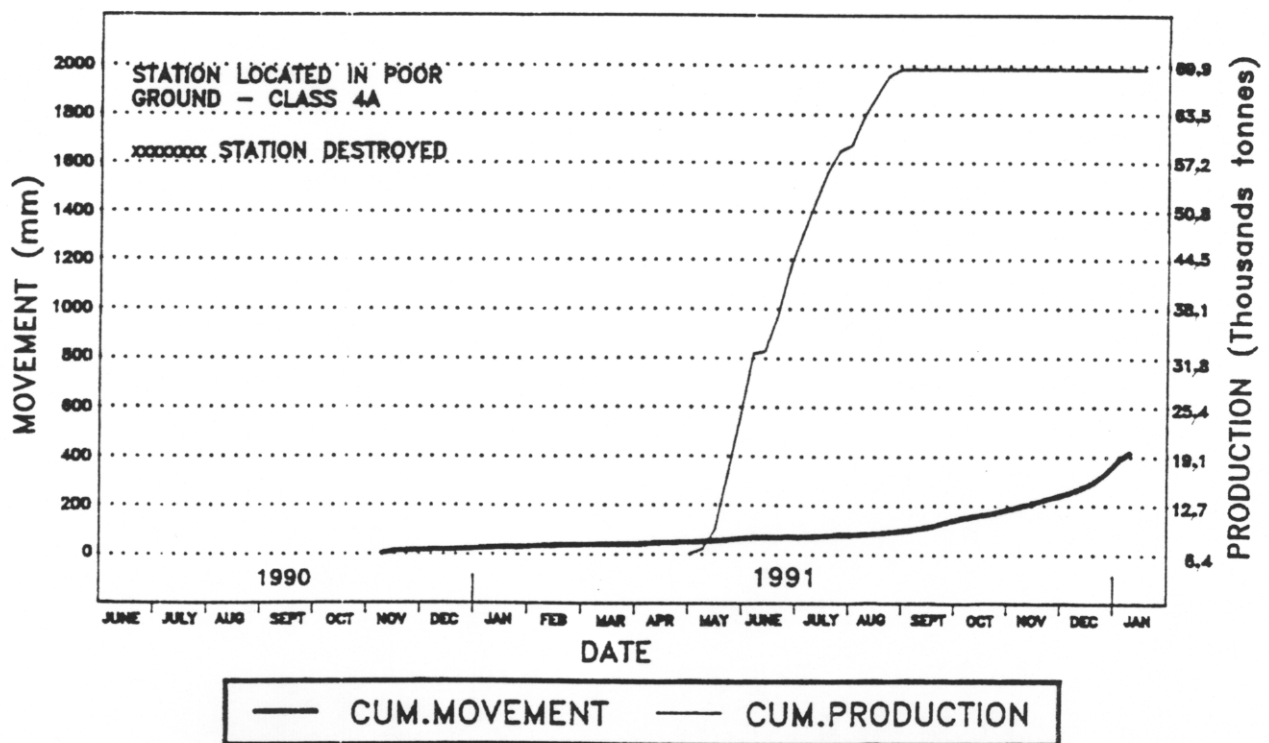
Figure 20. Cross-drift deformation, drawpoint no. 16

25 mm ropes were grouted 3.0 m into the floor. Figure 20 shows the convergence record of drawpoints supported with the new system.

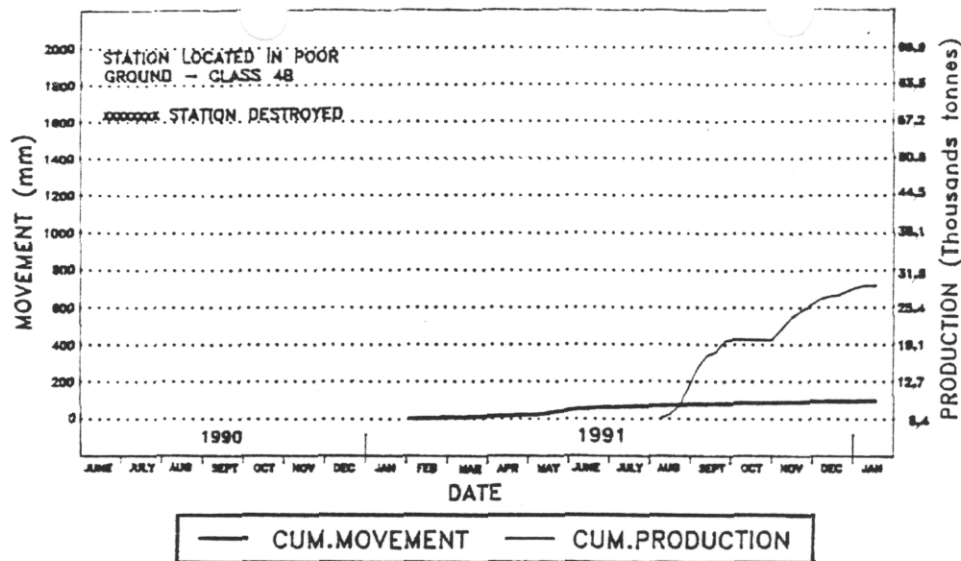
Figure 21. Cross-drift deformation, drawpoint no. 21

Since some cracks were observed in the shotcrete lining, a vertical strap system was added to increase the support stiffness. The results of closure monitoring of the drawpoints with the described support system are shown in Figure 21. Because of its poor performance, welded-wire mesh was later replaced with one layer of 50 by 50 mm

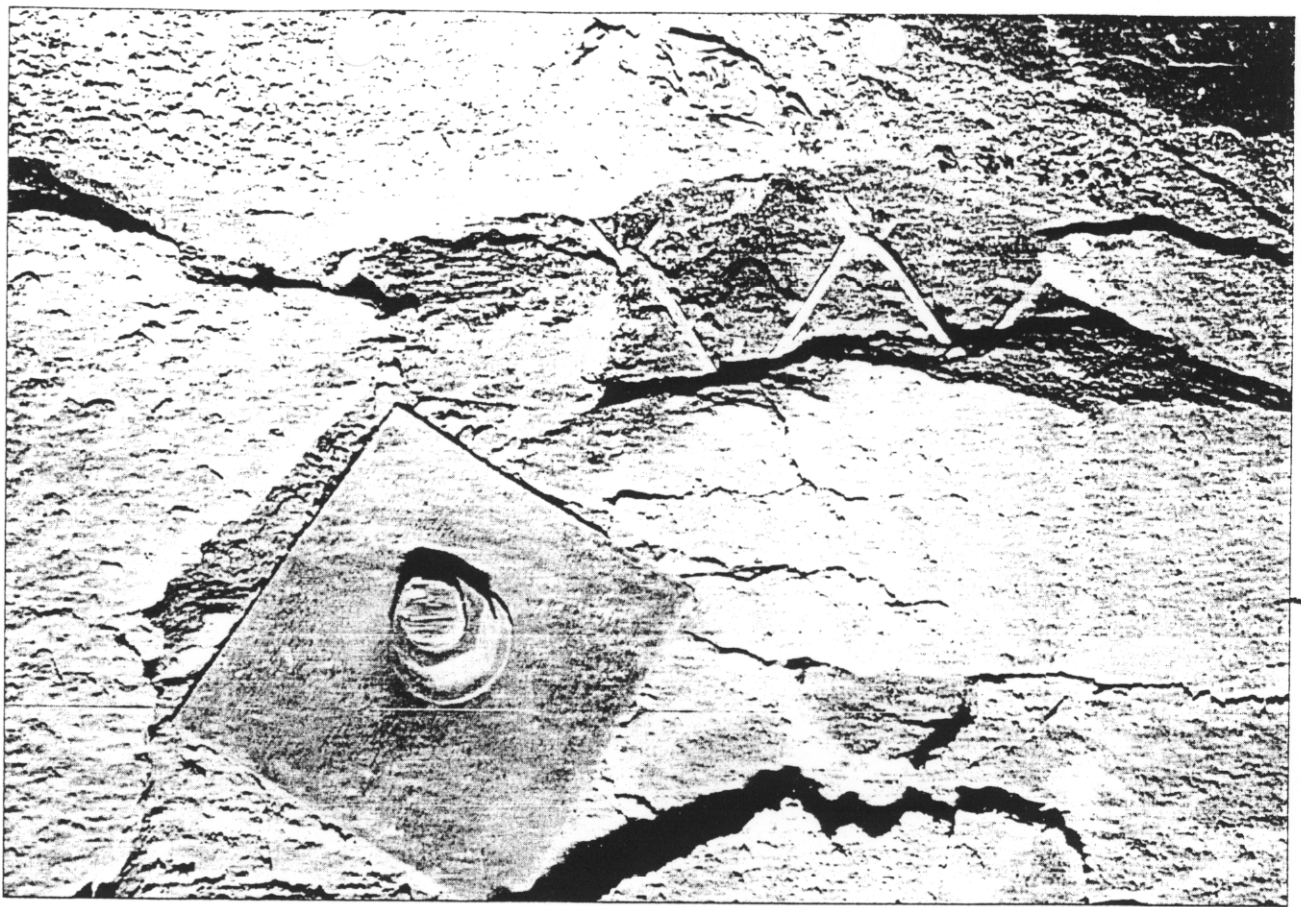
gauge-6 chain-link mesh (Figure 22). The chain-link mesh proved to be far superior to the welded mesh in its deformation capability (Figure 23).

Figure 23. Intact chain-link mesh in cracked shotcrete lining

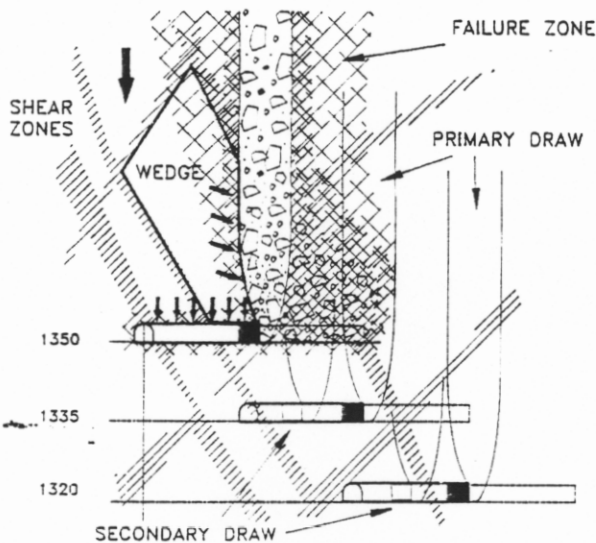
Figure 27. Wedge failure and drawpoint loading

Extreme vertical loading of the drawpoints on the north occurred after the cave zone had extended from 1350 level into the argillite. This was caused by massive wedge failure above the level. Figure 27 shows an idealized cross-section.
