44. Looking south only over  
main zone pit, ENDAKO

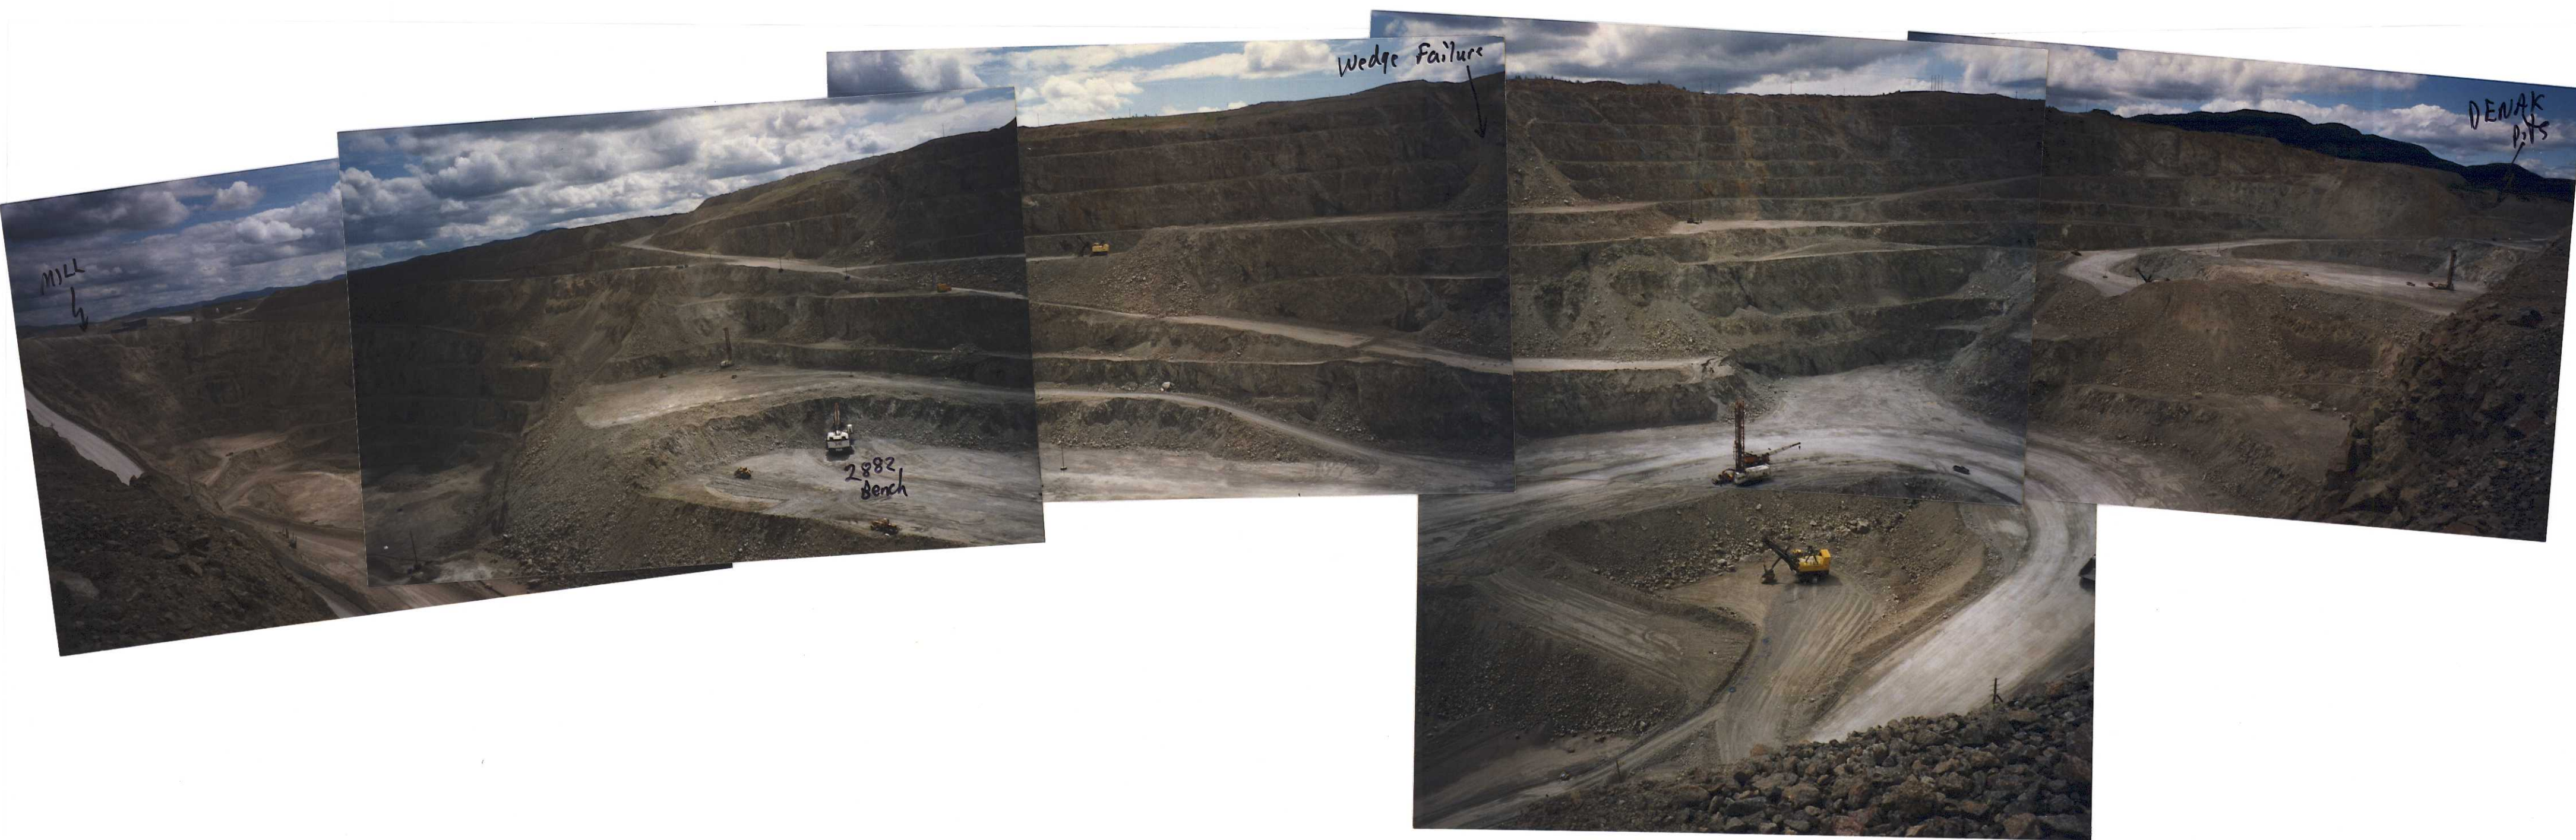
Wedge Failure  
↓
