43. Looking easterly along main
zone pit, ENDAKO.

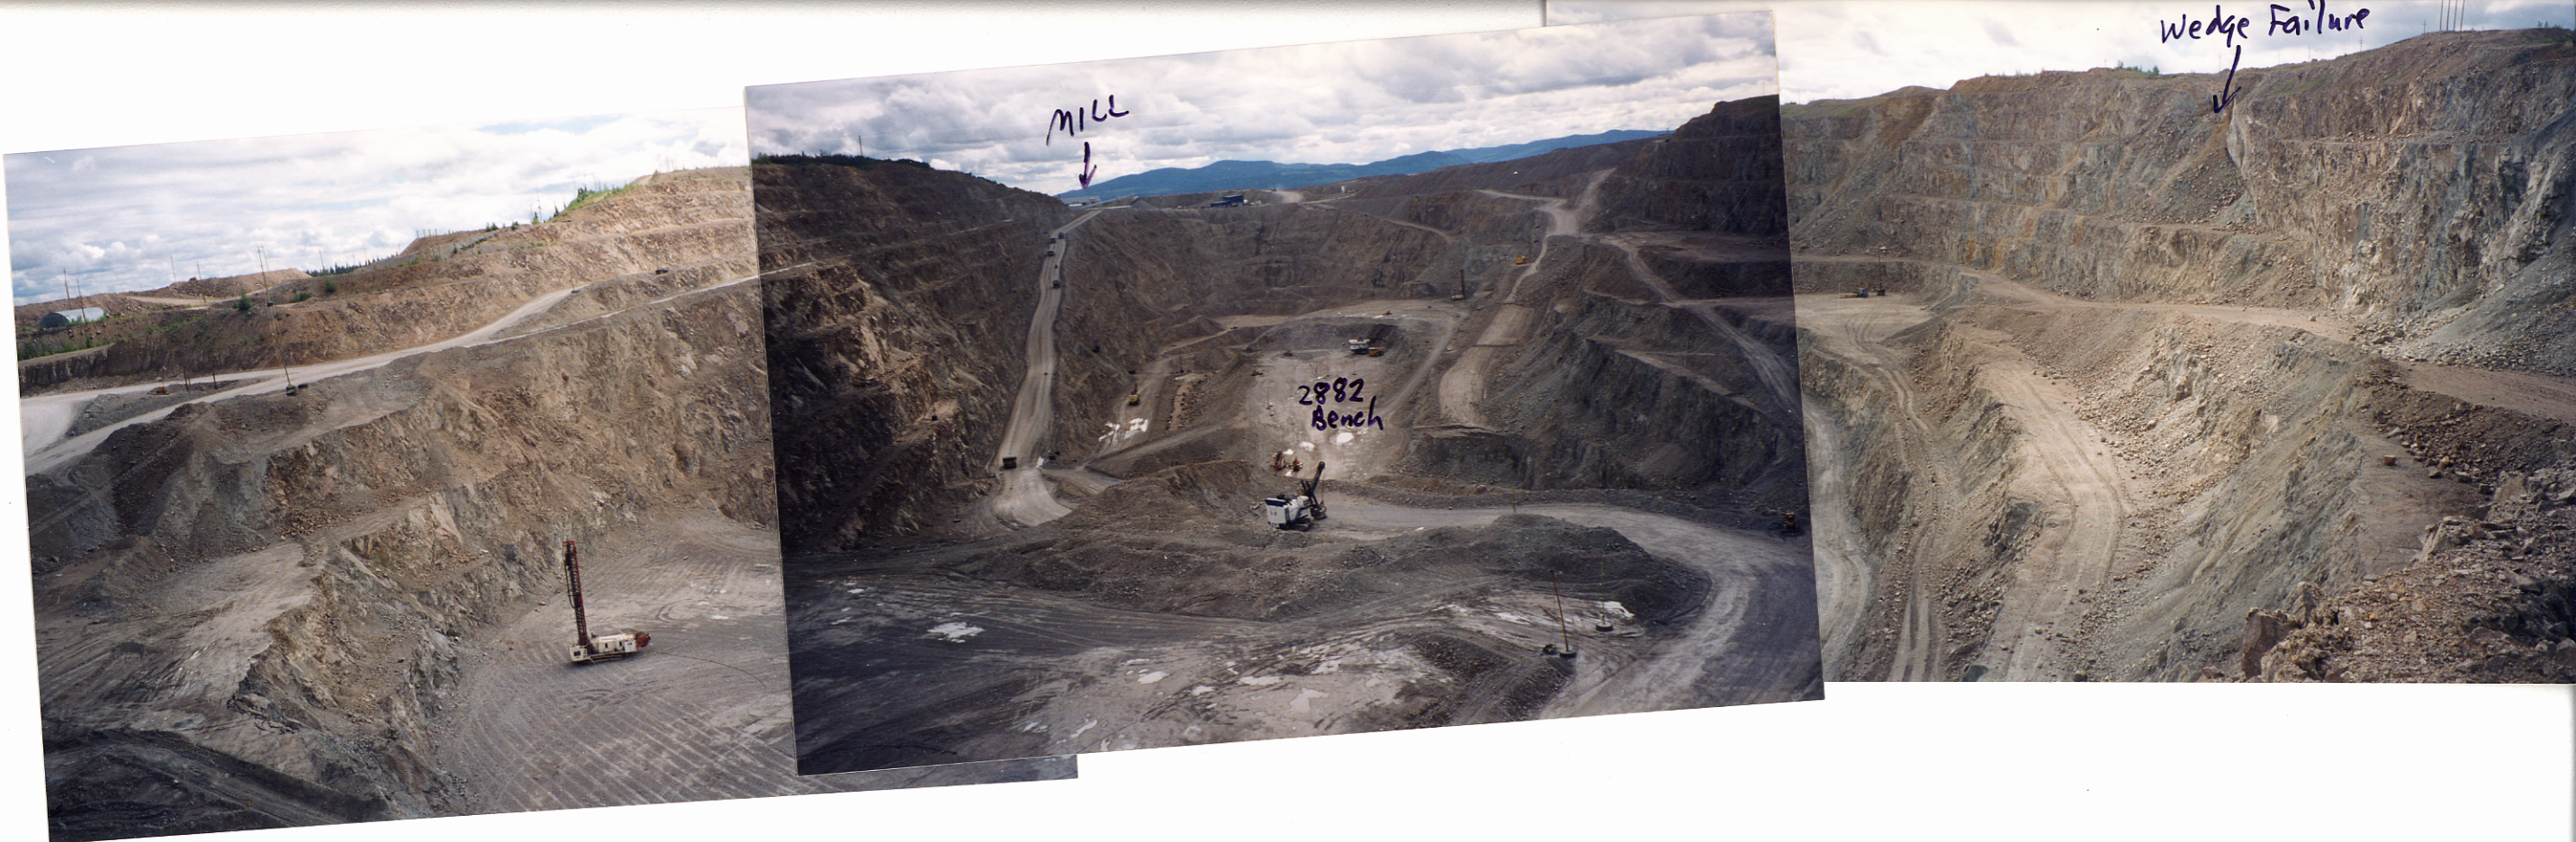
Wedge Failure
↓
