DAM INSPECTION REPORT

D-630004
Nov. 28, 1985

Cougar Lake Dam

Inspection Date: September 5, 1985

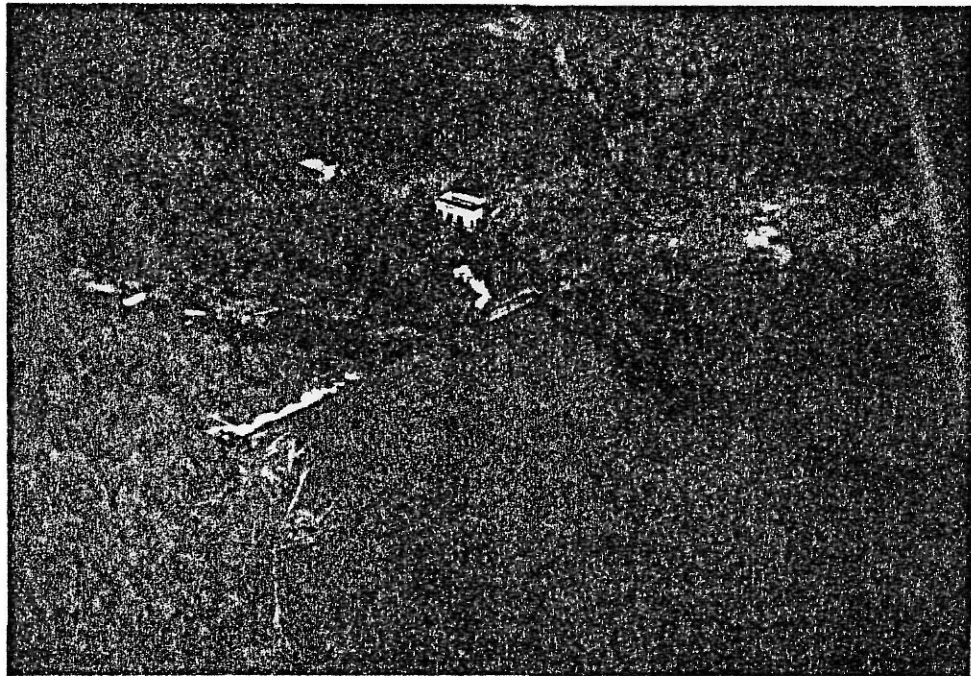
Upstream face of the dam with the powerhouse and Surf Inlet in the background.

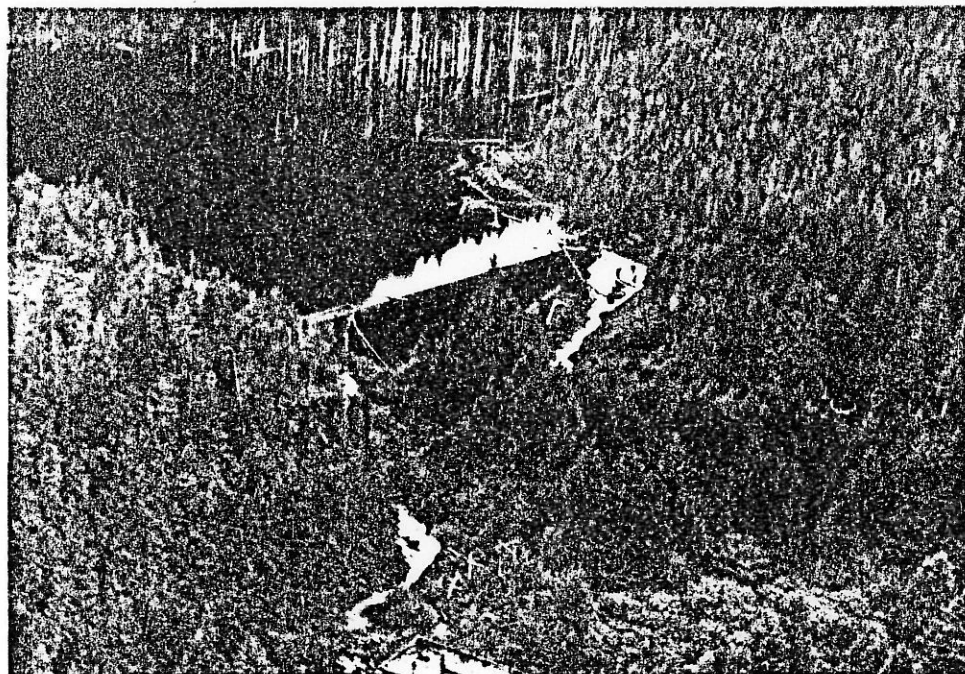
At the time of the inspection the only flows by-passing the dam were through the log-chute near the left abutment and through the penstock opening near the right abutment. The wood stave portion of the penstock has collapsed and the steel portion is flowing at about 20% of capacity.

Downstream face of the dam viewed from the air. Flow on the right abutment originates through a broken penstock. flow on the left abutment is through the log chute.

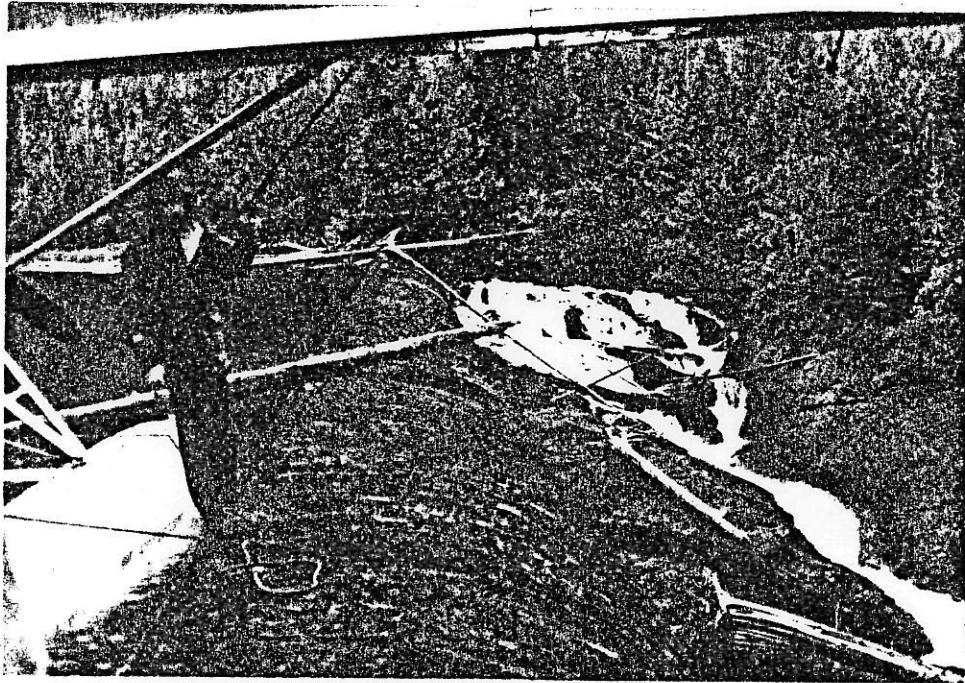
The spillway crest was inspected and found to be in fair condition. Although the reservoir has large stands of drowned timber and concentrations of floating material the crest was relatively free of any debris build-up.

Spillway crest viewed from the right abutment. Left abutment flow through the log chute.

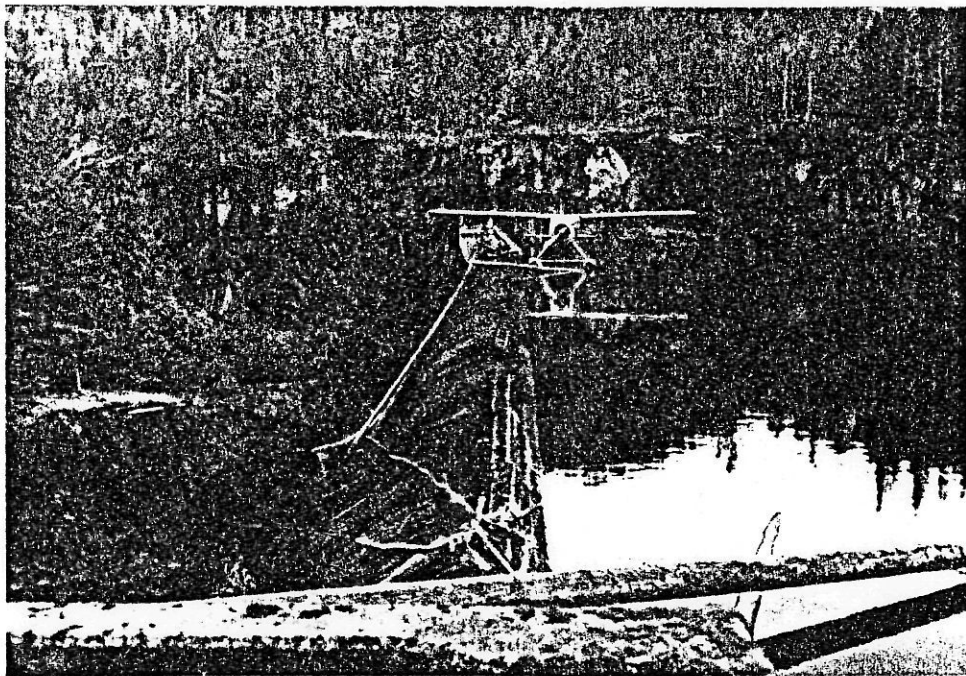
Dam crest viewed from the left abutment. Note: The large rock formation at the downstream toe would prevent any flow going along the right abutment in the event the dam was removed.

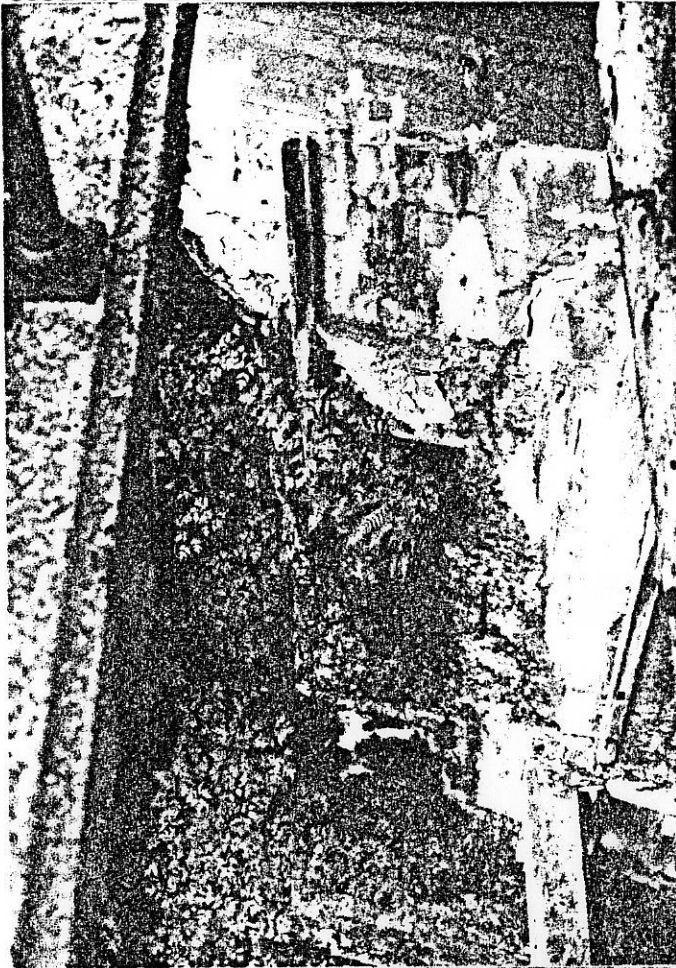
Concrete deterioration of
buttresses on right abutment
near penstock outlets.

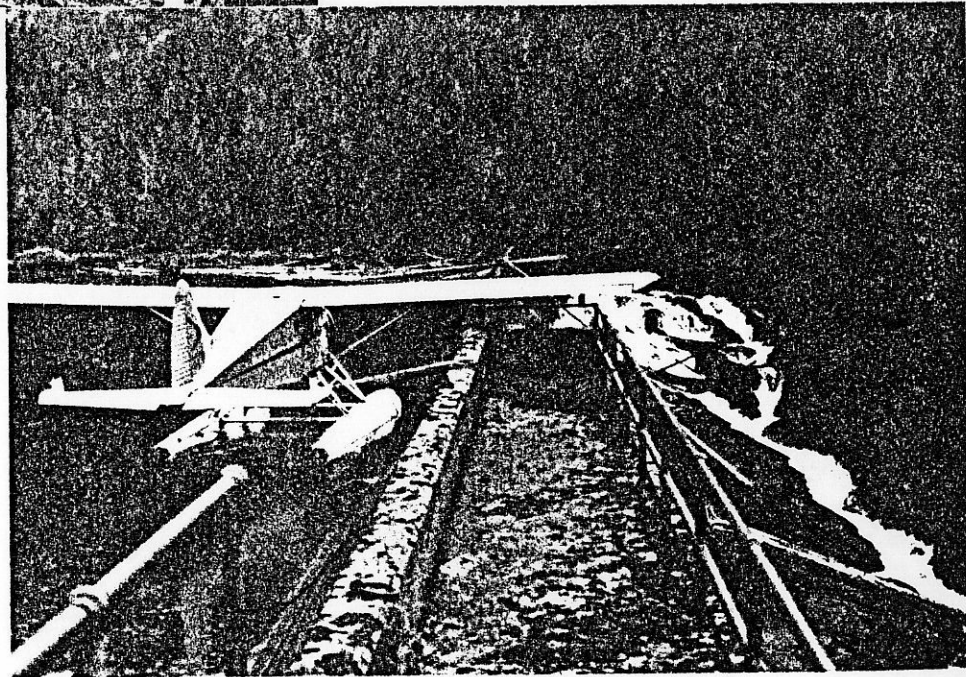
Float plane moored to upstream face of dam near right abutment.

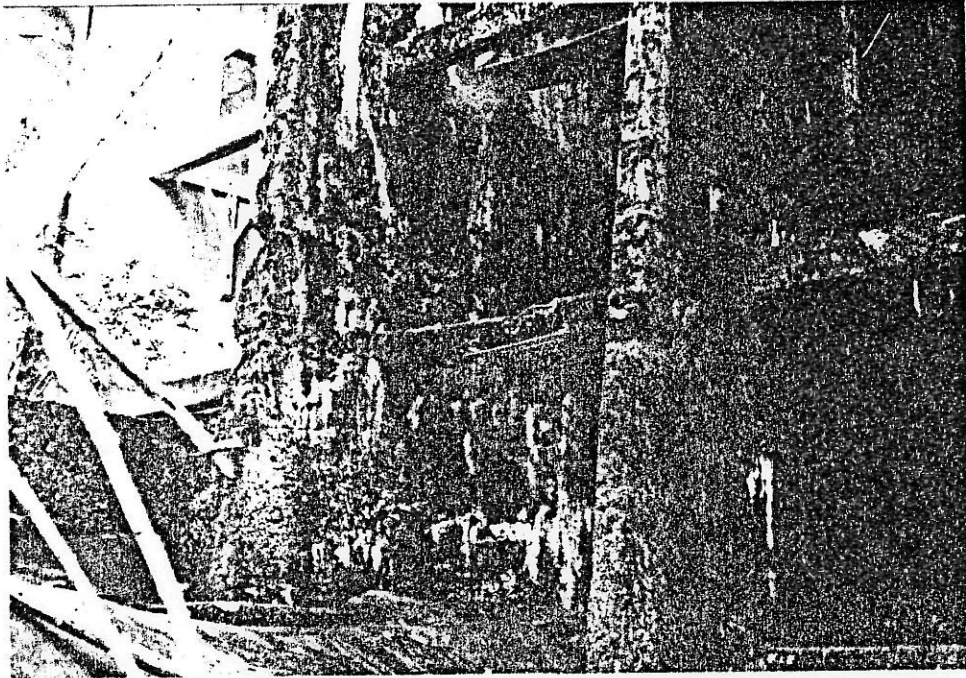
The concrete in the dam appeared to be sound with only localized freeze thaw damage. This deterioration was particularly noticeable on the transition buttress (see photo) adjacent to the spillway near the right abutment. This has occurred where the surface of the concrete is continually subjected to changing moisture conditions. Other localized areas of erosion are evident on the dam where segregation of large aggregate occurred during the original construction. This damage does not affect the structural integrity of the dam.

Deterioration of lateral support beam and more severe freeze-thaw damage in the transition area between wet and dry areas located near the right abutment.

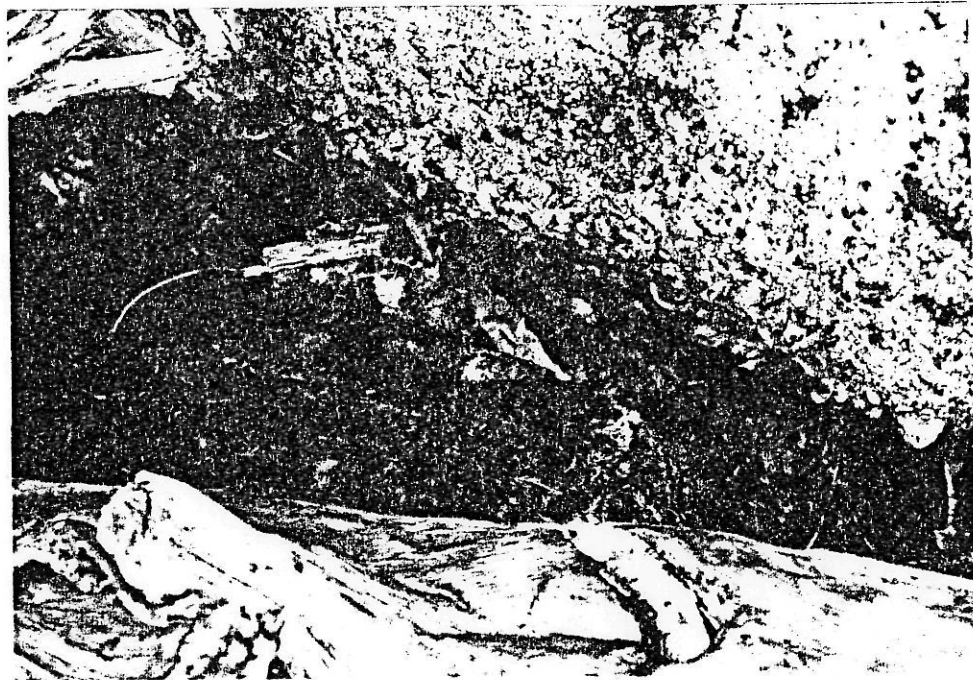
Concrete deterioration at the interface of the ogee spillway crest at the right abutment. Note: deterioration extends 8-10" into the concrete exposing reinforcing steel.

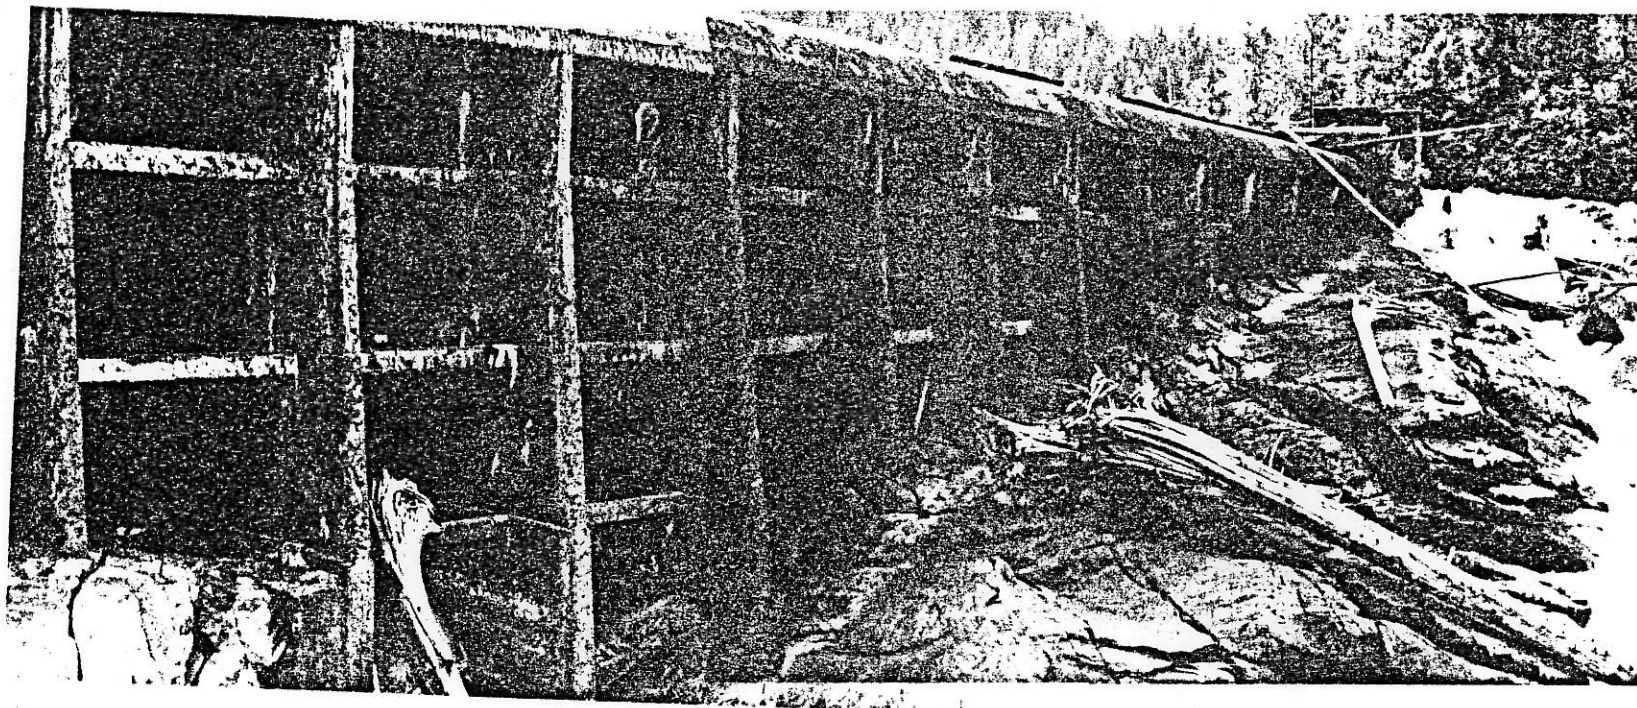
Buttresses from the dam's maximum section to the left abutment. Concrete in the area showing only minimal signs of freeze-thaw deterioration.

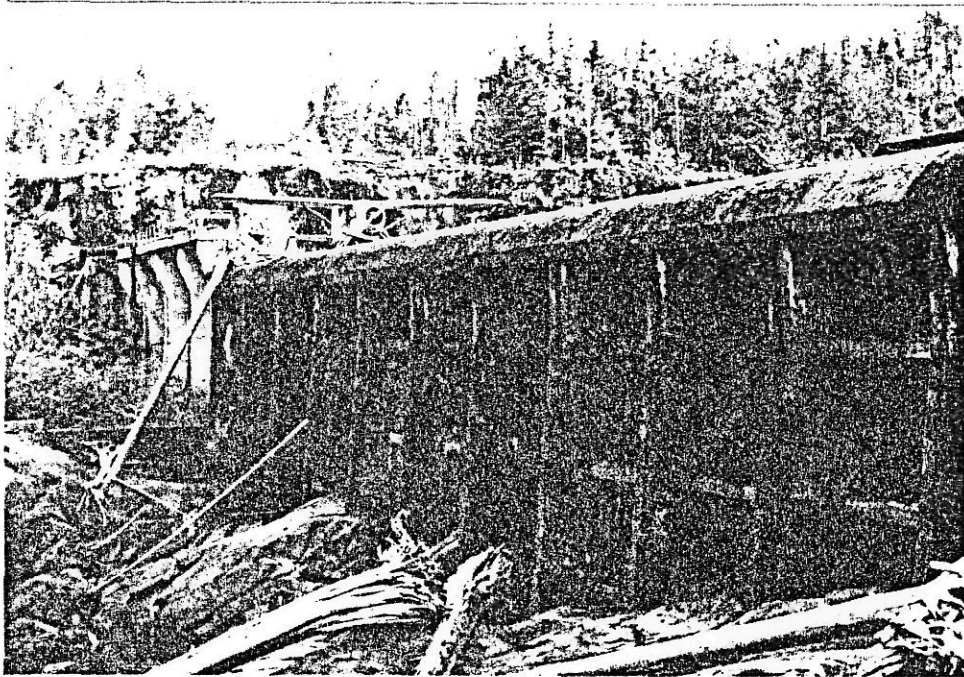
View of buttresses from downstream on the left abutment.

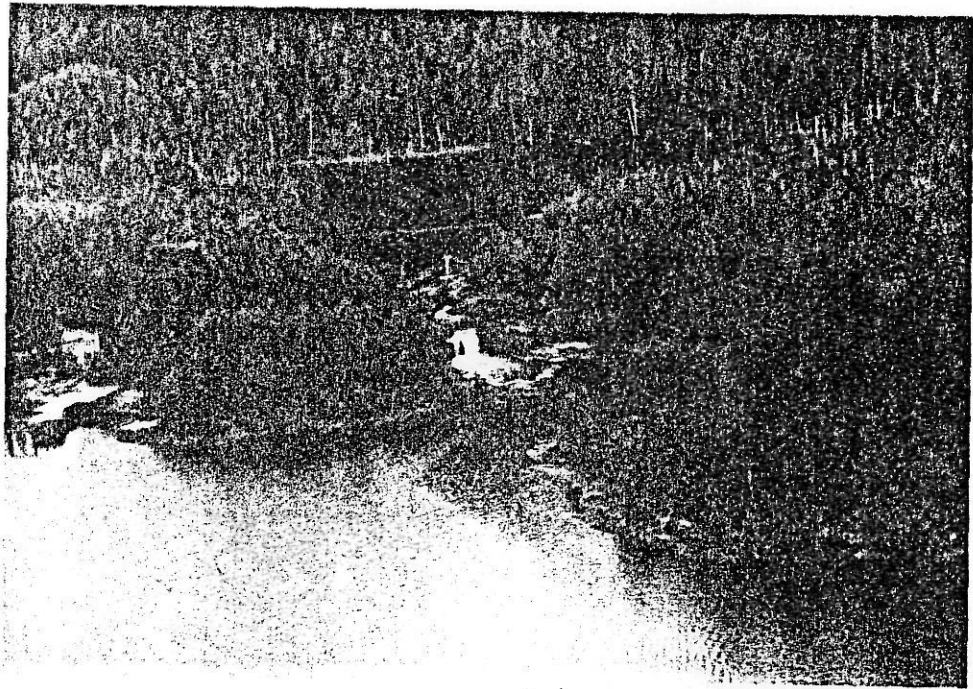
Downstream face of dam viewed from the air over Surf Inlet. The falls are located in the original river channel. (see close-up).

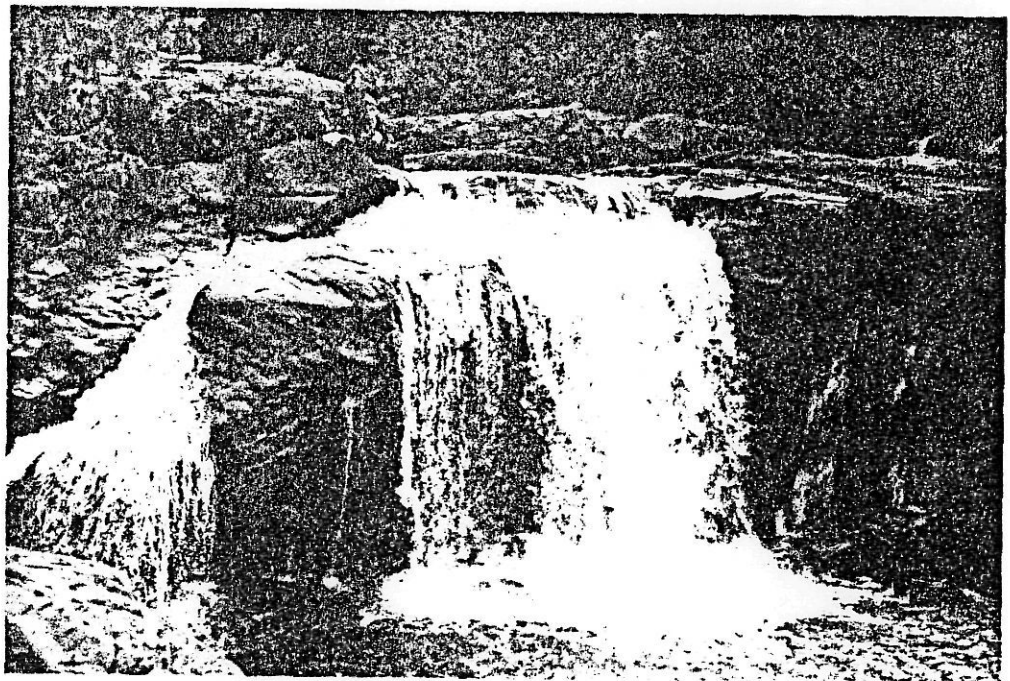
An inspection was undertaken of the approximately 600' of rock channel directly downstream of the dam leading to Surf Inlet. Some recent interest has been expressed by fishermen in the Prince Rupert area to remove the dam and "restore" the salmon fishery in the river system. The inspection confirmed the presence of a 20' high cliff in the river channel below the dam (see photographs) which would prevent any salmon run into the system. A letter from the Chief Inspector of Fisheries dated April 17, 1916, was located and confirms these findings (letter attached). The rock in the downstream channel was found to be substantial and no scour or erosion was evident in the downstream area.

Close-up of falls downstream of dam. Note: falls height (24') relative to the height of inspector standing on the rock at the left.
