**Annual Reclamation Report for 1994**

**Centipede Resources Ltd.  
Ruth Vermont Mine (82K/15W)  
Golden Mining Division**

**Reclamation Permit M-89**

**31 March, 1995**

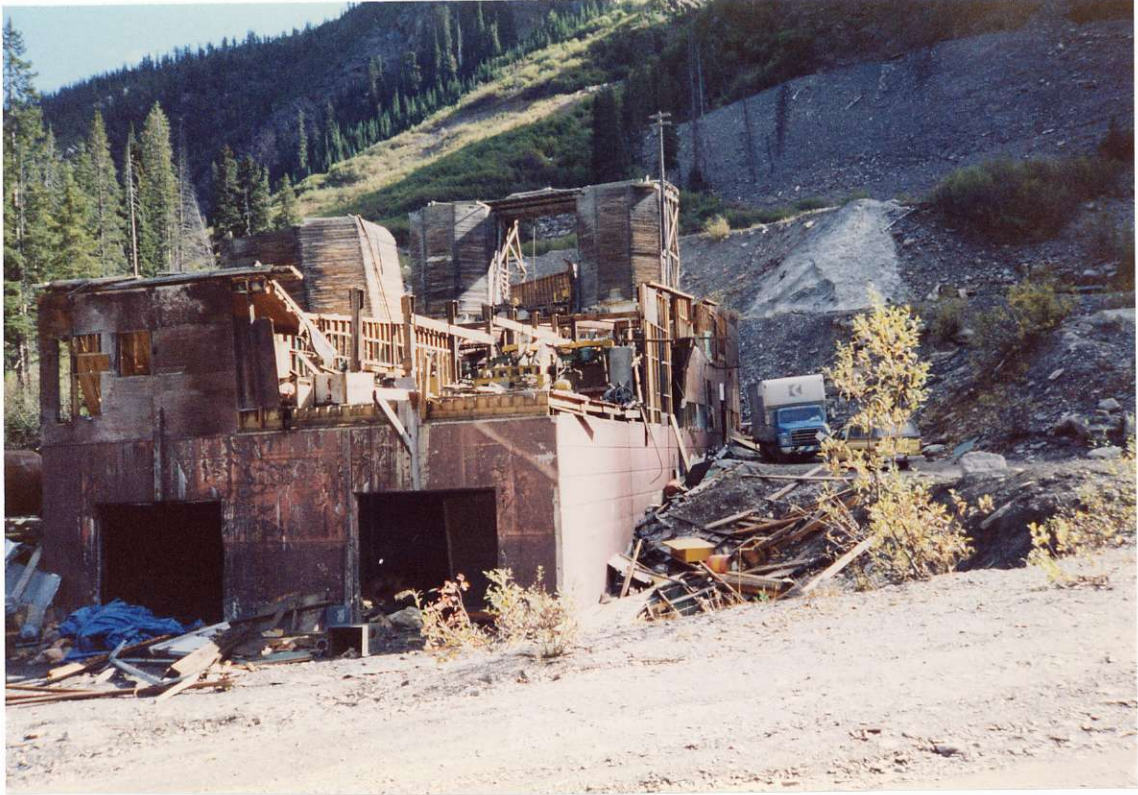
**Figure 1.**

This picture shows the Mill Building during demolition in preparation for the removal of the Ball Mills.

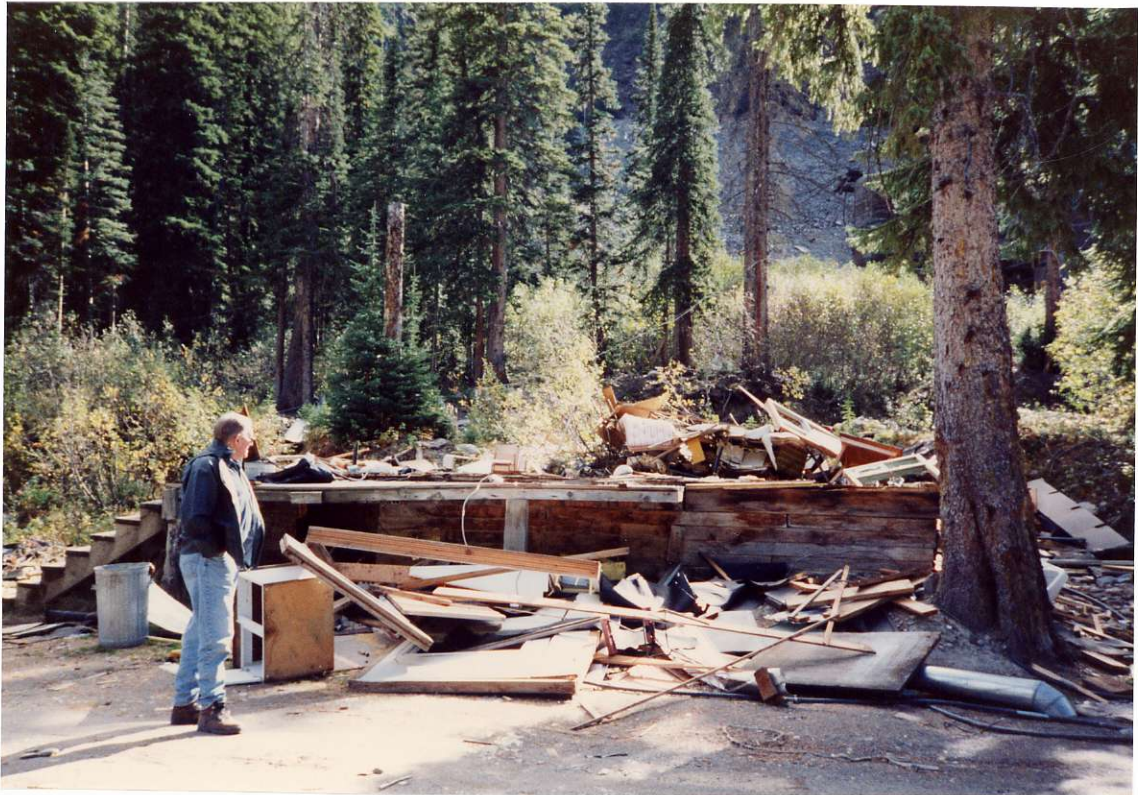
**Figure 2.**

A view of the remains of the "A" Frame following removal of the structure by Gary Waters. Tony Milligan, the Mines Inspector is seen in the lower left of the photograph.

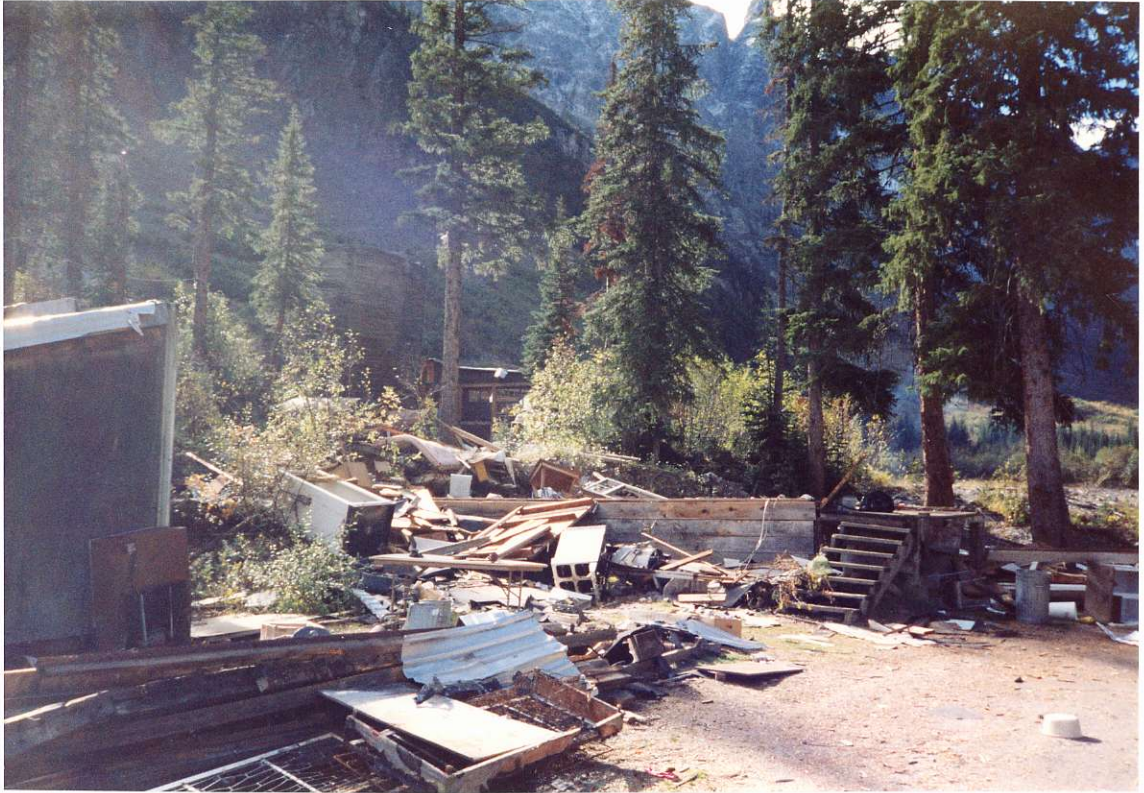
**Figure 3.**

The "A" Frame remains. Photo taken looking west.

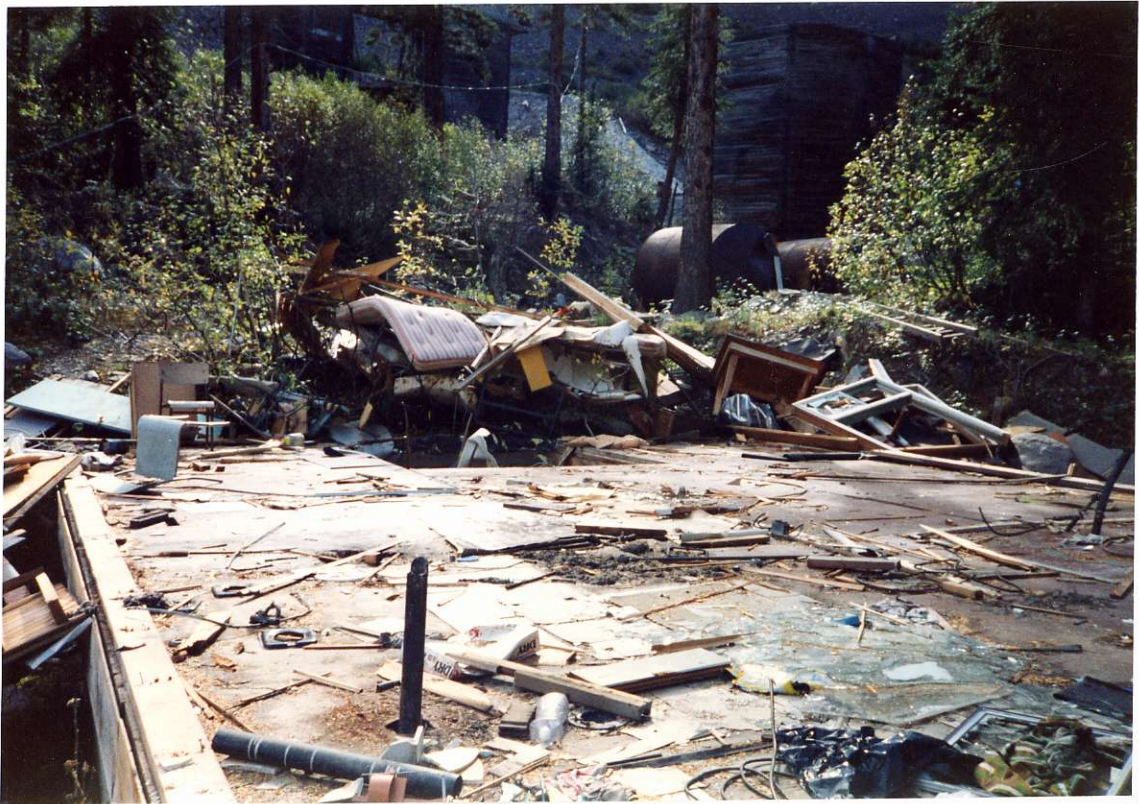
**Figure 4.**

"A" Frame remains showing the debris left following Water's removal of the structure. The Mines Inspector was not pleased with the way the site had been left by Water's crew.

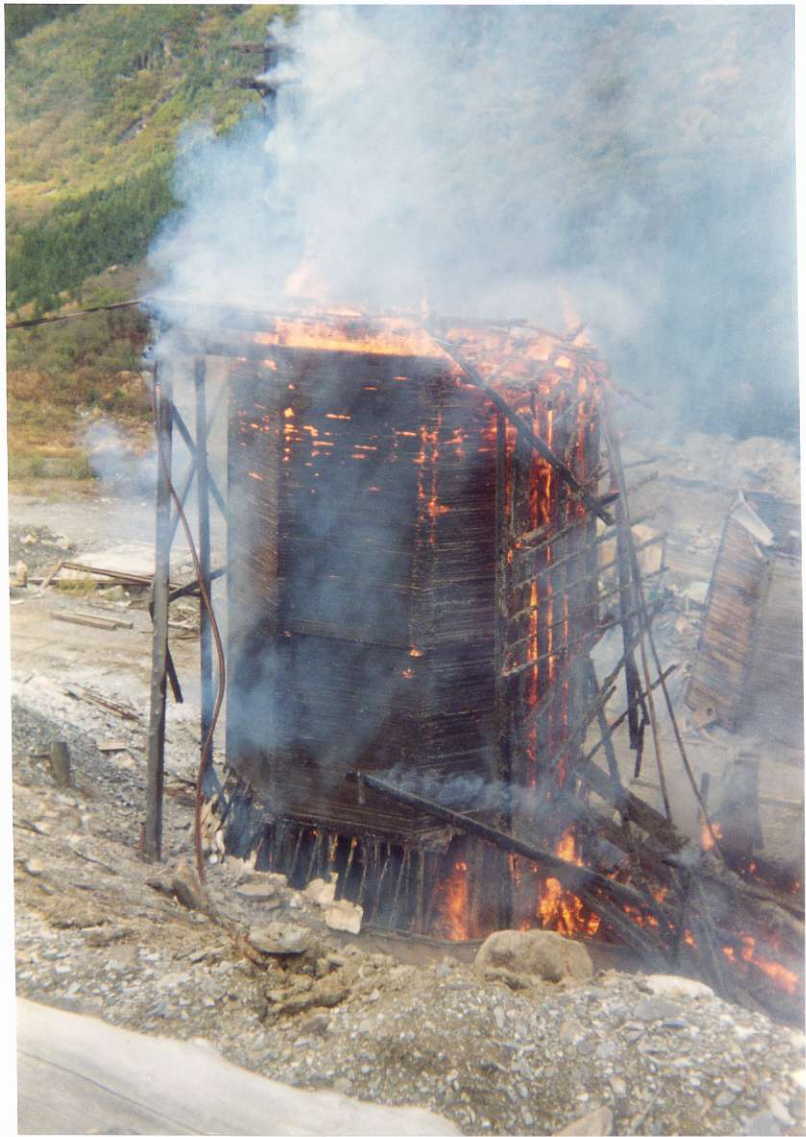
**Figure 5.**

Burning the Coarse Ore Bins. This photo shows the western Coarse Ore Bin being burned. The other bin had already been burned.

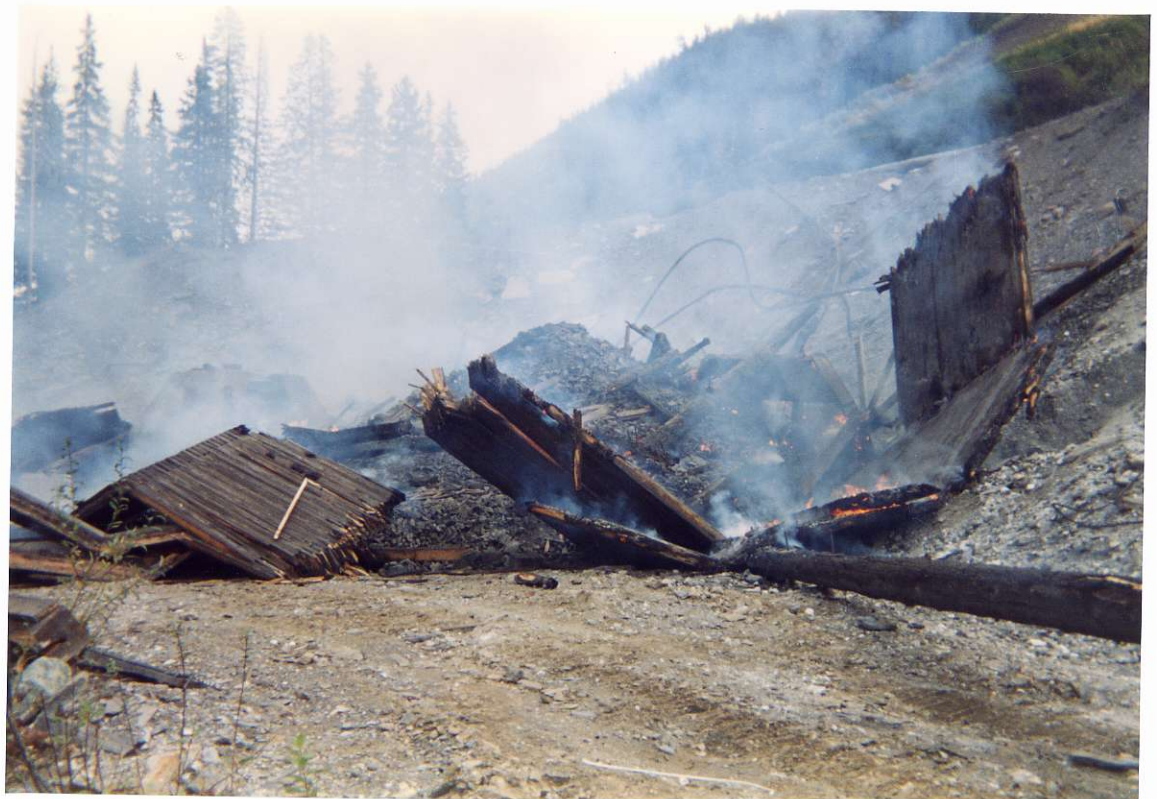
**Figure 6.**

Remains of the Coarse Ore Bins prior to burial. The wood was piled and burned, then the site covered.

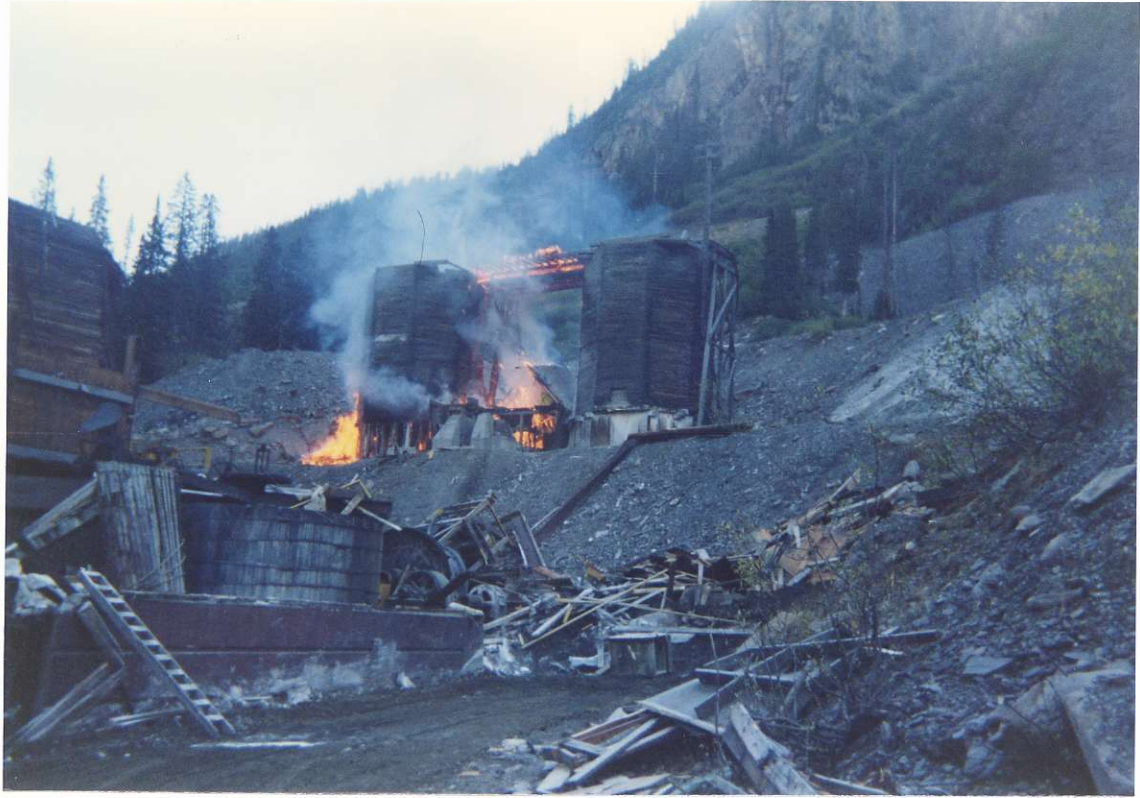
**Figure 7.**

Coarse Ore Bins being burned.

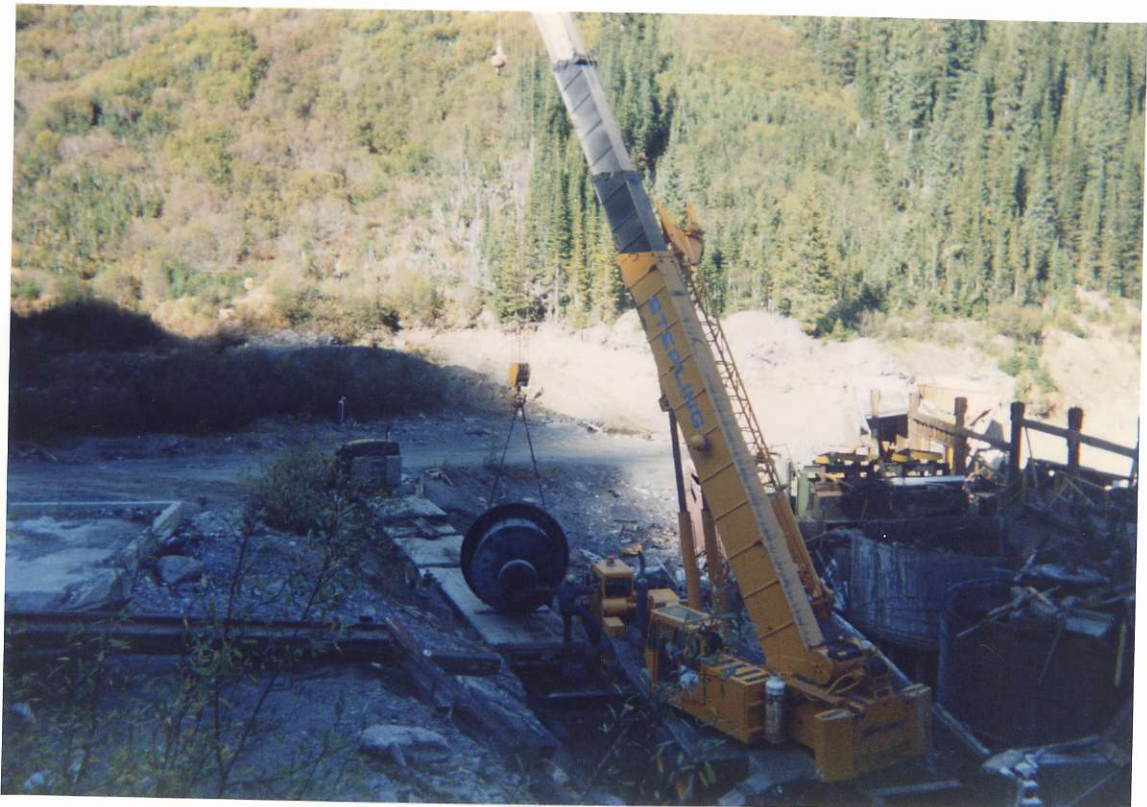
**Figure 8.**

One of the Ball Mills being removed from the Mill Building.

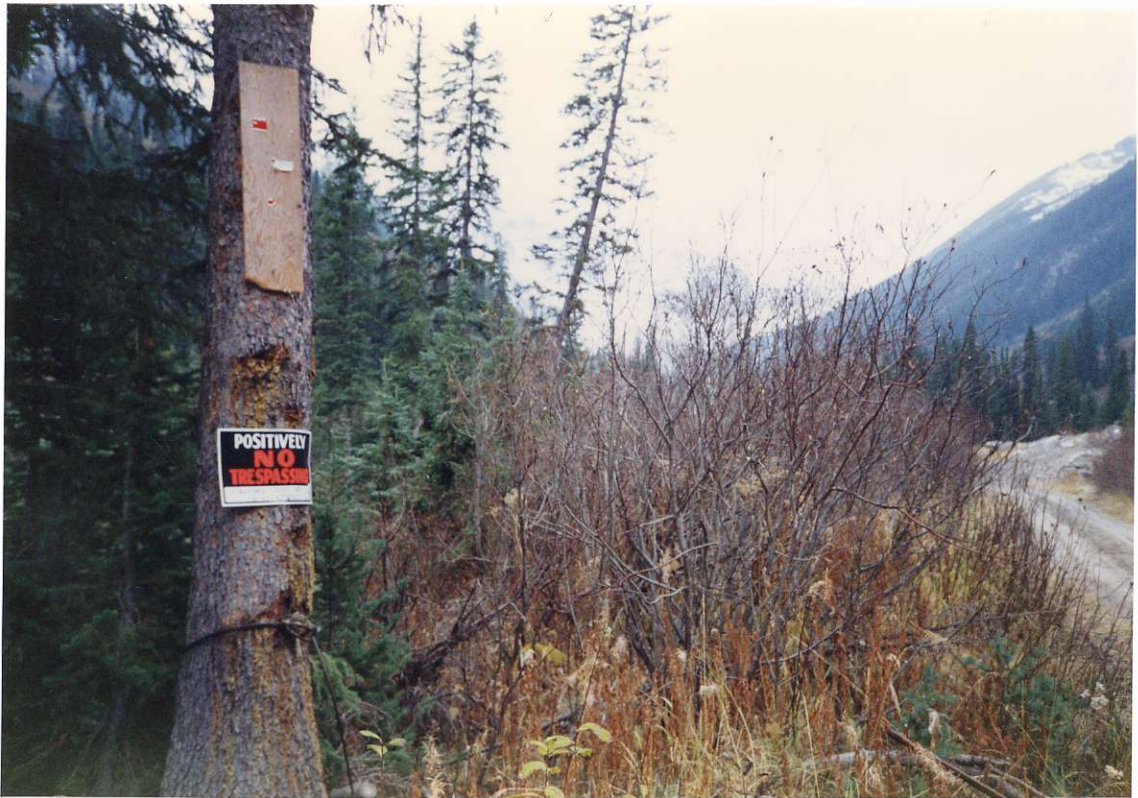
**Figure 9.**

"No Trespassing" sign posted on the mine road. Five more of these signs were posted around the site in visible locations. Many of these signs have been posted over the years and have been found to make excellent targets for hunters.

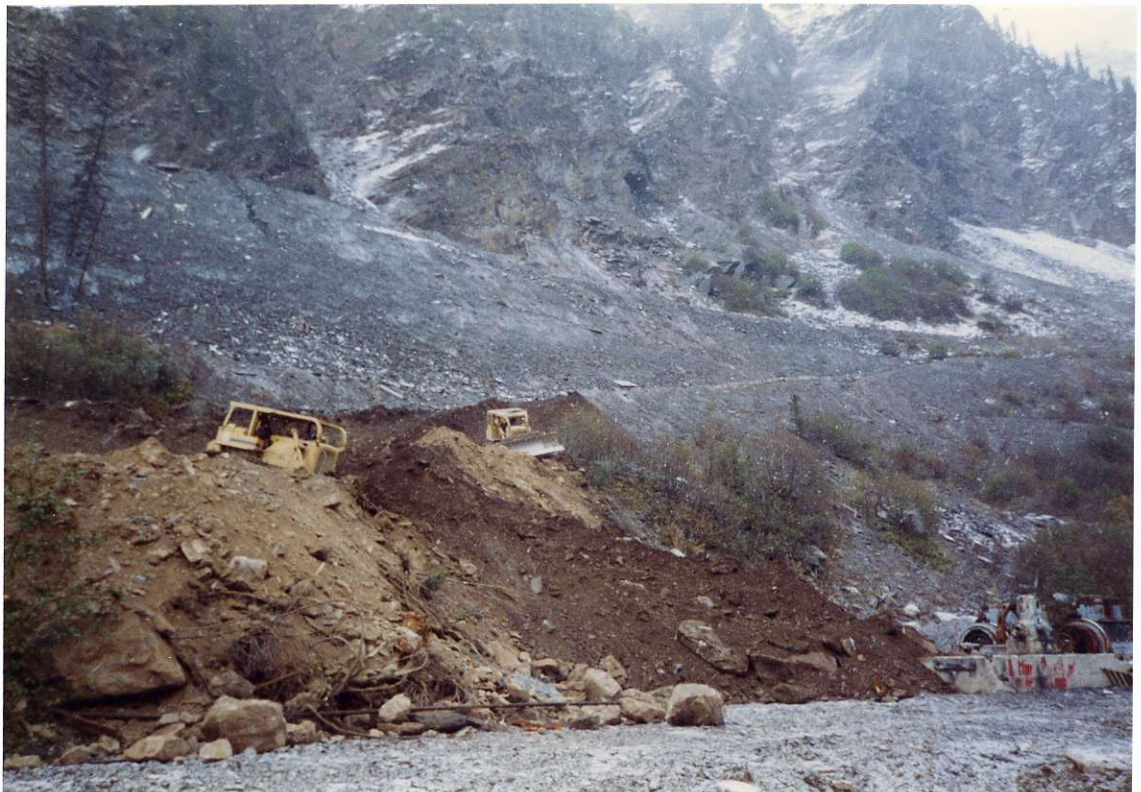
**Figure 10.**

Grading at the 5750' level. Final grading of the site encompassed the removal of the mine road up to the workings. This picture shows the road being graded down to the 5750' level and the burial of the old powerhouse.

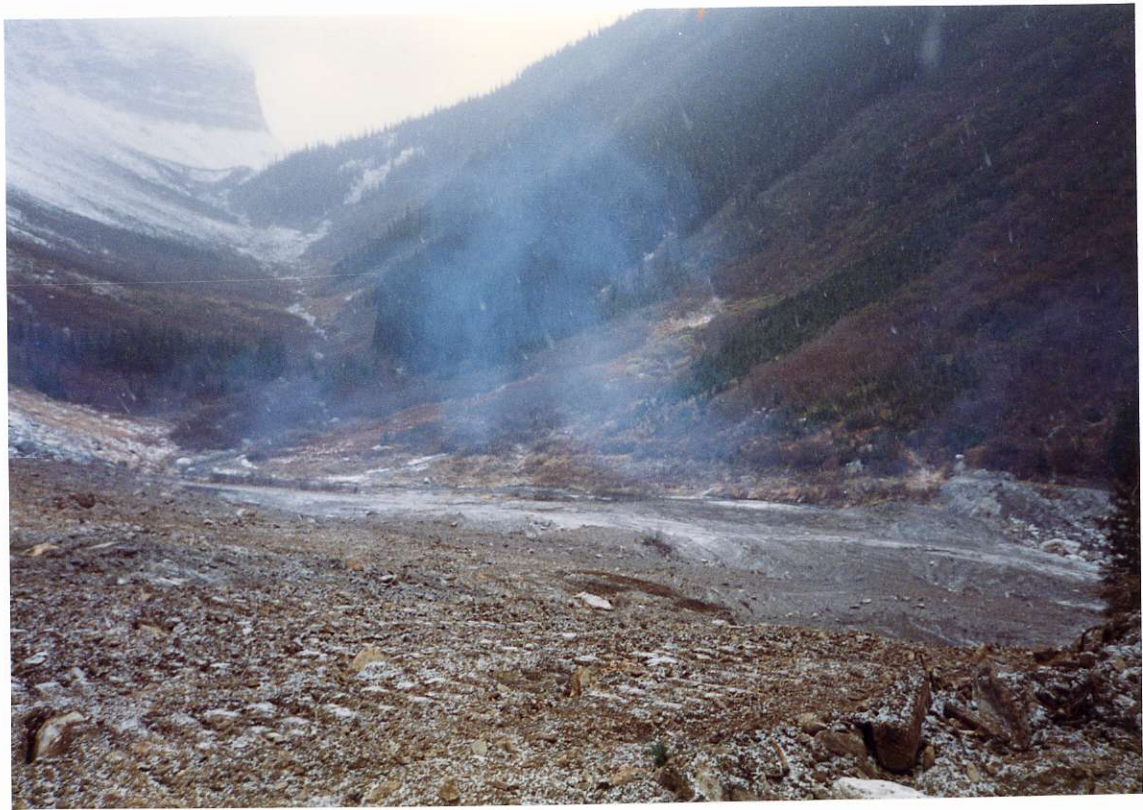
**Figure 11.**

This picture shows a view of the minesite from the 5750' level looking west. The barren area in the foreground of the photo is where the Ore Bins and Mill Building stood. The area was graded in a continuous slope from just above the 5750' level to the base of the site near the south edge of Vermont Creek.

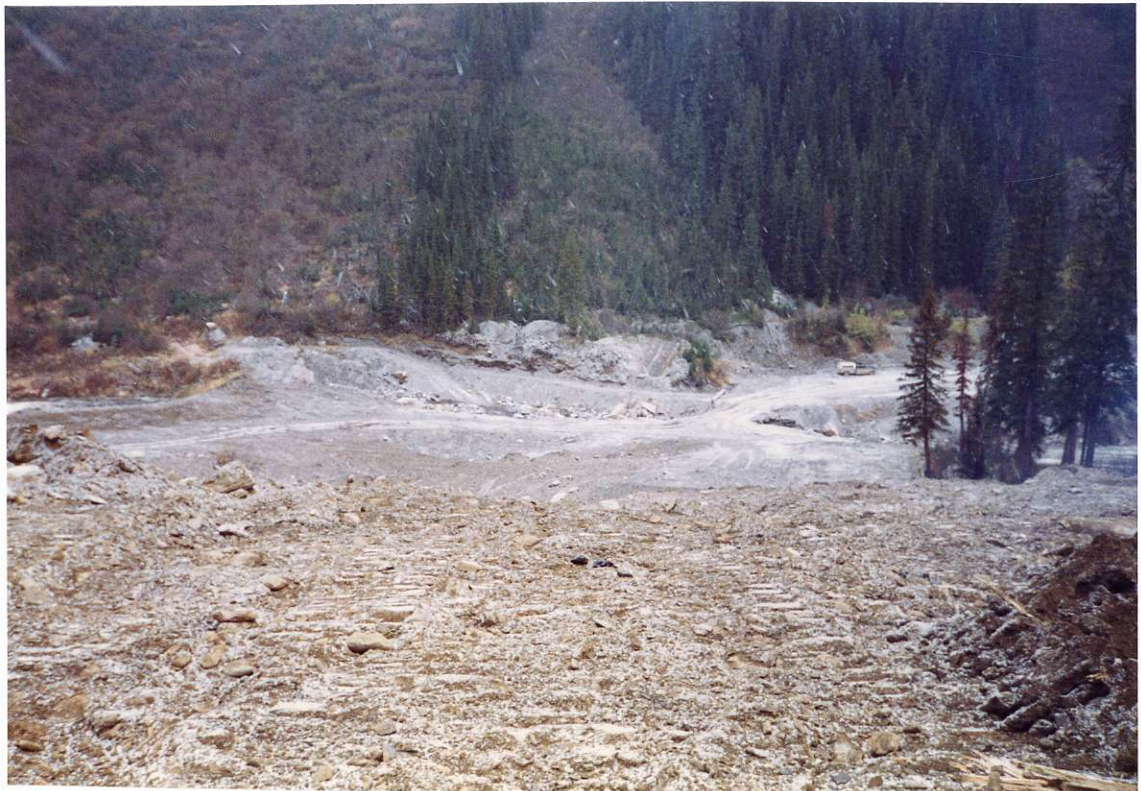
**Figure 12.**

The same area as in Figure 11, but viewed looking north to the mine access road.

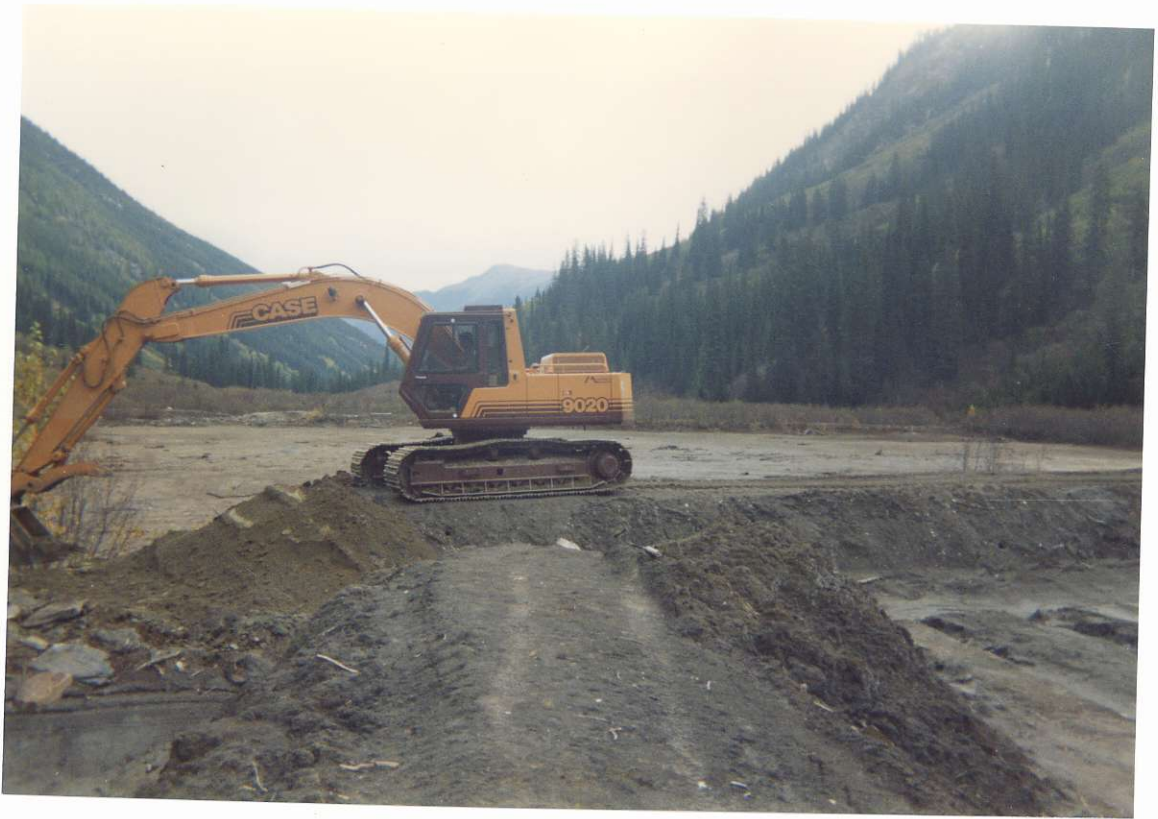
**Figure 13.**

The spillway at the northern end of the berm between Pond Number 1 and Pond Number 2 was widened and more rip rap added to handle the increased flow during the spring runoff period (Figures 13 and 15).

Remedial work being done to the drainage ditch on the #1 Tailing Pond.

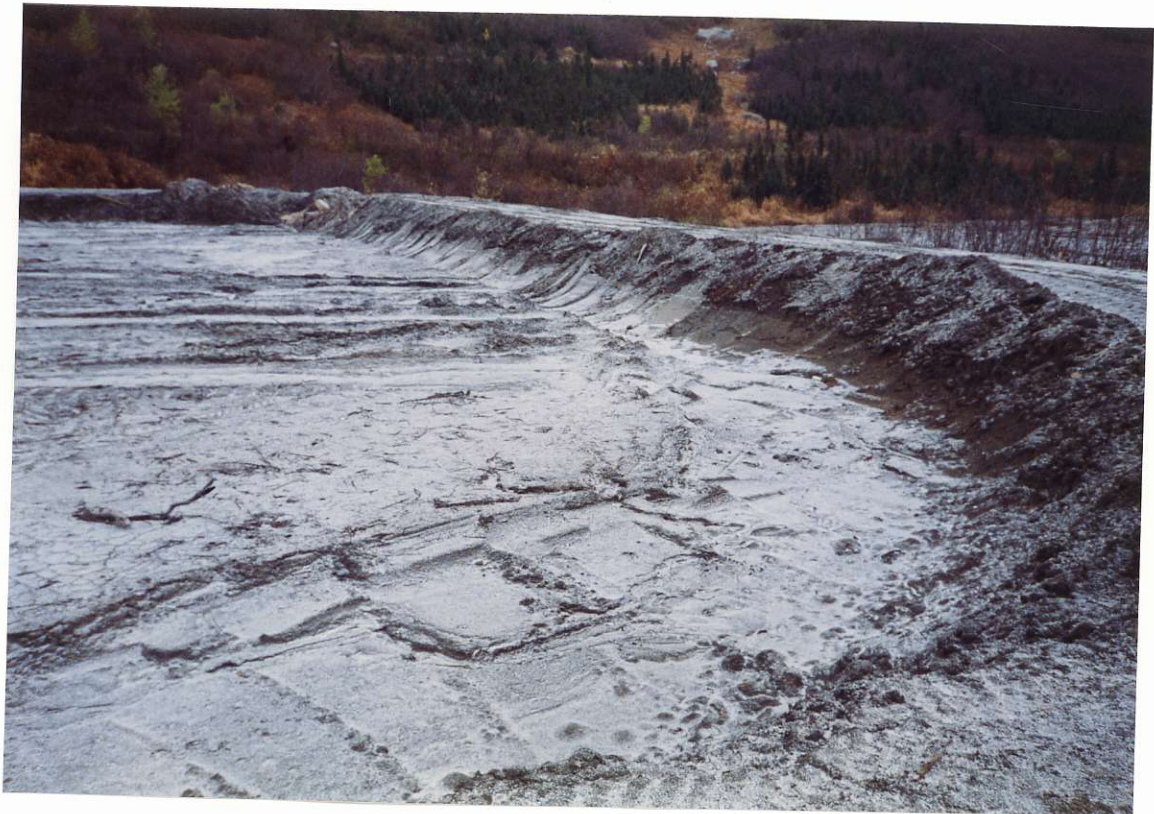
**Figure 14.**

During 1994, at the southeast corner of the Number 1 Pond, the pond surface was sloped along the berm to the drainage ditch running along the north side of the pond (Figure 14). This grading properly aligns the pond surface with the drainage ditch and reduces erosional potential in the southeast corner of Pond Number 1.

The southeast corner of Pond #1 showing the regrading to allow water to drain toward the main drainage channel along the north edge of the Pond.

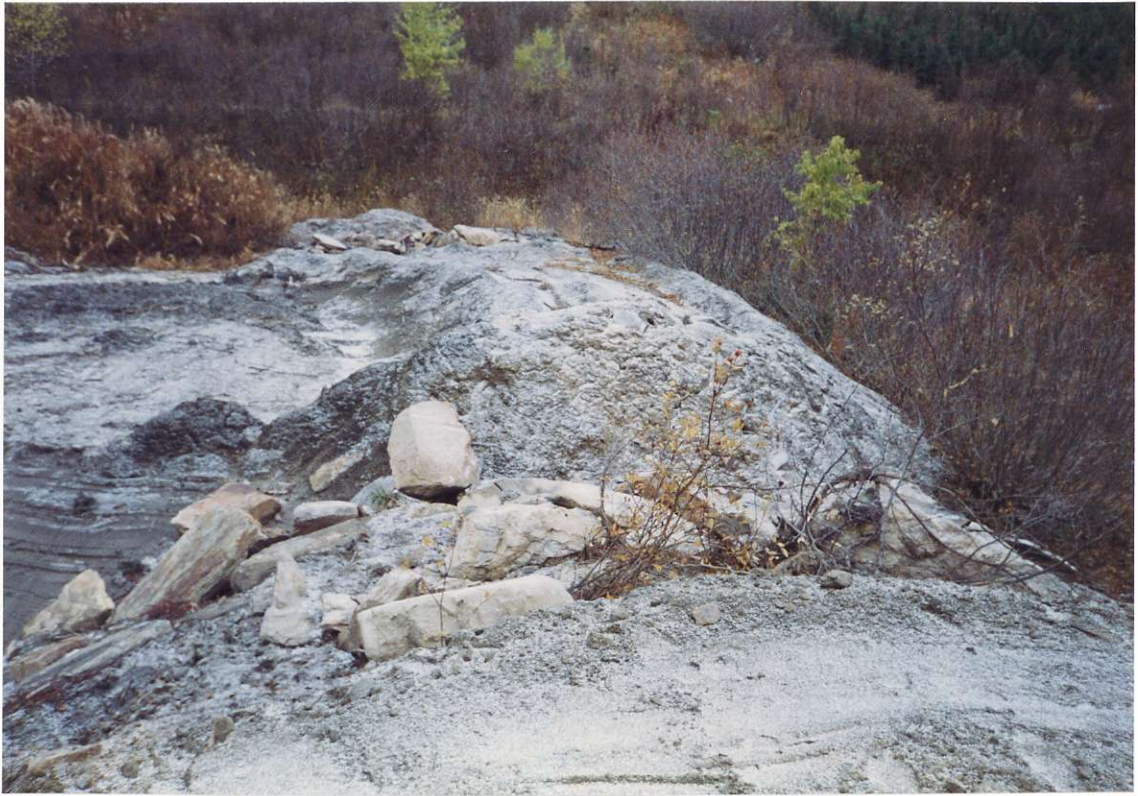
**Figure 15.**

The drainage spillway at the north end of the berm between Ponds 1 & 2. This spillway was enlarged and had more rip rap added to accommodate the increased discharge from the drainage channel.

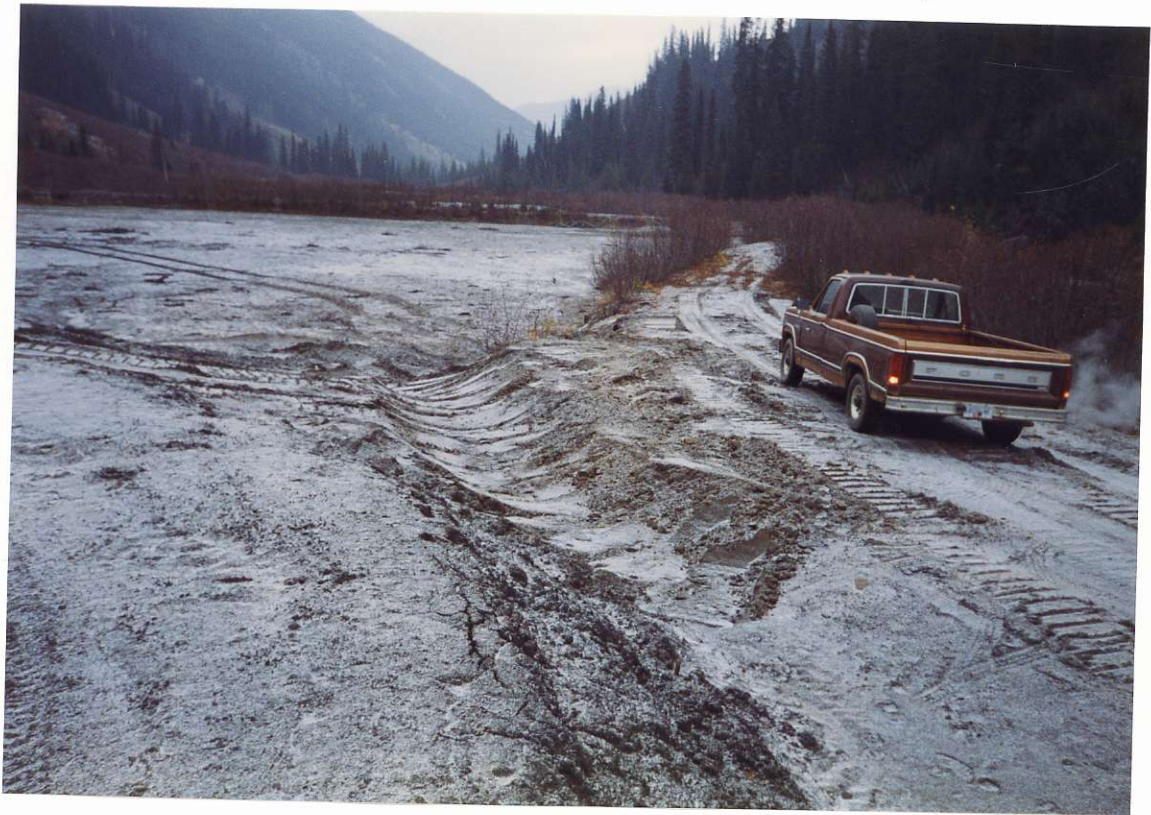
**Figure 16.**

Water traversing the junction of Pond Number 1 and Pond Number 2 had started to cause erosion across the berm between the two ponds. To keep the erosion from spreading across the south pond system berm, a ditch was dug along the inner part of the southwest berm of the Number 2 pond (Figure 16). This will direct the water flow into the Number 2 pond and halt potential flooding of the pond system south berm.

An erosional channel was beginning to form between Ponds #1 and #2 at the junction of the dividing berm and the south pond system berm. This picture shows the channel scooped out to prevent a channel forming across the south berm to Vermont Creek.

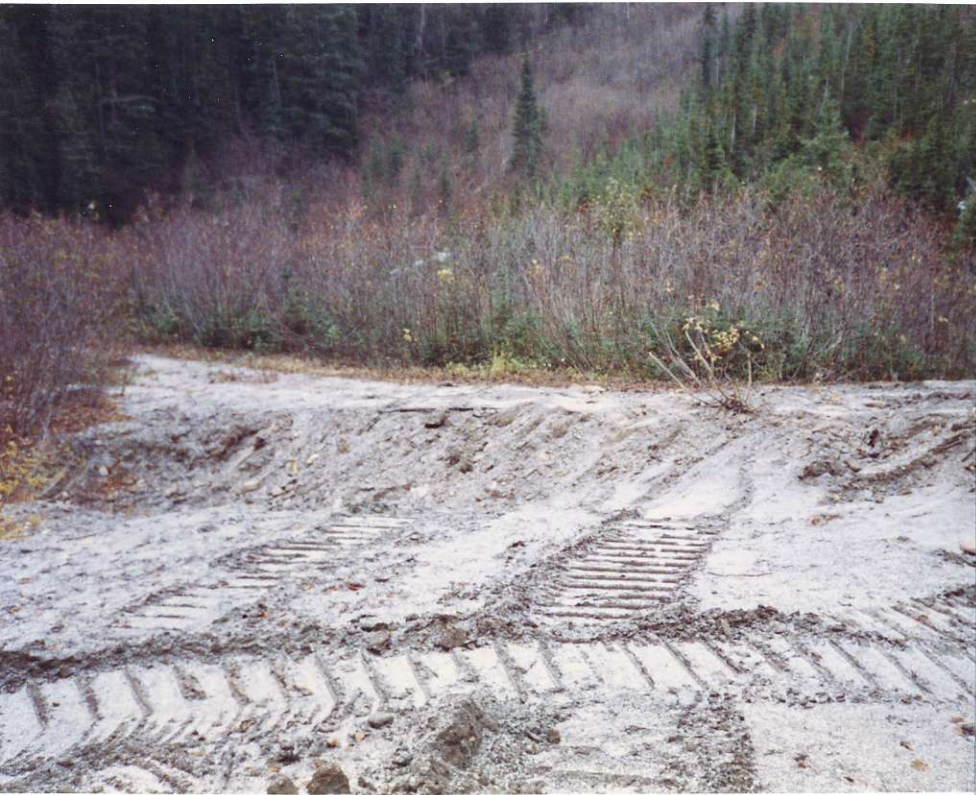
**Figure 17.**

To prevent a similar situation between Ponds 2 and 3, a spillway was constructed between the ponds near the southern end of the dividing berm. The spillway was filled with rip rap as shown in Figure 17.

This picture shows a new spillway constructed between Ponds #2 and #3 close to the south berm of the pond system. This spillway will relieve pressure on the south berm from erosion and will prevent crosscutting of the south berm to Vermont Creek.
