KINBASKET LAKE DAMSITE, COLUMBIA RIVER

By M. S. Hedley,

January 16, 1958.

**British Columbia Department of Mines,
Victoria, B. C.**

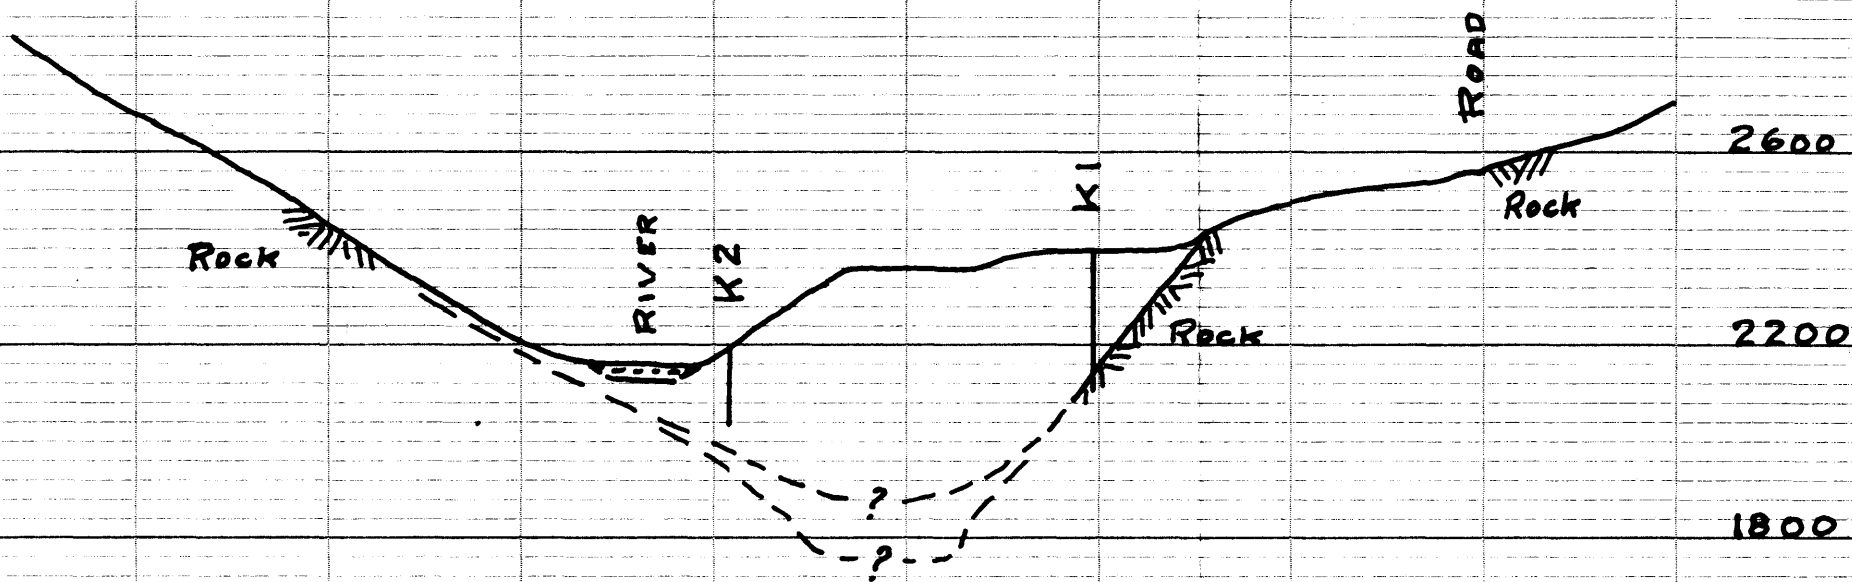
PROFILE
KINBASKET LAKE
RIVER DAMSITE

From the base of sorted or partly sorted gravels in hole K 1 at about 2,330 feet to the bottom of hole K 2 at 2,032 feet is a vertical interval of approximately 300 feet. The material in this interval is very bouldery and appears to consist of unsorted till-like material interspersed with boulder sheets or lenses. The till-like material is apparently relatively impervious, but the boulder runs are not and appear to constitute openwork gravels. The downward, vertical permeability of the entire sequence must be low, but the lateral, horizontal permeability is high. Since water was completely lost at the

bottom of both holes it follows that the water table must lie below 2,032 feet, more than 120 feet below the bed of the river. It is unthinkable that the lowermost part of the channel is dry.

boulder concentrations and is relatively impermeable vertically but is highly permeable horizontally. The fill is possibly as much as 600 feet deep (see profile), and is exceptionally difficult to drill. The tasks of determining what might be the effect of a load of 400 feet of water and of finding what steps might be necessary to minimize leakage are judged too expensive, lengthy, and uncertain.
