Property Examination

PROPERTY NAMES: GOLDEN BEAR, MUDDY LAKE

ZONE: BEAR ZONE

SUBMITTED BY: D.V. Lefebure

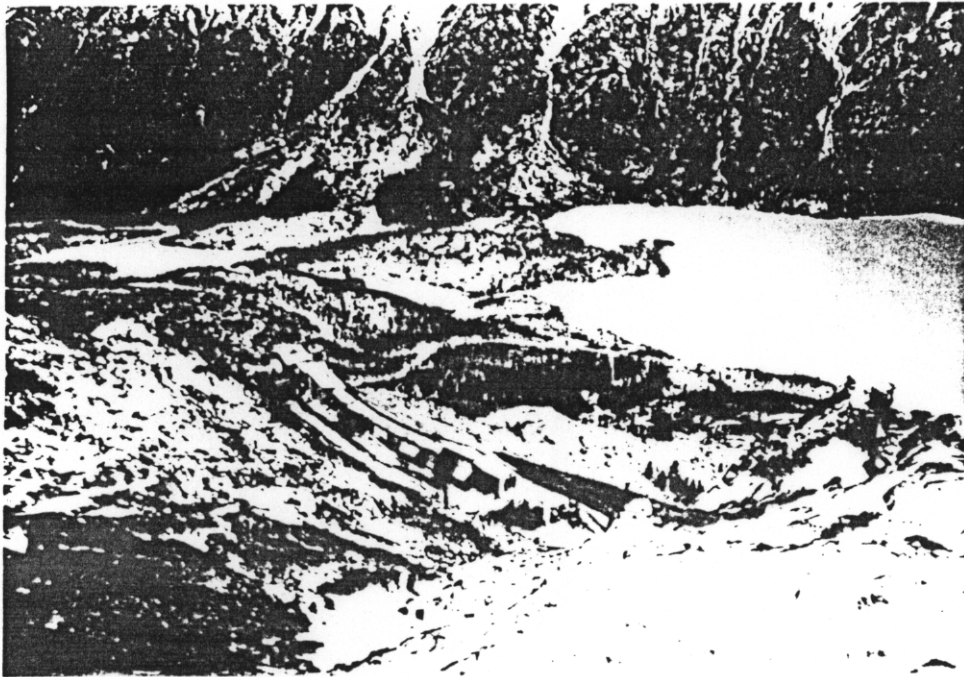
Figure 3. Buildings at portal in the foreground. Blue ventilation pipe leads to portal. Buildings and ground near lake underlain by landslide material. (R#45-13a)

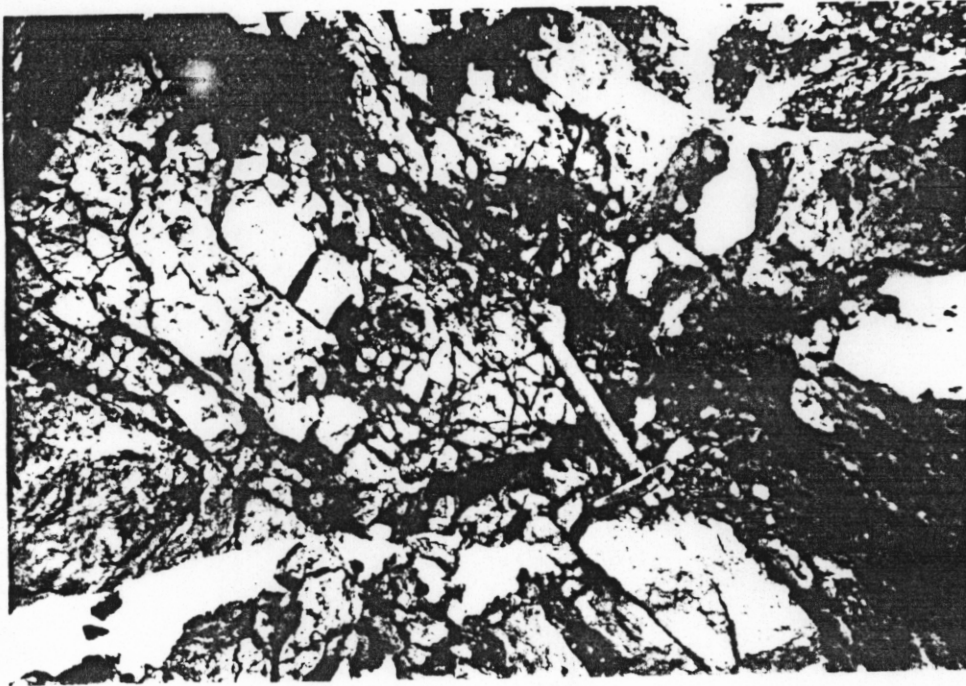
Figure 5. Altered breccia with sericitic tuff fragments and siliceous matrix/veinlets. The yellowish stain is reportedly jarosite, a common constituent of limonitic gossans.  
(R#45-12a)

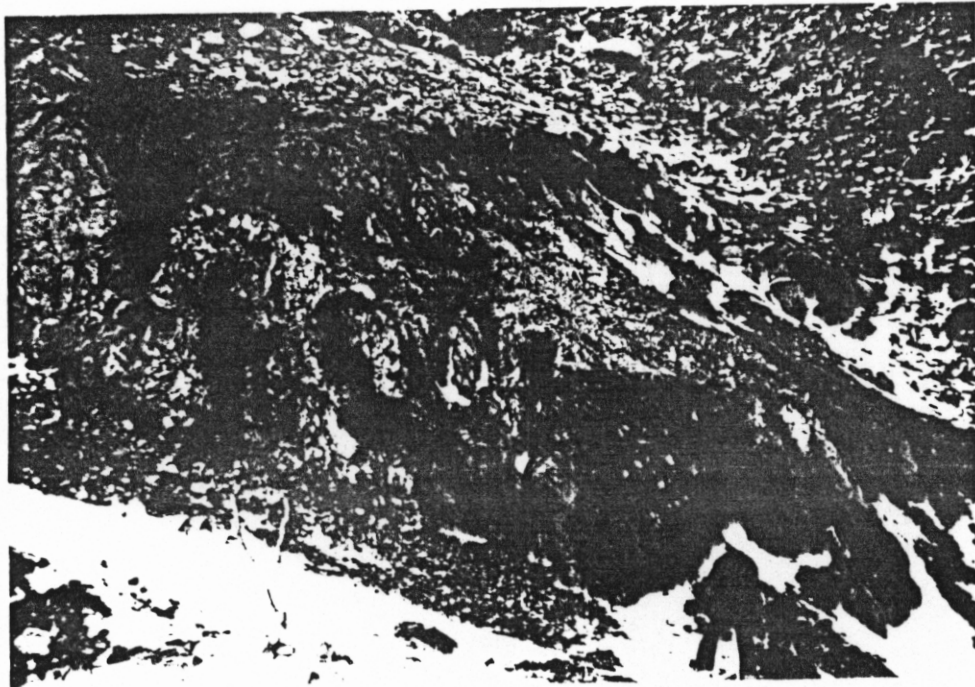
Figure 6. Surface expression of the Bear Zone. North of portal. Note large horsts of rocks caught up in strongly sheared zone.  
(R#45-14A)

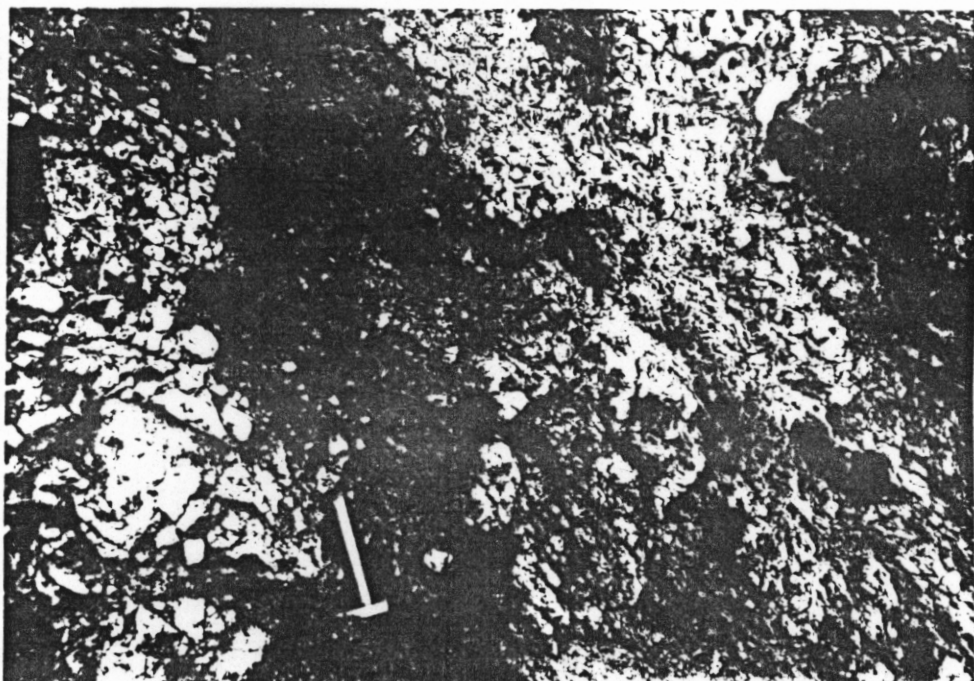
Figure 8. Close up of black gouge in western margin of fault zone seen in Figure 6. Note gray quartz breccia to right.  
(R#45-17a)

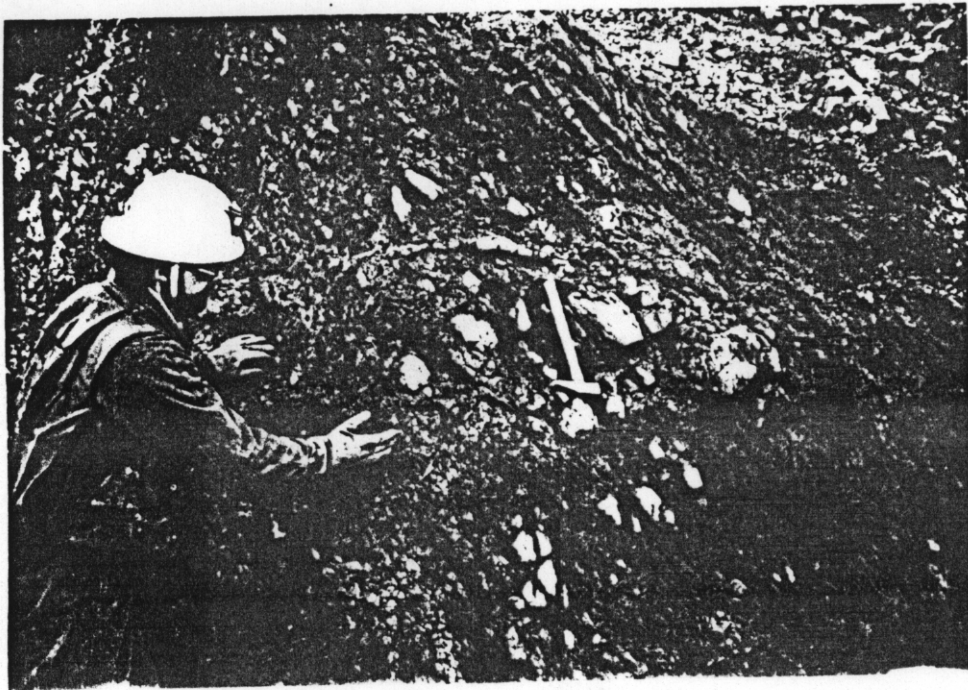
Figure 9. Close-up of altered and brecciated zone which E. Titley (in photograph) reported contained up to 1 oz gold. Reddish stain (limonite)? characteristic of certain zones in Bear Zone. Flat veinlets are composed of ankerite. (R#45-18a)
