# Support at Cassiar Underground Mine

J. JAKUBEC

*Cassiar Mine, Cassiar, Canada*

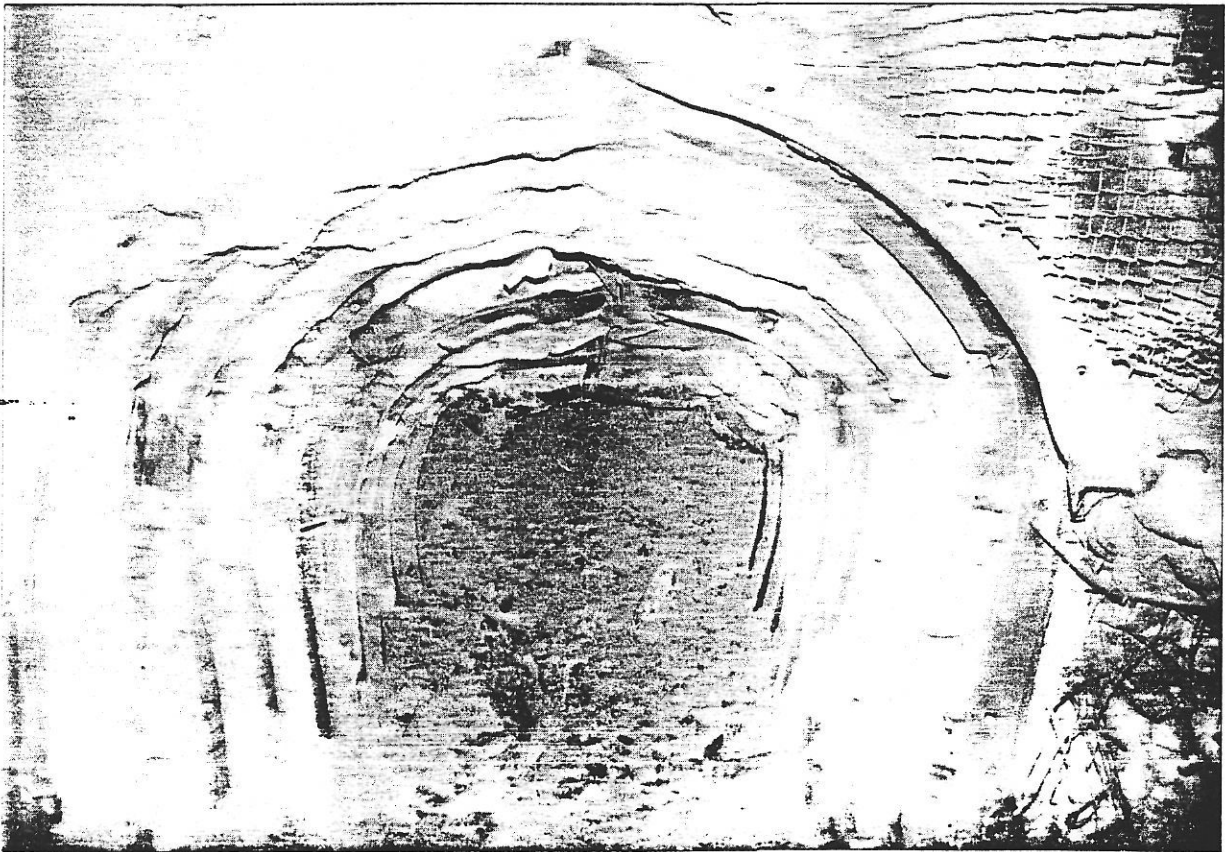
The rigid steel arches themselves have behaved fairly well. It was surprising that the arches functioned well and applied support pressure even after severe deformation (Figure 10). Part of the success was the interlocking of the arch structure with the top plates and connection bars, which prevented disintegration of the arch unit. The weakest point was the anchoring system. Arches were installed on the top of the concrete floor, so that no concrete was placed after the arches had been erected, which could block the legs from moving into the drift. The bottom channels were not bolted to the floor, and the cable grips, on which the whole anchoring system relied, failed. The combination of poor excavation and excessive pillar deformation often necessitated the slashing of the drift in order to install arches. Once considerable deformation and distortion of the arches had occurred, the connection bars pulled through the arch beam.

Several weak points were observed in the yielding sets that were tested in one drawpoint in Class 5A ground. Firstly, the legs and crowns had been joined with a jointing system consisting of a U-bolt and a flat clamp. This connection failed in the first three sets, where the yields exceeded 75 to 100 mm. Because of the shotcrete, which encases the whole structure, there was no access for the

Figure 10. Severe arch deformation on 1350 North

resetting of the connecting bolts. Secondly, the spacer channels that linked the arches had been attached to them by J-bolts. Under severe distortion, the J-bolts failed. A third problem was posed by the anchoring system, which failed as described earlier.

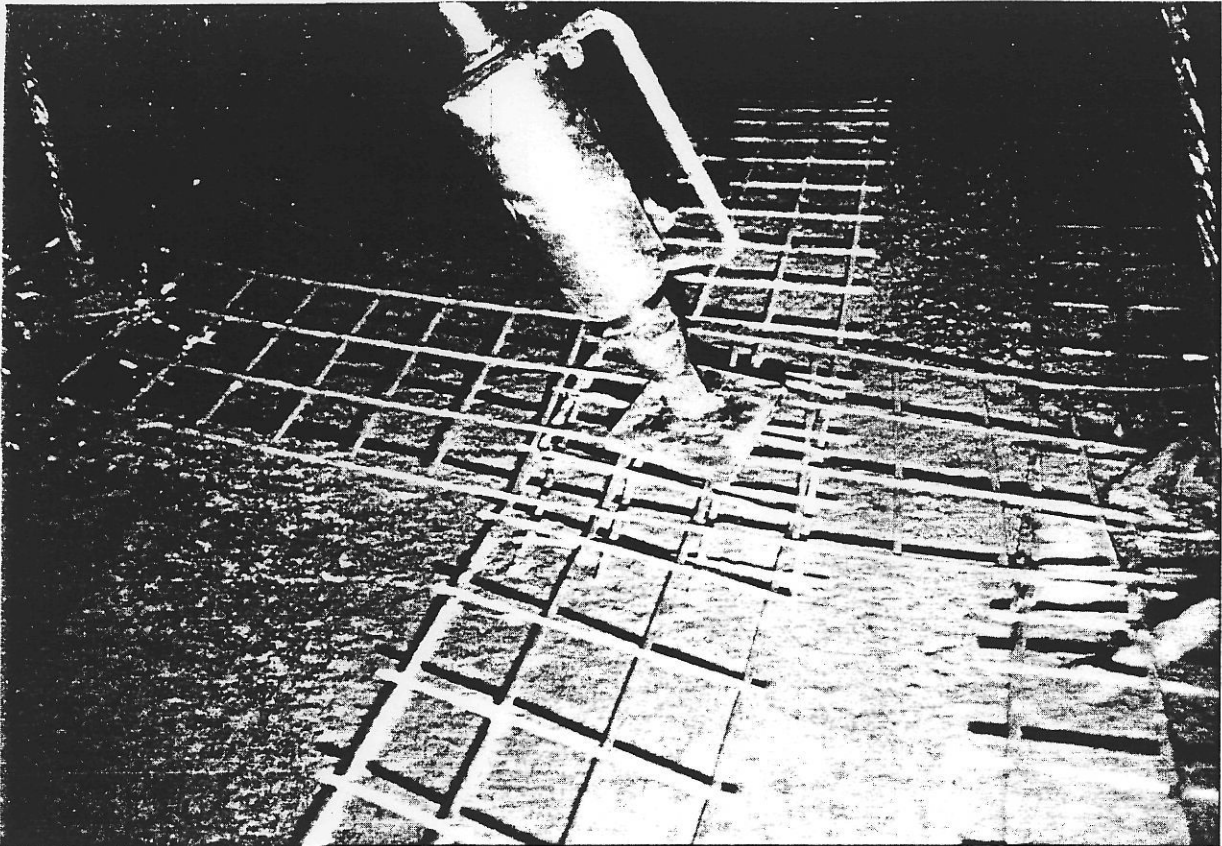
Figure 12. Detail of the horizontal and vertical strap system used for repairs at 1350 North. The cable grip is installed with a hydraulic jack

Since no damage was observed on the back, repairs were concentrated on the sidewalls. The critical situation of pillar failure was recognized, and large-scale repairs and installation improvements were implemented immediately. All the loose shotcrete was removed, and the exposed rock was re-shotcreted. The bottom area of the walls was reinforced with additional Dywidags connected horizontally with 0,3 by 2,4 m welded straps. A system of 16 mm fully grouted cable bolts was installed through the pillars (Figure 11). There were 3 cables in the ring, and the rings were at a spacing of 2 m. Surface restraint was provided by vertical and horizontal welded straps overlapped at the bolts and tightened with 150 by 150 by 15 mm plates and cable grips (Figure 12). The whole steel structure was encased in shotcrete: firstly, to provide good contact between the straps and wall and, secondly, to protect the support from LHD damage.

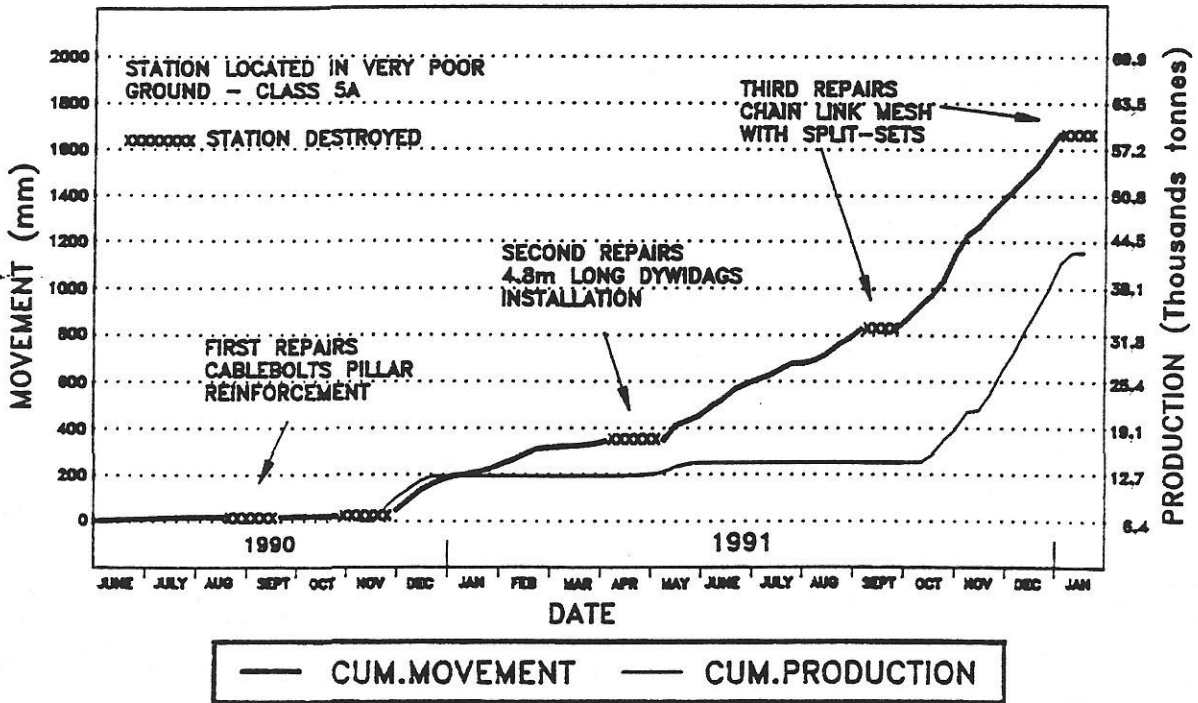
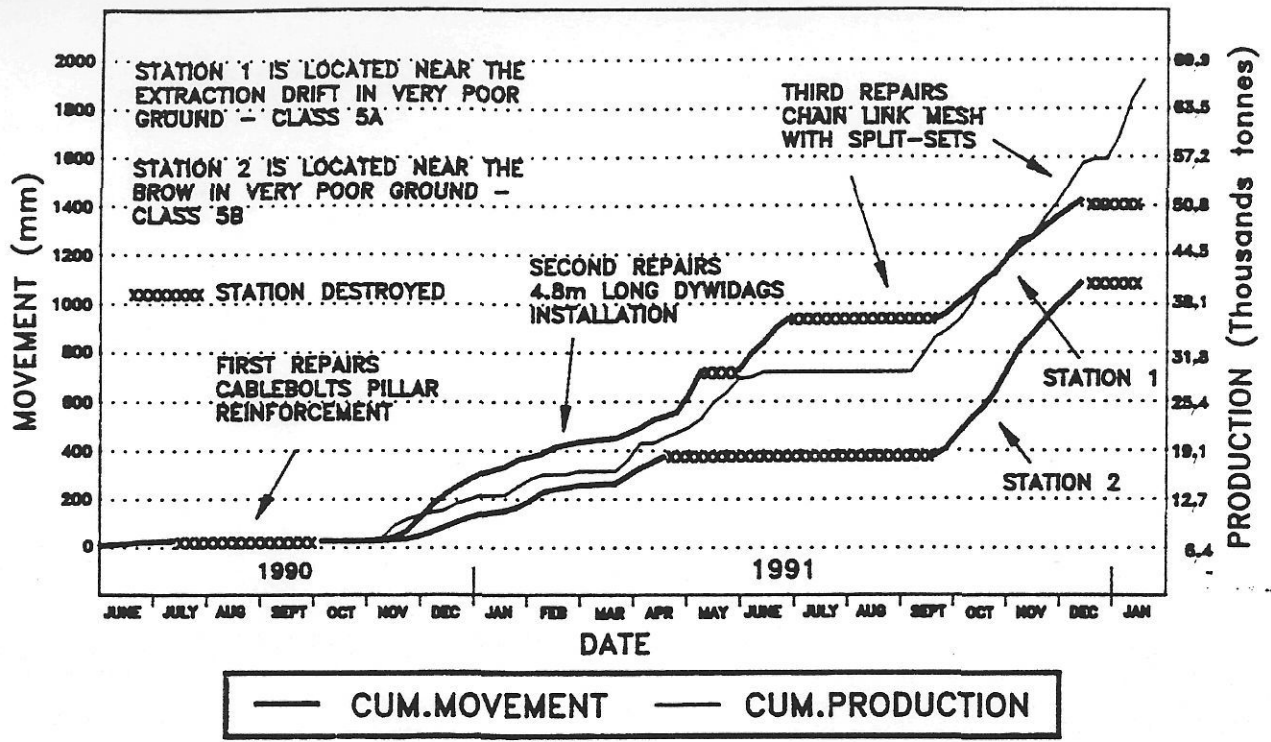
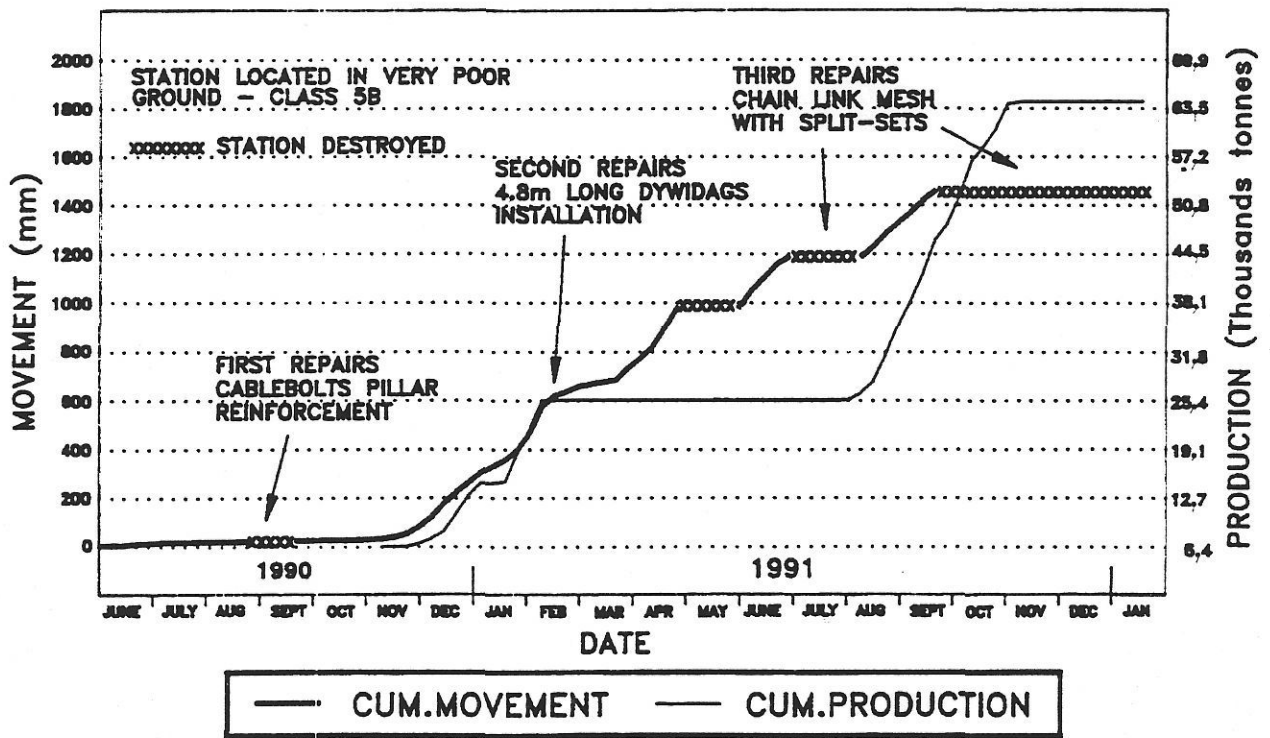
Monitoring of the drift closure was re-established, and the horizontal movement decreased from between 5 and 10 mm per week prior to the installation of cable bolts to almost 0 mm after repairs (Figures 13 to 15). Development of the level continued, and the undercut was excavated and supported.

Figure 13. Cross-drift deformation, drawpoint no. 2

Figure 14. Cross-drift deformation, drawpoint no. 6

Figure 15. Cross-drift deformation, drawpoint no. 9

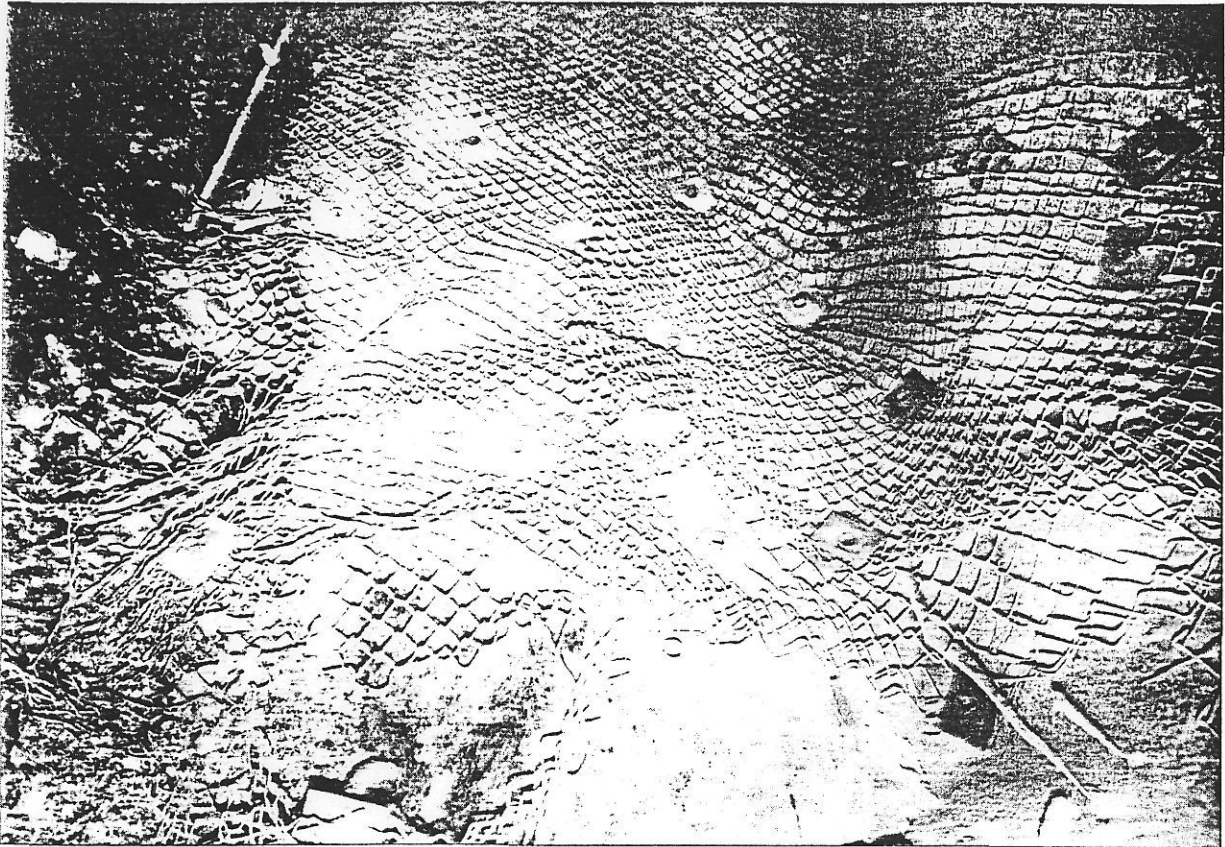
The excessive deformation (Figure 16) and floor lift (Figure 17) in the north has meant that most of the drawpoints have had to be slashed and re-supported.

Figure 16. Extensive sidewall damage in drawpoint no. 9, 1350 North

The low standard of support and repeated slashing gave the pillars additional opportunity to deform. This caused gradual pillar disintegration, and the load-carrying capacity of the pillars was reduced significantly. Plastic flow of the weak rockmass into the openings was observed on many occasions (Figure 16).

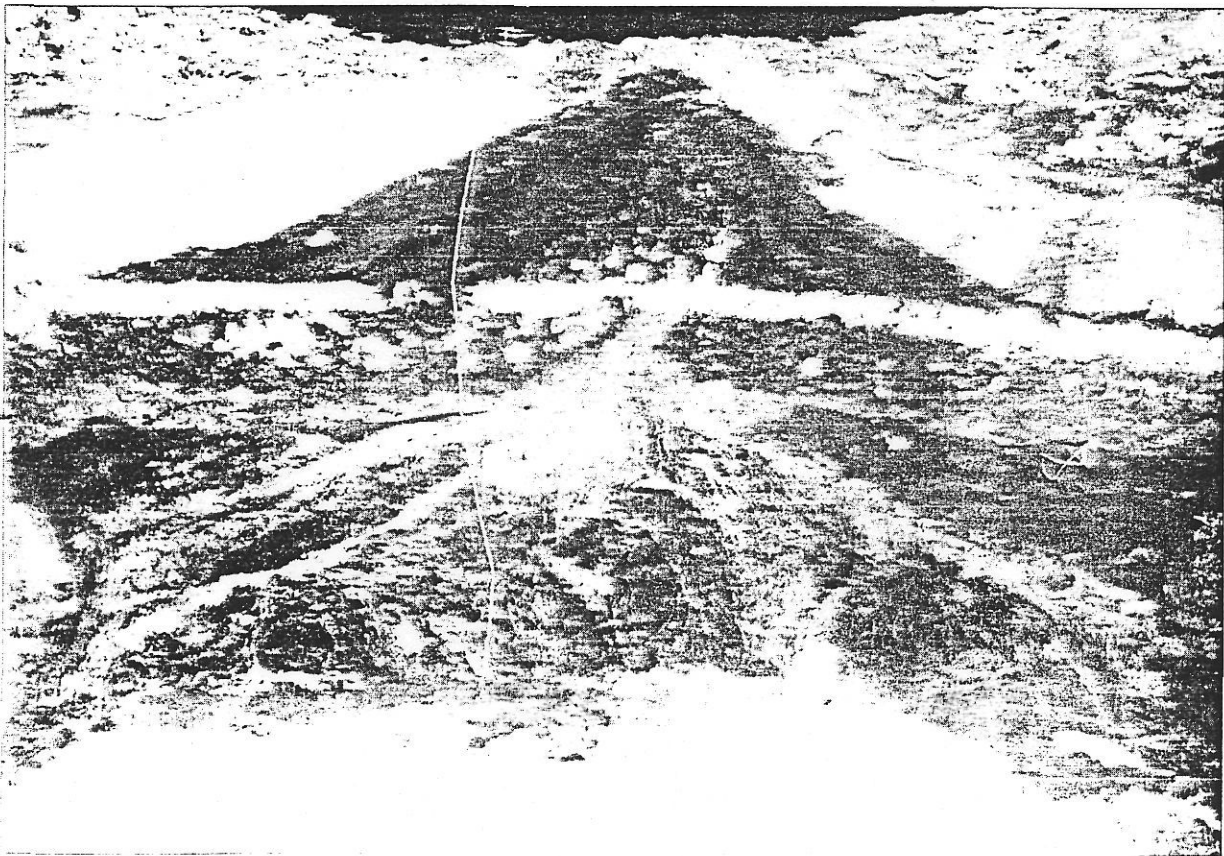
Figure 17. Floor heave in drawpoint no. 8, 1350 North, showing plastic deformation of the sheared serpentinite

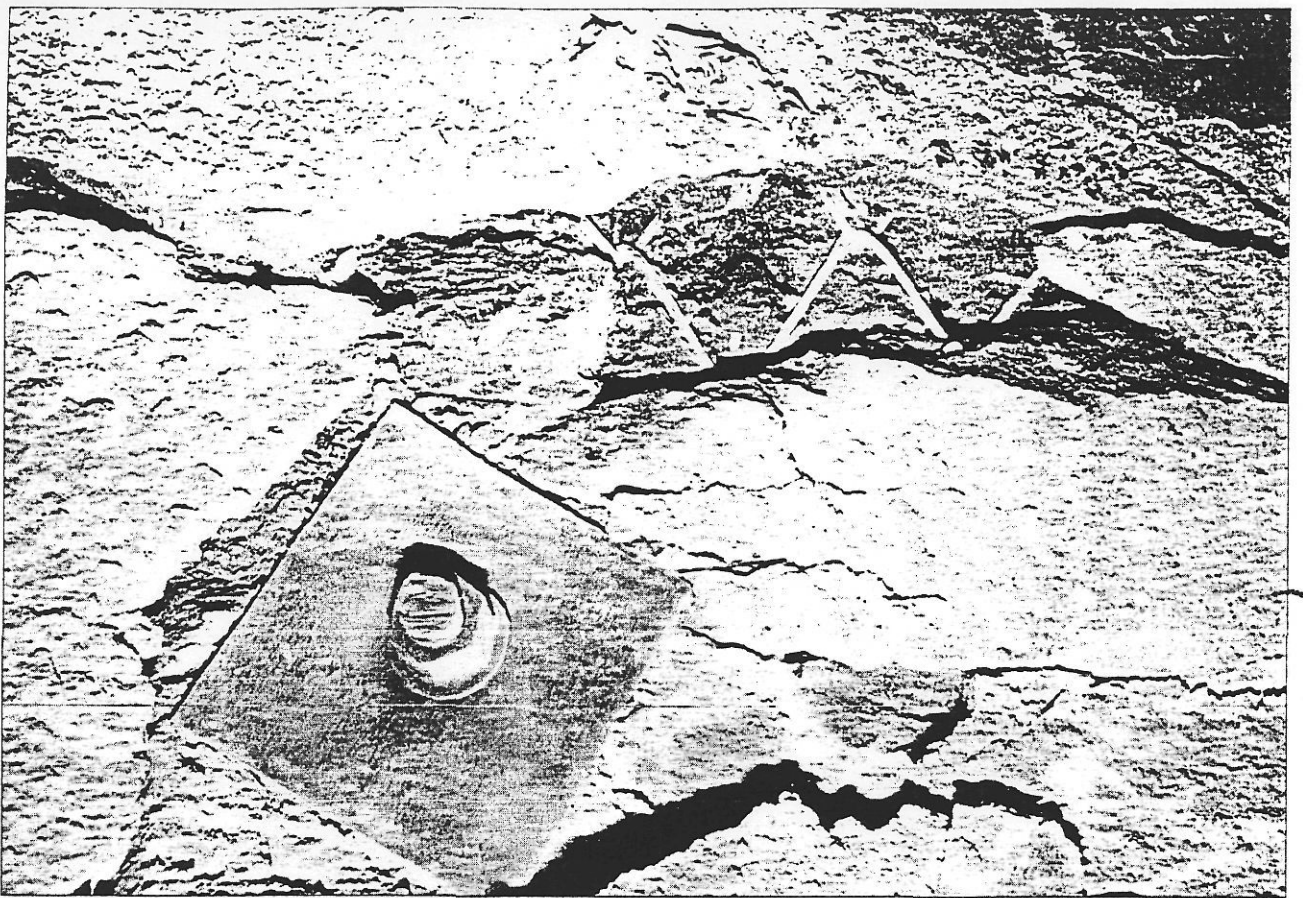
gauge-6 chain-link mesh (Figure 22). The chain-link mesh proved to be far superior to the welded mesh in its deformation capability (Figure 23).

Figure 23. Intact chain-link mesh in cracked shotcrete lining

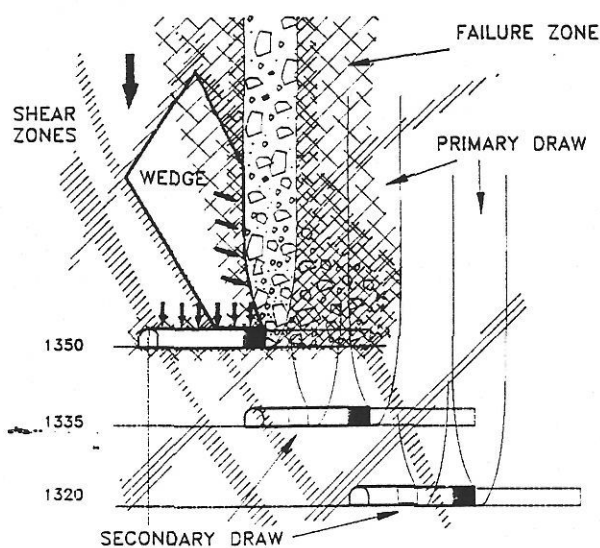
Extreme vertical loading of the drawpoints on the north occurred after the cave zone had extended from 1350 level into the argillite. This was caused by massive wedge failure above the level. Figure 27 shows an idealized cross-section.

Figure 27. Wedge failure and drawpoint loading
