840491
RAM CREEK
TUCHODI LAKE

June 30, 1971

I briefly examined Alberta Copper & Resources Ltd. copper prospect at Ram Creek, British Columbia on June 25, 1971. This report presents my assessment of the prospect.

COPPER OCCURRENCES

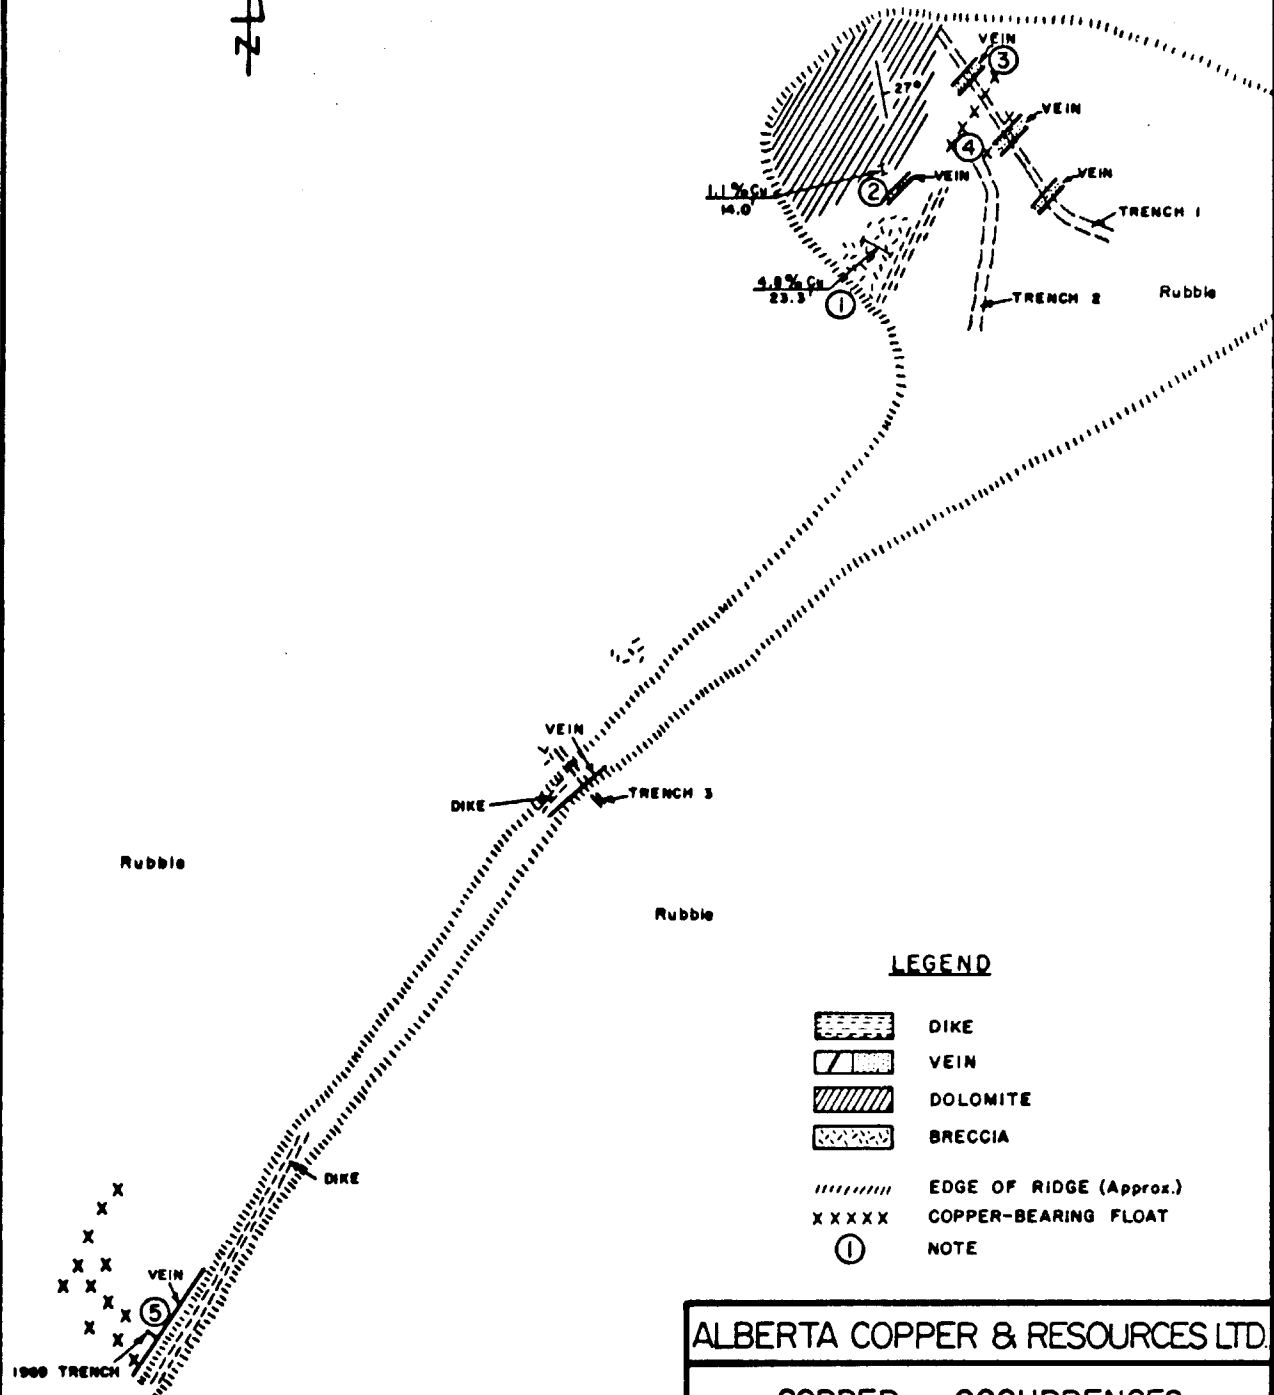
DWG. IAC-1

The information contained in this section summarizes notes made at each exposure. The notes are keyed by number to drawings 1AC-1 and 1AC-2 which are attached.
