PROPERTY FILE

Vigilant.

June 15/64

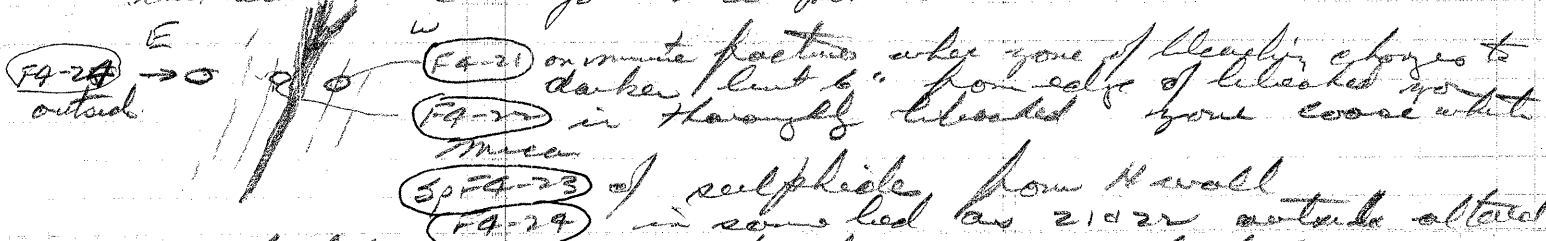
(B) Coarse galena in fracture to 3" wide in center of zone with 10-12 ft fracture. (6 on dark side) 75/725 pyrobitite + sphalerite + bleached walls. In 4' of beds. This up a down vein but wall yellow surface? composition
