No 2 (LOWER) ADIT.
1" = 30' (3)

No 1 (UPPER) ADIT
1" = 30' ①

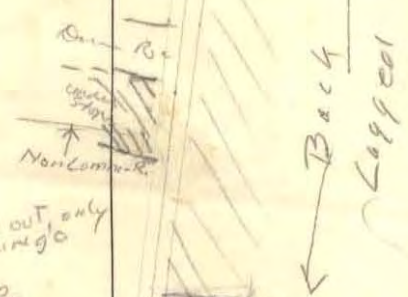
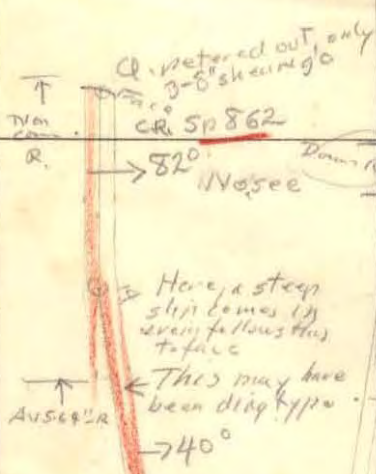
Climb up to back - vein lousy 2-3'
 (1/2 W) sheared breaks to a 2-3' break

Nothing in X-C
 only Q.d.

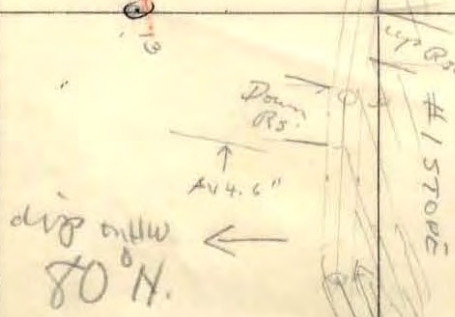
N61 (UPPER) ADIT
 1" = 30' (2)

Climb up R5 @ 09 ± 20' to back & within 3 1/2
 back - steep 3' W. vein 2-3" @ 5 sp 863-4
 some sharp angled veins edging it, lying pretty well within
 5-7" vein - shear - west is at a vein in shear.
 vein shear - shear - no crushed leached white Q.d.
 coming to face FW, straight very free thw, dip
 STOPE 2 1/2 - 4' mostly 3.0 Open, stop, no ore, stulls,
 6-10" ac. Stope.

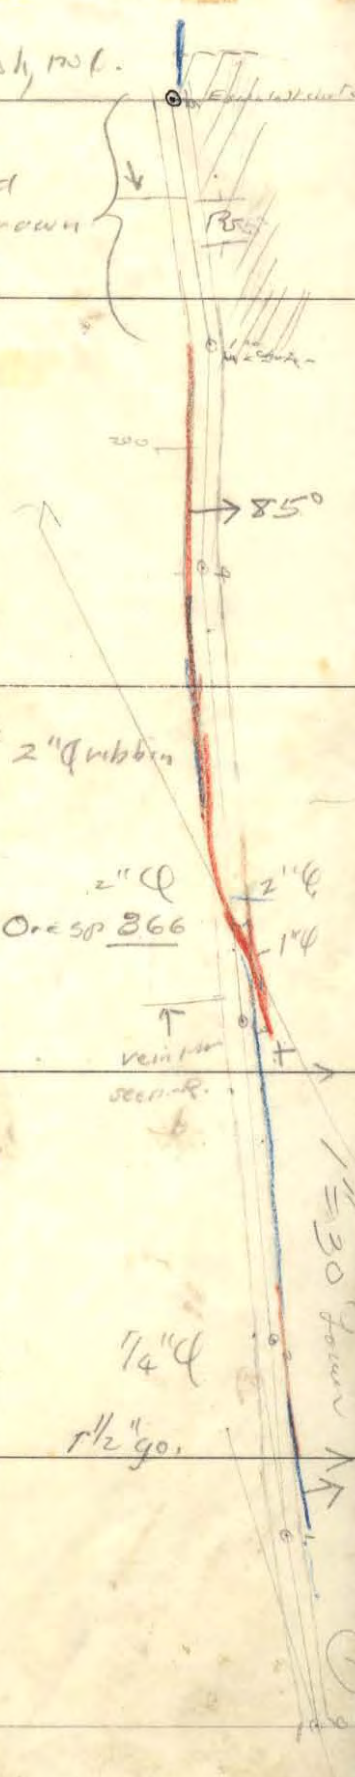
No 2 (LOWER) ADIT
1" = 30'
①

SPT 69 - shows alterations eg d. for a" for vein-stripe
dense black dye, spots out at 6"

more spindles, smooth, str 10° dV. @ port 1
