### Preliminary Environmental Assessment of a Proposed Quarry West of Apple Bay on Holberg Inlet

**Prepared for Homegold Resources Ltd. by:**

February 2000

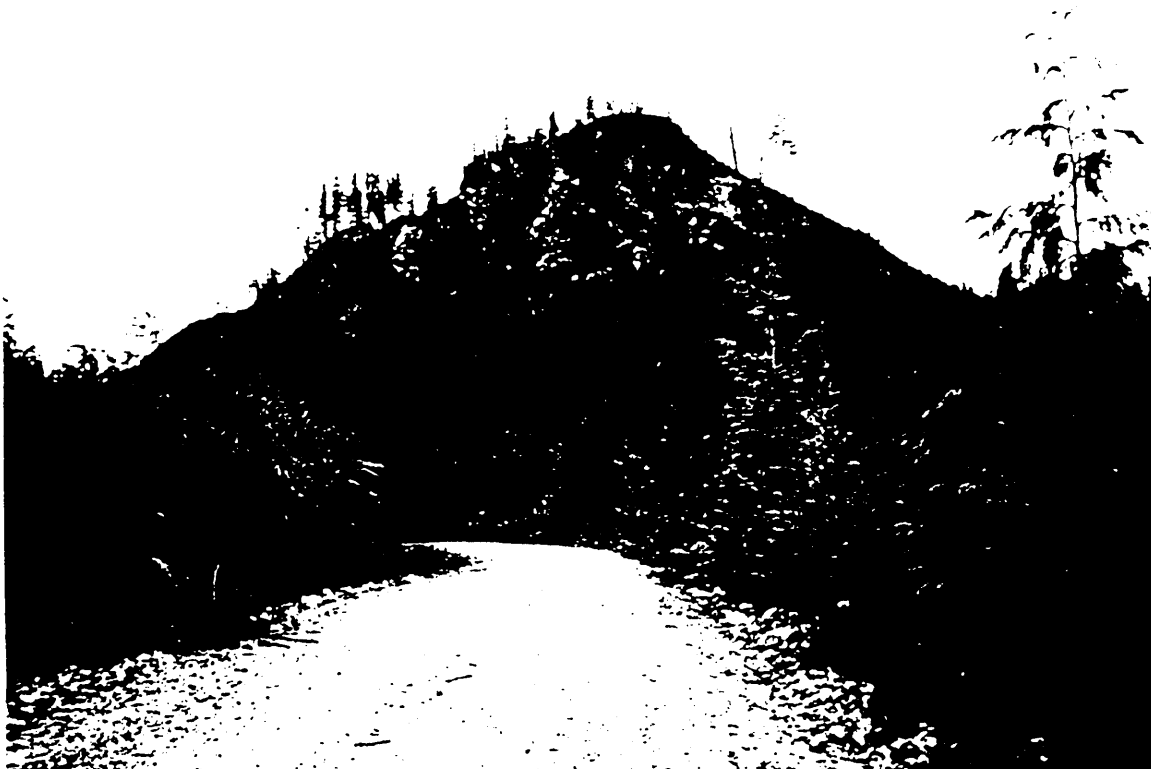
Photo 5: The southwest face of the western knob. This recently logged area appears to have been replanted in 1998 or 1999.

Photo 6 (Right): Looking northeast from the peak of the western knob (Sampling Site 6). The peak has a sparse canopy of fire-damaged trees, and a dense understory dominated by salal.

The second is a recent clearcut covering the southwest face of the knobs. Based on the size and spacing of the small conifers, it was probably replanted in 1998 or 1999. It is shown in Photo 5. A few much less defined game trails were noted in this area.

The third is an older clearcut area to the north, east, and south of the knobs, which was replanted in 1988. It is shown in the backgrounds of Photo 3 and 6. This area is very heavily vegetated and is dominated by cedar and hemlock. There is significant growth of alders along the roads and streams, some of which have been recently weeded out.

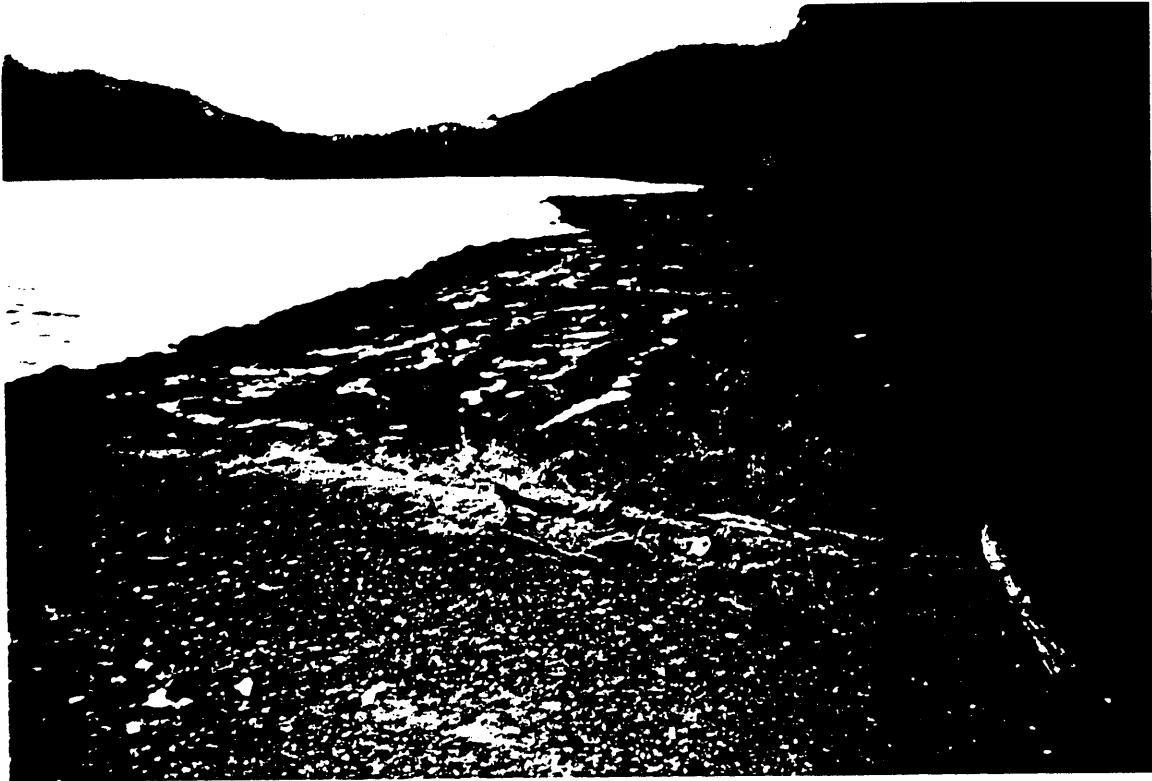
Photo 9: The view from the potential loading platform. A well-developed saltmarsh zone extends from the rocky shelf, in the upper intertidal, to the edge of the forest. The rockweed in the mid intertidal is visible near the shore.

A loading platform built about 500 metres to the west of Norton Point (see Figure 1) may be used for loading chalky geyserite from trucks to a barge. Since Norton Point is the outlet of Youghpan Creek, this site is somewhat estuarine in character. A saltmarsh lies along the foreshore immediately east and west of the access road to the facility. An area of bare rock separates the saltmarsh from a rockweed-covered area in the mid-intertidal zone. Backshore vegetation was dense and overhanging. Several small streams flow into the inlet near the facility. The habitat adjacent to the log dump was photographed (Photos 8 and 9).
