PROPERTY INFORMATION FORM

Name of Property L. A. Claim Group

Location Atlin M.D.: Mile 60.25 South of Alaska Highway on Atlin access rd.

Examining Engineer  
Roderick Macrae

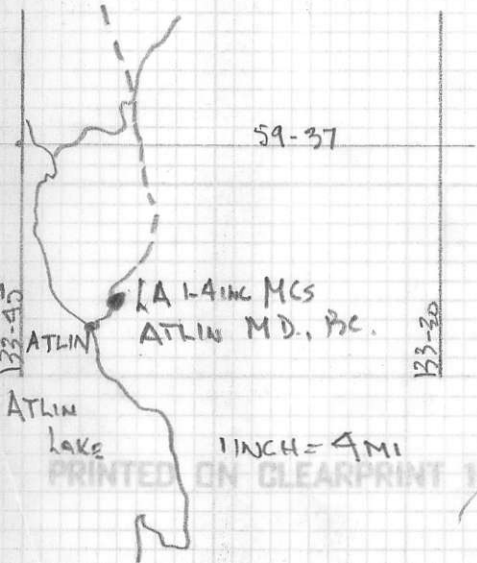
LA 1-ACLS  
ATLIN M.D.

Present Known Extent and Possible Extensions vein is continuous for 16 feet in longest exposure. Other exposure traced for 7.5 feet where it is pinched or faulted. There is no indication by float or exposures of any concentrations of veins in the vicinity of main exp. Old trench recently cleaned out for inspection shows similar vein, minor mineralization, same strike, but may be parallel vein.

one old trench, 4 x 8 ft: two vein exposures in vicinity of rd. road.

two assumed on strike at 320 ft interval, longest of two exposures less than 20 ft.

known exposures are not important: close, detailed prospecting towards the intrusive exposures is recommended to owners.
