# SCHEMATIC SECTION OF MINE SH-

BRALORNE RESOURCES LIMITED  
VANCOUVER, B.C.

TO ACCOMPANY REPORT BY  
BACON & CROWHURST LTD. **826949**

# TYPICAL STOPPING ARRANGEMENT

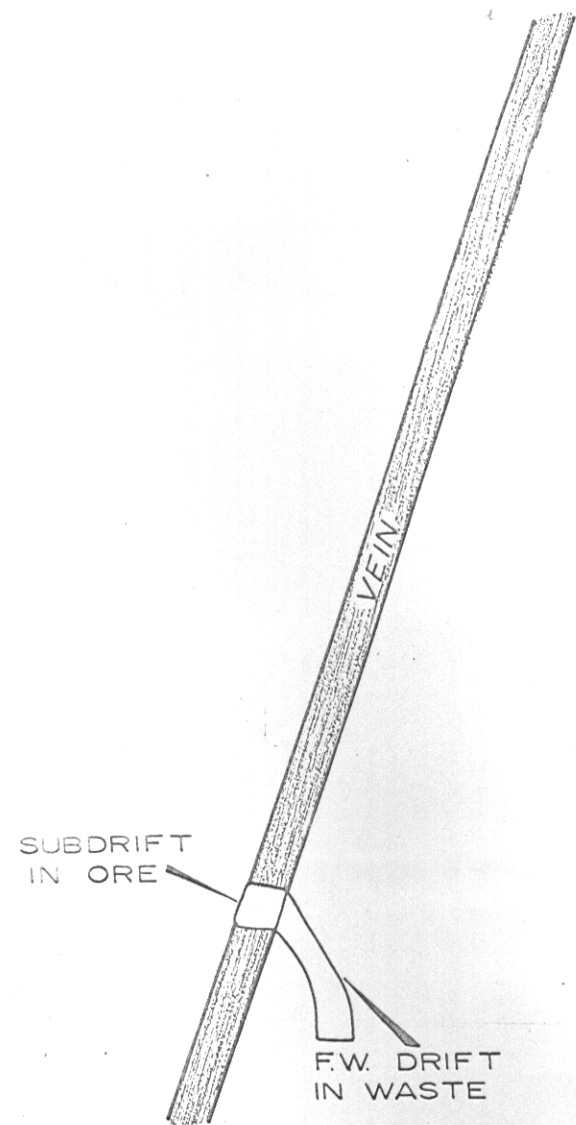
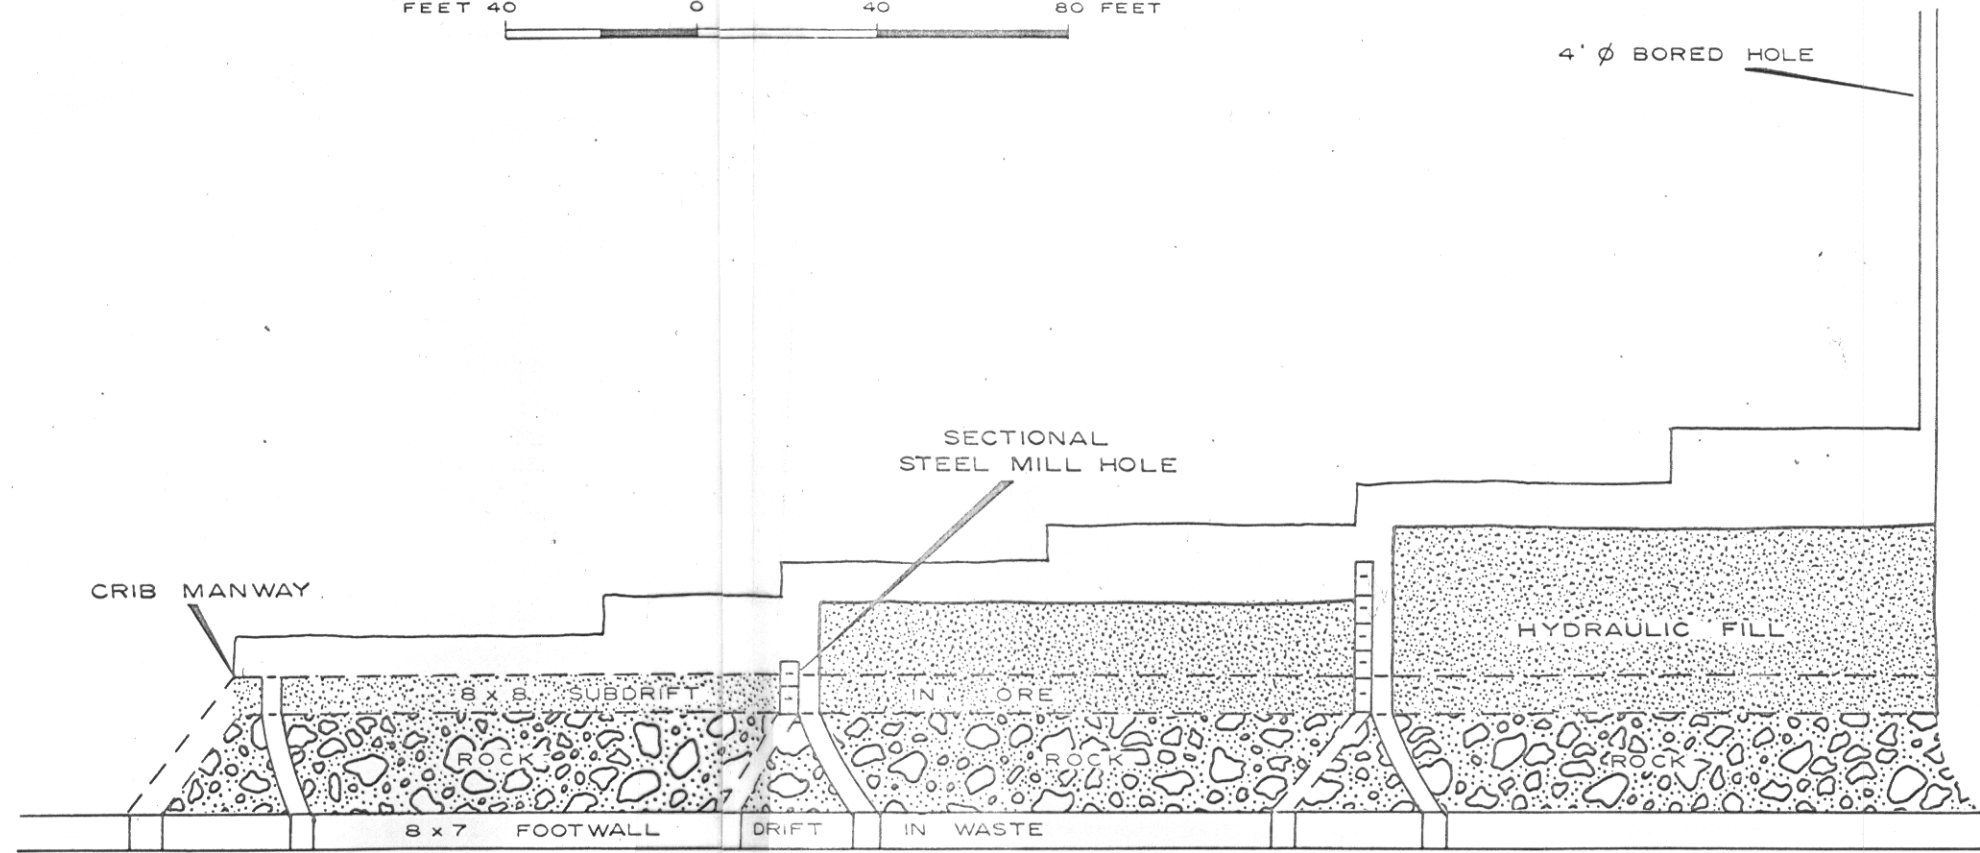
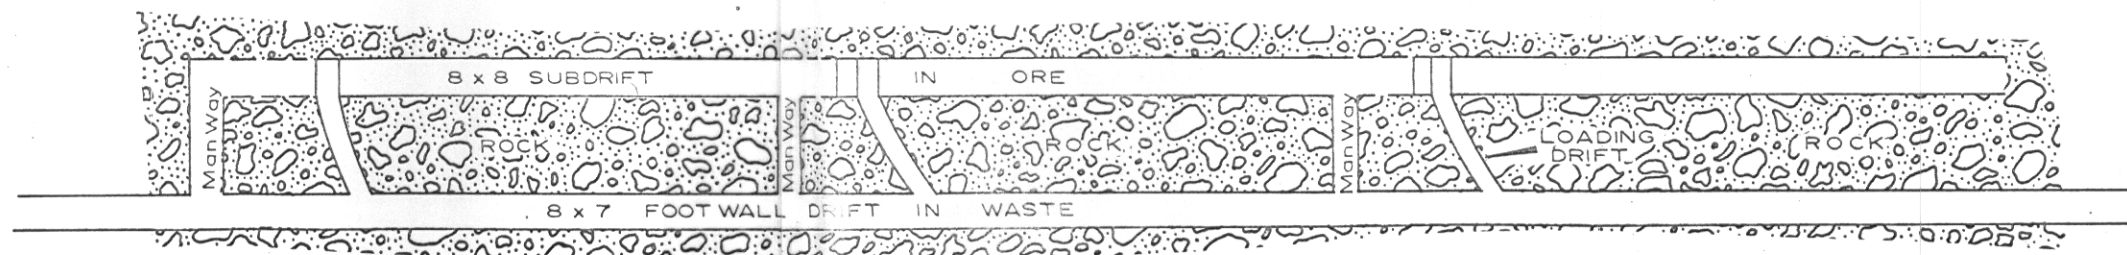
4'  $\phi$  BORED HOLE

SECTION

- + 6' - JACKLEG BENCHES
- 6' - STOPER BENCHES
- + 9' - USE CAVE
- 9' - USE SLUSHER

PLAN
