ECHO CLAIMS

JAN 17/92

ECHO PROPERTY

JAN. 24/92

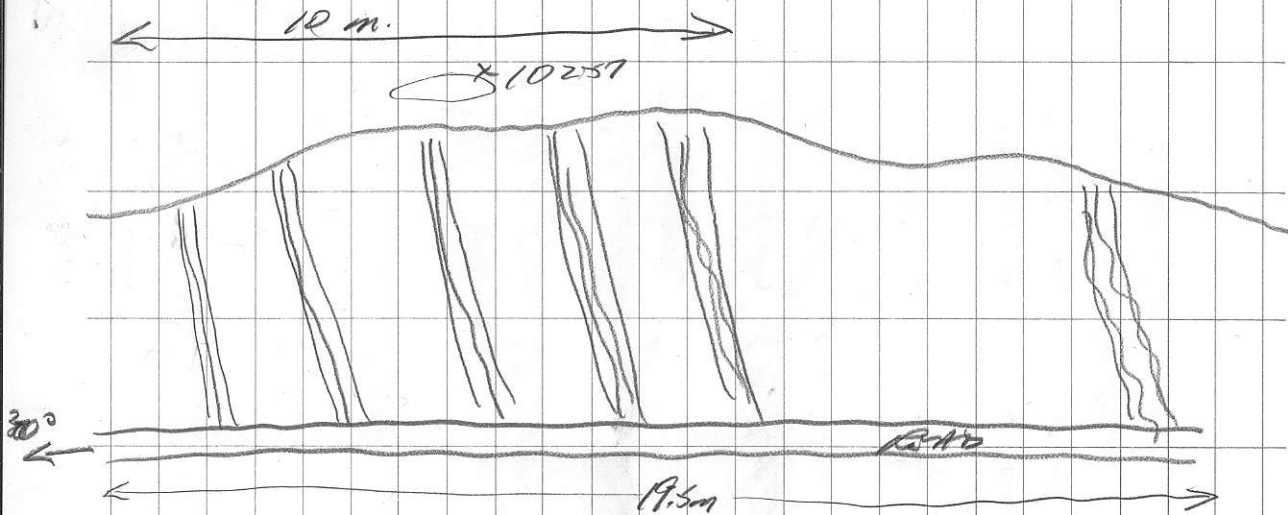
- fracture zone on road
@ DKO/75-80 E.
(Rd @ 3000)

zone 19 m wide

Malachite staining in grt
Varnung - br, cp, py.

3 m samples from west
end of zone.

6 samples west to
sand - chips

#10251-10256

#10257 collected from central
part of zone above road
cut - some malachite stain.
- Best results should be in
first 3 samples.

Several fracture zones @ 010-030/80E
with malachite stain, FeO + CO₂ bn + trace
gold.
