MICRO GOLD

Field Notes

Sept 20-25

PROPERTY EXAMINATION

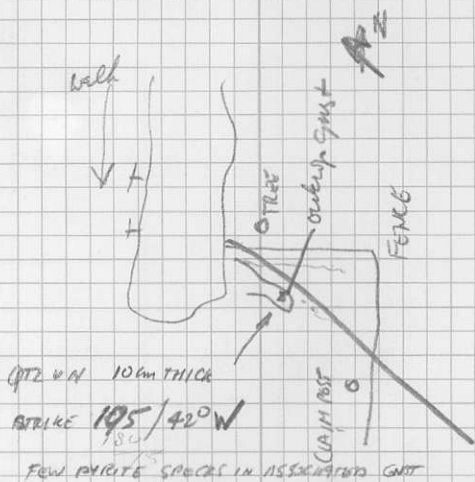
QTL VMS DIPPING INTO LAKE

WHERE FENCE ENDS AT LAKE

GRAY MASSIVE QUARTZ RIBBONS W/ 1 cm THICK VMS OF QTL

AND AT LEAST 30 cm THICK 210°/30° W.

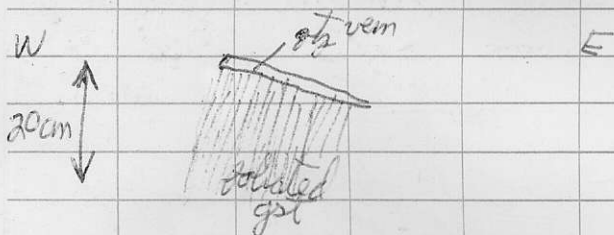
- white qtz vein truncates steeply dipping gst foliation

- qtz vein attitude:

025/25 SE

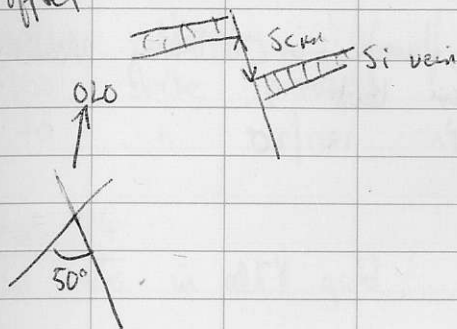
↳ Fractures 085/70
195/20

shallow set Si filled + appear to be truncated by steep set.

↳ Steep set have apparent normal fault offset

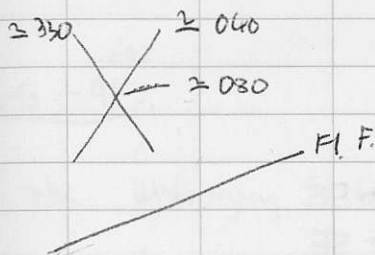
of strong fracture pattern on NW side
NE-SW striking Fl. vein
