GEOLOGICAL INVESTIGATIONS AT MORAN
IN 1957

By Stuart S. Holland

BRITISH COLUMBIA DEPARTMENT OF MINES

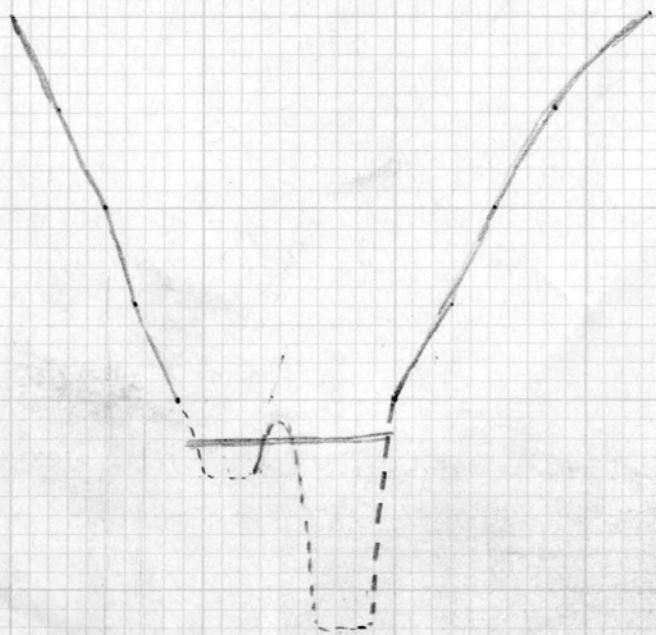
DRILL HOLES
4 & 5.

Two drill holes (Nos. 4 & 5) were collared in rock on the east side of the island and drilled westerly. No. 4 inclined at minus 40 degrees broke out of rock into gravel at 136 feet, indicating a depth to bedrock below present low water level of at least 75 feet. Hole No. 5 inclined at minus 50 degrees was stopped at 300 feet. The end of the hole is 40 feet east of being vertically beneath the west side of the river. The core was examined and no evidence of faulting is apparent. Nevertheless, it is still possible for a westerly dipping fault to lie between the island and the west abutment. Information regarding this point could be secured by deepening No. 5 drill hole about 60 feet and drilling a vertical hole on the west bank to a depth of 275 below present water level. At present, however, the chance of a fault lying in the channel between the island and the west abutment appears less than was previously thought from geological observation.
