GRAND CANYON DAMSITE

By W. C. Jones

British Columbia Department of
Mines and Petroleum Resources

February 8, 1962

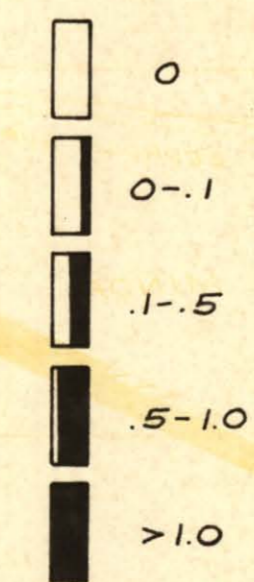
FIG. 2

The three drill holes put down in the river (see Sections A-A' and C-C', Fig. 2) indicate a considerable variance in the water conducting properties of the rock underlying the river bed in this immediate area. Drill hole 1 and the upper half of the angle hole 7, drilled near the right bank and under the right part of the river channel respectively, recorded generally high water losses during pumping tests, apparently mainly through open joints, whereas drill hole 2 and the lower section of drill hole 7, drilled near the central and left part of the river channel, recorded no to low water losses during pumping tests. Although several small faults and one relatively wide fault (drill hole 7, -252 feet to -258 feet) were encountered in these holes, the faults are apparently mainly filled with clay gouge and do not appear to offer open channels for the passage of water. No cavernous areas were detected in any of the limy rocks penetrated by these holes.

Except for sections of rock penetrated by drill hole 3, put down on the left bank, the three holes drilled into the proposed abutment areas (see drill holes 3, 4, and 5, Section A-A', Fig. 2) recorded no or, locally over short sections, low water losses during pumping tests although relatively severely fractured

The chief problem associated with the soils at the site is the depth and extent of the glacial till in the left abutment area. The bedrock surface is approximately 70 feet lower than the proposed dam crest at drill hole 3 (see Section A-A', Fig. 2) and appears to slope toward the river at about 7 degrees below horizontal in this immediate area. A steep cliff composed of the same formation as that exposed at the site occurs about 2,000 feet northwest of drill hole 3. Until further pre-construction drilling is done on the flat immediately above and to the west of drill hole 3, it must be assumed that the bedrock surface under this flat is at the same general elevation as encountered in drill hole 3 or rises very gradually to the base of the cliff mentioned above. As previously stated, till was encountered in several of
