REPORT ON**TAILINGS DAM INSPECTION
CAROLIN MINES
HOPE, BRITISH COLUMBIA**

Athabaska Gold Resources Limited
#200 - 1185 West Georgia Street
Vancouver, B.C.
V6E 4E6

October 27, 1995

952-1483

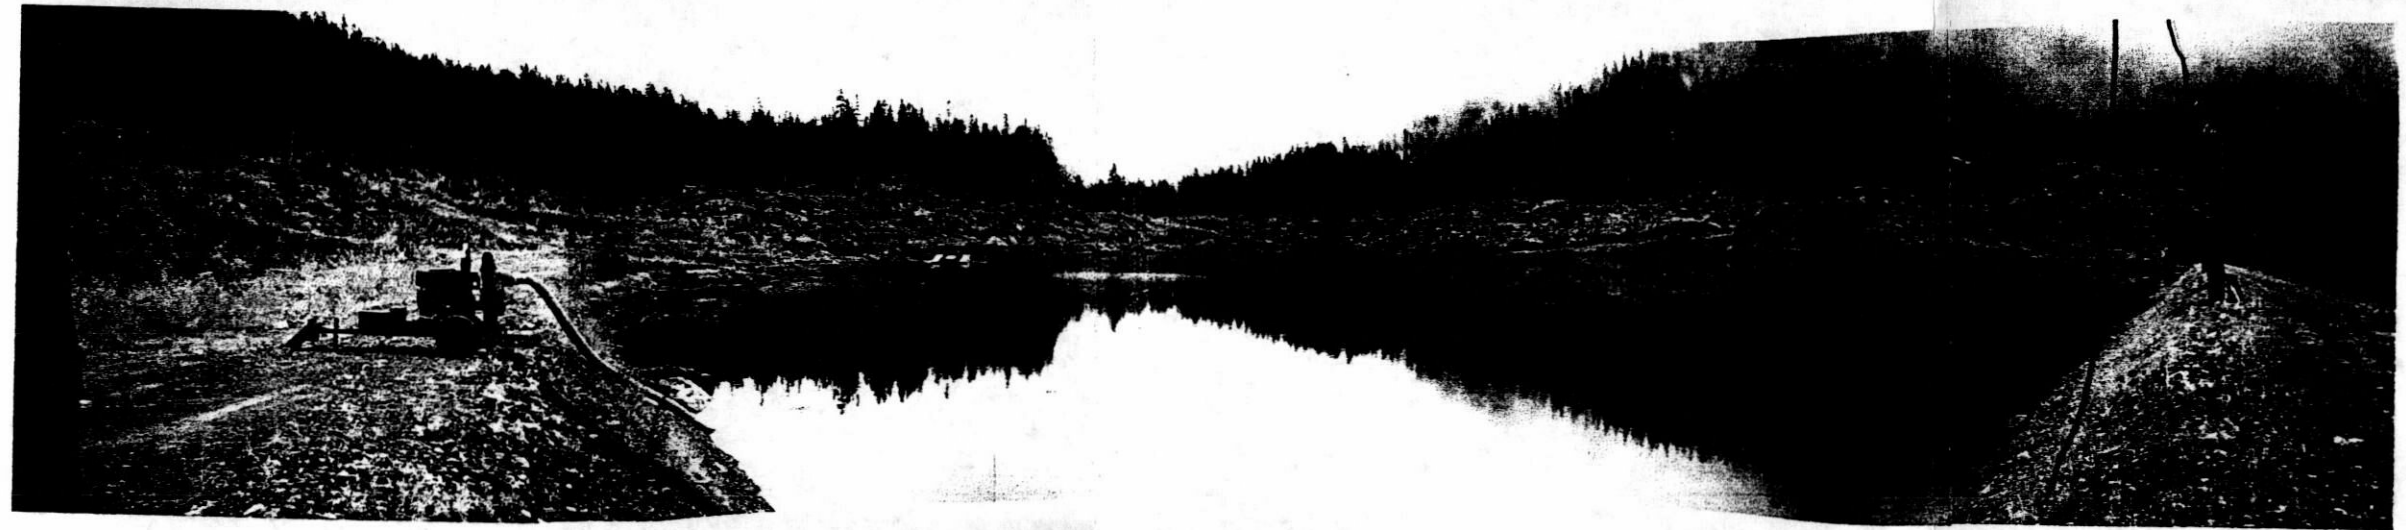
CAROLIN MINES LTD.			
Golder Associates			
CAROLIN MINES TAILINGS DAM COMPLETION OF FIRST PHASE STAGE II DAM			
drawn	R.D.	checked	AW
date	OCT. '95	project	052-1483
figure	3	revised	F.E.

- The mill effectively ceased operation during 1984 and the final tailings solids beach level is as shown on Figure 3.
- The water storage level behind the dam ranged from 3,190 to 3,203 feet during the period 1984 to 1987 as water quality affected discharge. From mid 1987 to 1989 the pond level was controlled by pumped and siphoned discharge, and was maintained near elevation 3,187 feet.

No mill operation has taken place during the period from 1989 to 1995, and therefore the tailings solids stored remain the same as in 1984 and as shown on Figure 3. The beach is currently inundated but ranges from elevation 3,194 to 3,199.5 feet at its intercept with the upstream dam slope.
