# Support at Cassiar Underground Mine

J. JAKUBEC

*Cassiar Mine, Cassiar, Canada*

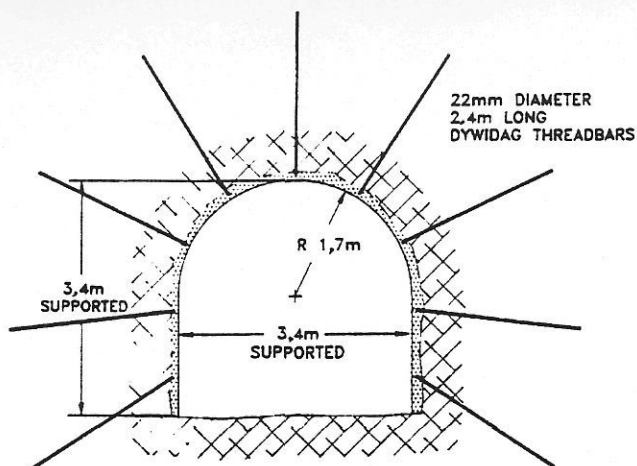
Figure 8. Layout of the rock support on 1350 North

The development and the support system described below was adopted for the extraction drift and drawpoints on 1350 North production level (Figures 8 and 9).

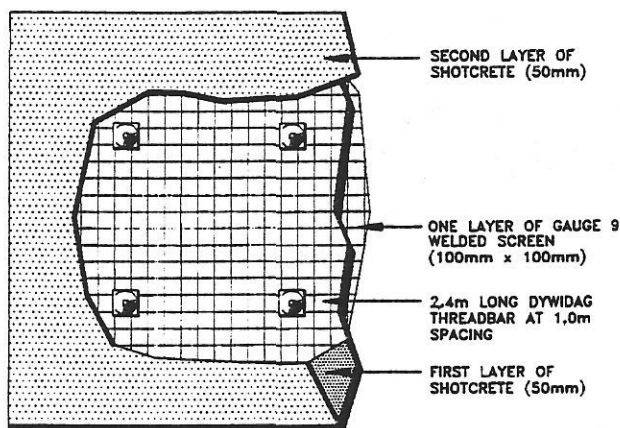
Figure 9. Detail of the original support

NOTES:  
5,0m LONG CABLE BOLTS CONNECTED WITH STRAPS WERE INSTALLED APPROX. 6-8 WEEKS AFTER SUPPORT COMPLETION  
AMOUNT OF STEEL IS APPROX. 1,5 kg PER SQ.METRE

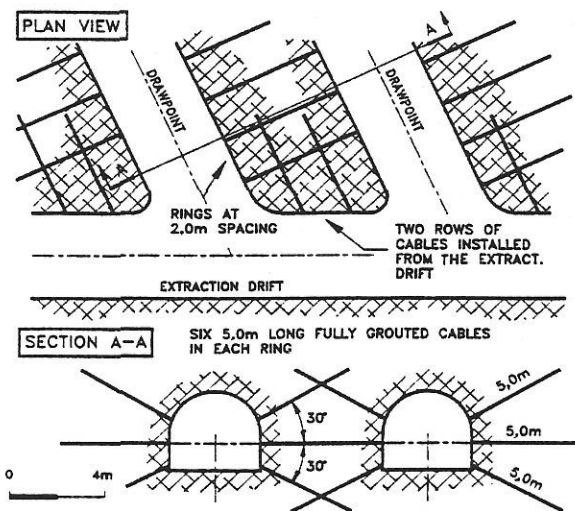
Figure 11. Pillar cable reinforcement

shotcrete developed large vertical cracks as a result of initial pillar deformation. Exposed ropes were showing signs of high tension. The corners in which four ropes had been installed retained the pillar well, but the corners with two ropes suffered extensive damage and failure of some of the ropes. As a result of such failures, all the corners were re-supported with four ropes.

Since no damage was observed on the back, repairs were concentrated on the sidewalls. The critical situation of pillar failure was recognized, and large-scale repairs and installation improvements were implemented immediately. All the loose shotcrete was removed, and the exposed rock was re-shotcreted. The bottom area of the walls was reinforced with additional Dywidags connected horizontally with 0,3 by 2,4 m welded straps. A system of 16 mm fully grouted cable bolts was installed through the pillars (Figure 11). There were 3 cables in the ring, and the rings were at a spacing of 2 m. Surface restraint was provided by vertical and horizontal welded straps overlapped at the bolts and tightened with 150 by 150 by 15 mm plates and cable grips (Figure 12). The whole steel structure was encased in shotcrete: firstly, to provide good contact between the straps and wall and, secondly, to protect the support from LHD damage.

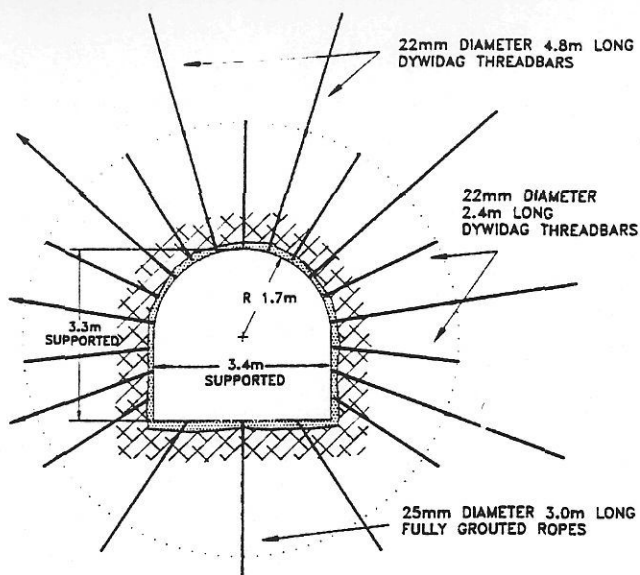
Figure 18. Layout of the rock support on 1350 South

Figure 18 shows the basic support layout used on 1350 North. Horizontal straps were now integrated as part of the support (Figure 19), which increased the amount of steel in the shotcrete by approximately three times. After the drawpoint excavation had been completed, 4,8 m long fully grouted Dywidag bolts were installed at a spacing of 1,0 m in the middle of the existing pattern. Concrete reinforced with rebars was installed on the floor and, additionally,

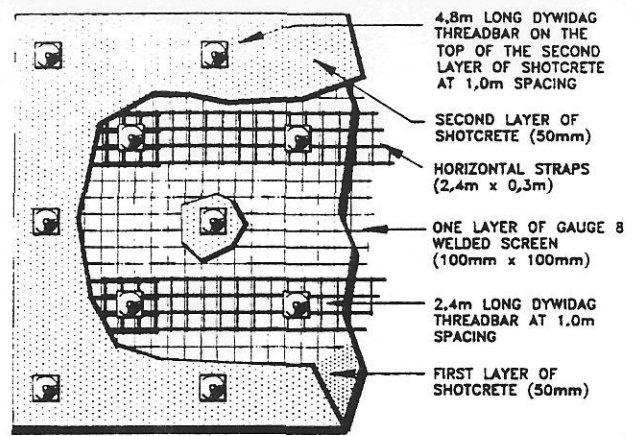
Figure 19. Detail of support lining—horizontal straps

NOTES:  
 4,8m LONG DYWIDAG THREADBARS WERE INSTALLED APPROX. 4 - 6 WEEKS AFTER DRAWPOINT COMPLETION  
 AMOUNT OF STEEL IS APPROX. 5,0 kg PER SQ.METRE

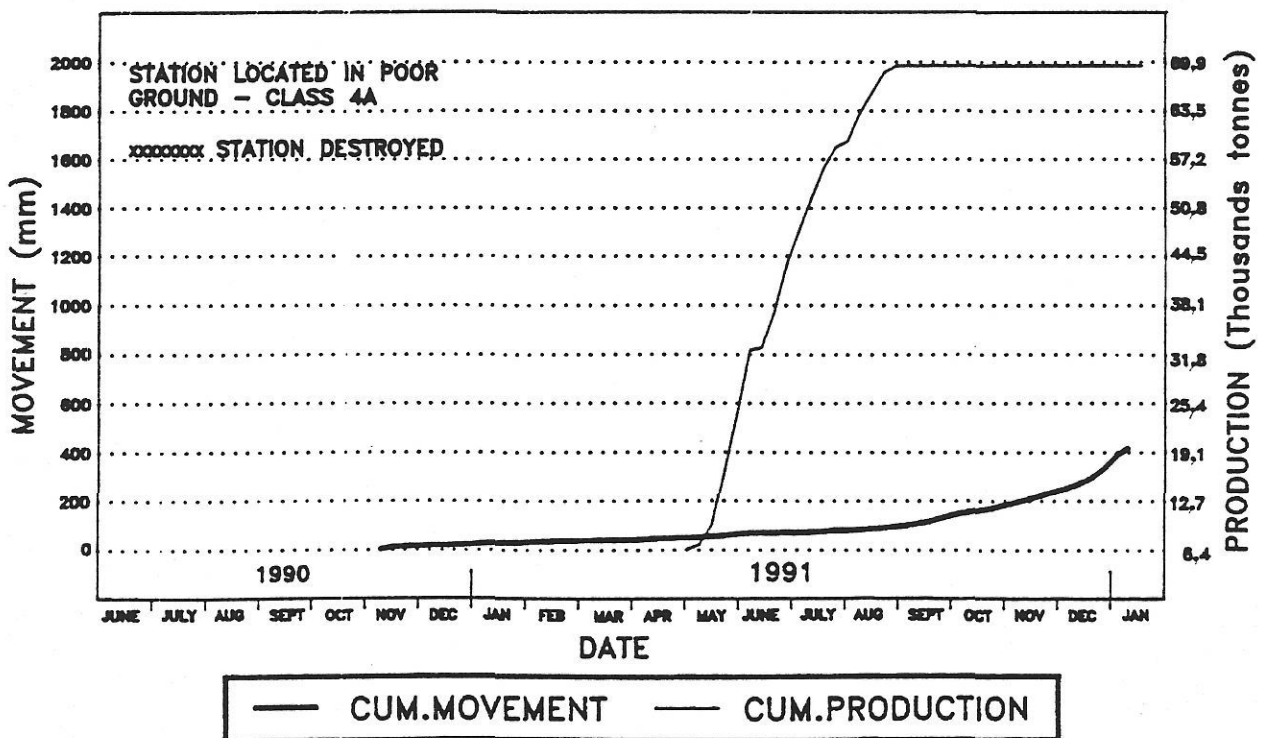
Figure 20. Cross-drift deformation, drawpoint no. 16

25 mm ropes were grouted 3.0 m into the floor. Figure 20 shows the convergence record of drawpoints supported with the new system.

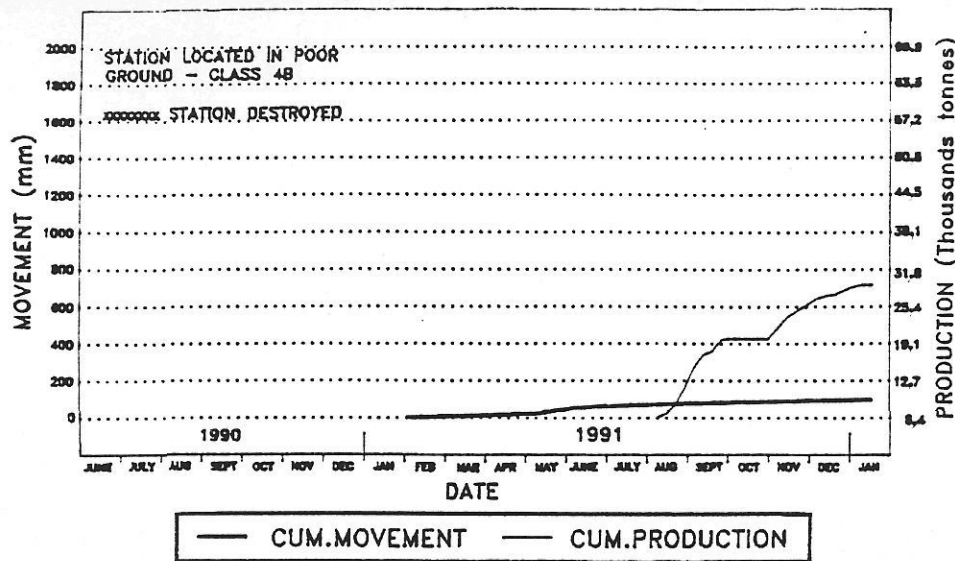
Figure 21. Cross-drift deformation, drawpoint no. 21

Since some cracks were observed in the shotcrete lining, a vertical strap system was added to increase the support stiffness. The results of closure monitoring of the drawpoints with the described support system are shown in Figure 21. Because of its poor performance, welded-wire mesh was later replaced with one layer of 50 by 50 mm

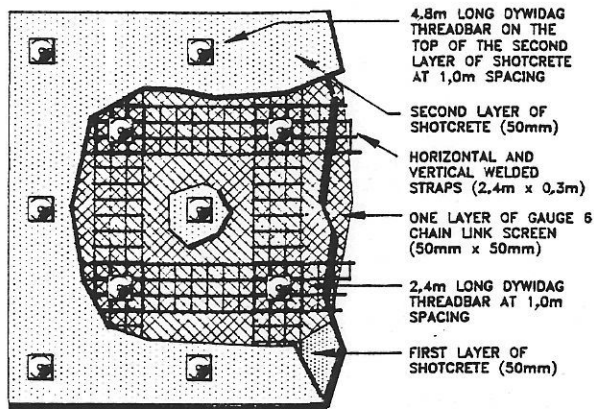
Figure 22. Detail of the support lining—horizontal and vertical straps

NOTES:  
4.8 m LONG DYWIDAG THREADBARS WERE INSTALLED APPROX. 2-4 WEEKS AFTER DRAWPOINT COMPLETION  
AMOUNT OF STEEL IS APPROX. 11.0 kg PER SQ. METRE

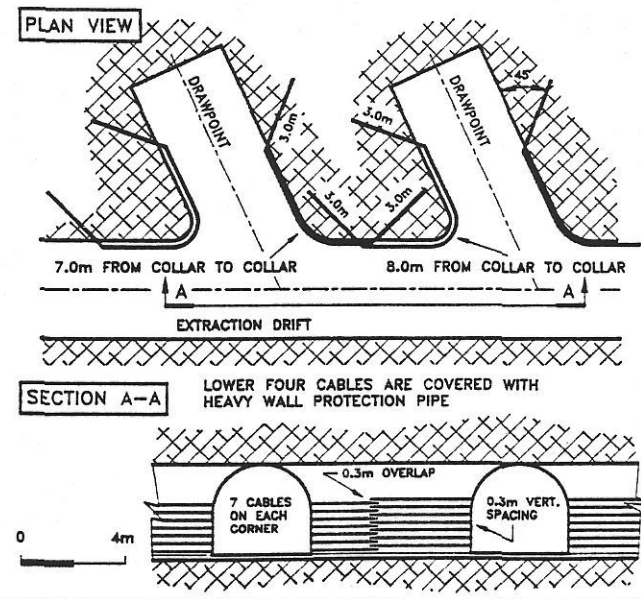
Figure 24. Pillar corner support

Because of difficulties with the rope installation (namely, proper tensioning to the wall), the ropes were replaced with 15 mm 27 t cable bolts. Seven cable bolts were installed on each corner, which improved their distribution over the entire corner. The typical layout is shown in Figure 24. Cable bolts were connected with steel blocks and cable

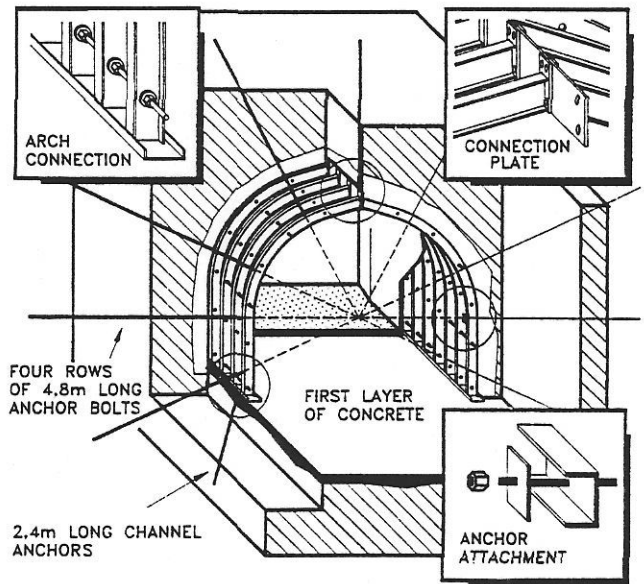
Figure 25. Brow support—rigid steel arches

Three types of steel arches were used as reinforcement in the drawpoint brows of 1350 South. All of them performed very well, and no failure of arches was observed. Compared with those for 1350 North, the anchoring techniques were significantly better. The cable bolts were replaced with 4,8 m long Dywidag bolts, and the floor channels were anchored to the floor with four 2,4 m long Dywidag bolts.

The first type was a rigid-arch system and is shown in Figure 25. The second type was a 29 kg yielding profile

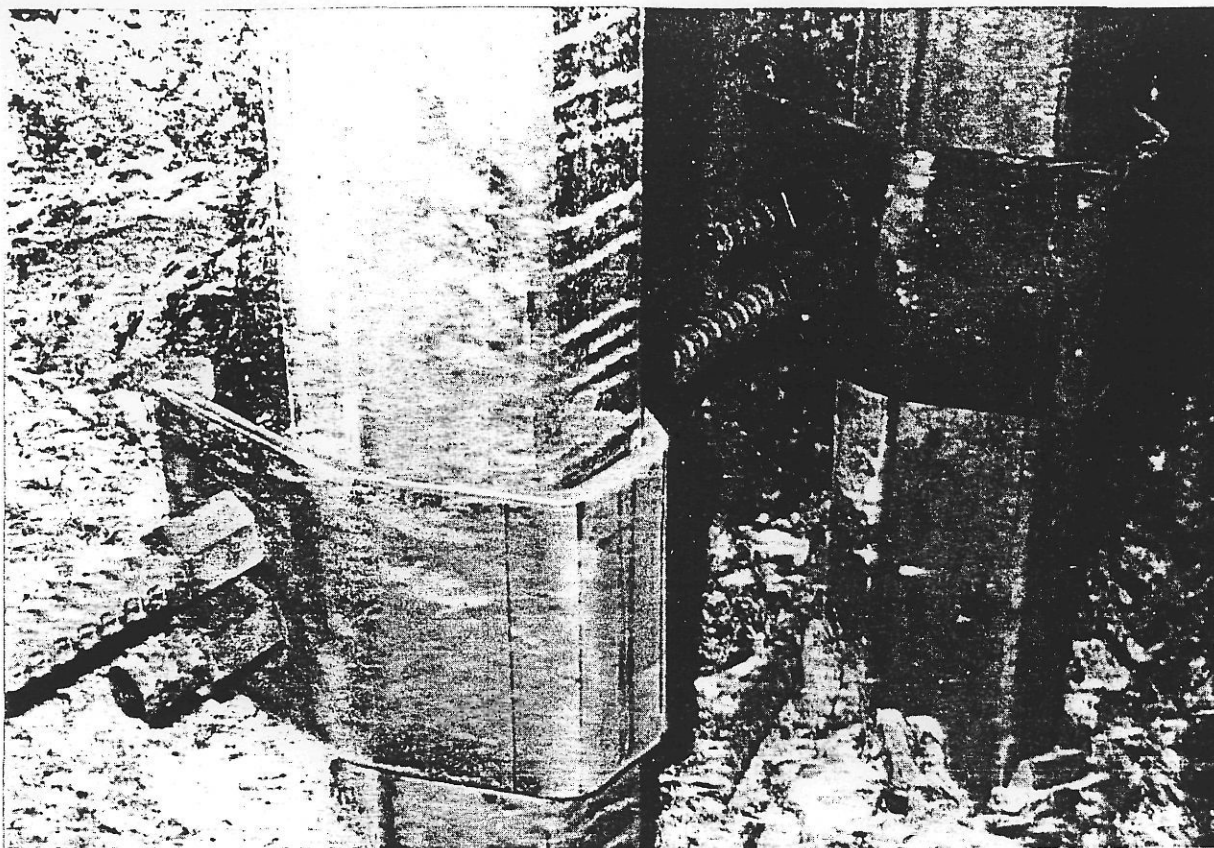
Figure 26. New arch-connection bracket

installed in the same manner as the rigid one. Later, during second-phase arch installation, the arch connection was re-designed and new connection brackets were successfully used (Figure 26). This new design provided a much stronger and simpler connection, as well as providing flexibility in the arch spacing.
