Support at Cassiar Underground Mine

J. JAKUBEC

Cassiar Mine, Cassiar, Canada

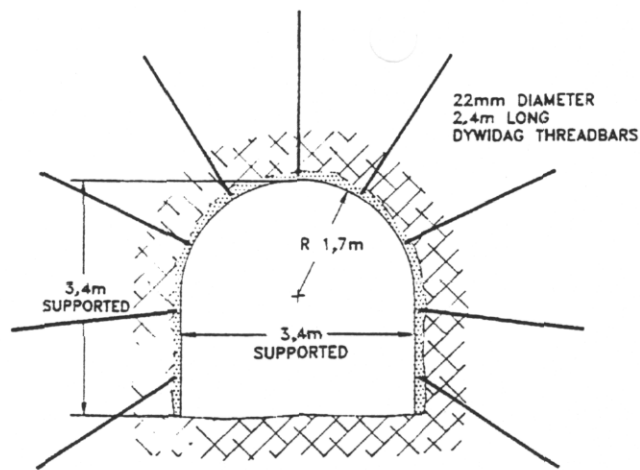
Figure 8. Layout of the rock support on 1350 North

The development and the support system described below was adopted for the extraction drift and drawpoints on 1350 North production level (Figures 8 and 9).

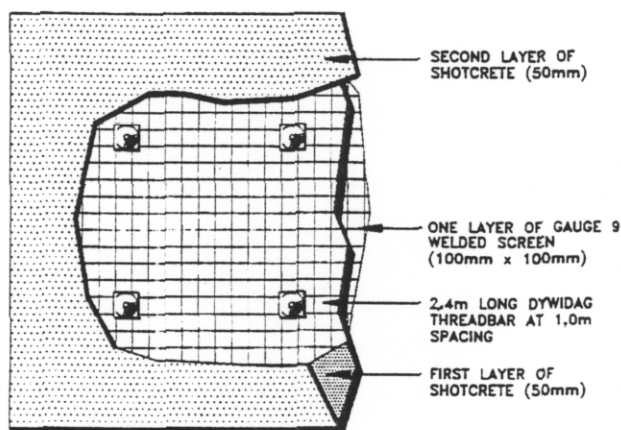
Figure 9. Detail of the original support

NOTES:
5,0m LONG CABLE BOLTS CONNECTED WITH STRAPS WERE
INSTALLED APPROX. 6-8 WEEKS AFTER SUPPORT COMPLETION
AMOUNT OF STEEL IS APPROX. 1,5 kg PER SQ.METRE

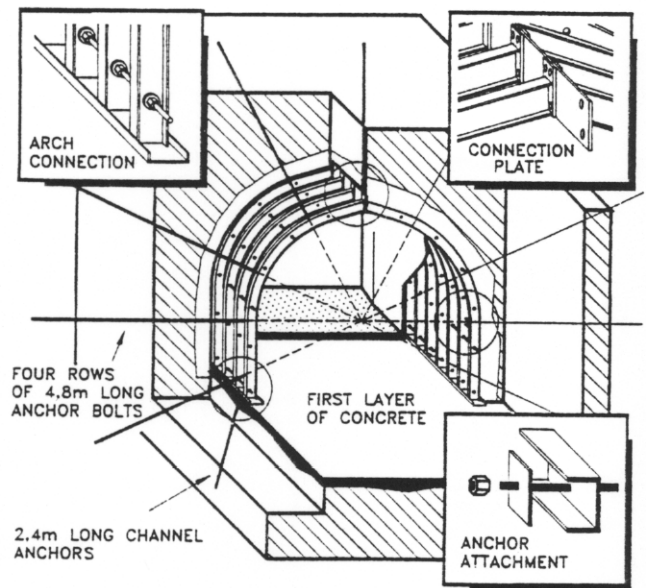
Figure 25. Brow support—rigid steel arches

Three types of steel arches were used as reinforcement in the drawpoint brows of 1350 South. All of them performed very well, and no failure of arches was observed. Compared with those for 1350 North, the anchoring techniques were significantly better. The cable bolts were replaced with 4,8 m long Dywidag bolts, and the floor channels were anchored to the floor with four 2,4 m long Dywidag bolts.

The first type was a rigid-arch system and is shown in Figure 25. The second type was a 29 kg yielding profile
