**Annual Reclamation Report for 1994**

**Centipede Resources Ltd.  
Ruth Vermont Mine (82K/15W)  
Golden Mining Division**

**Reclamation Permit M-89**

**31 March, 1995**

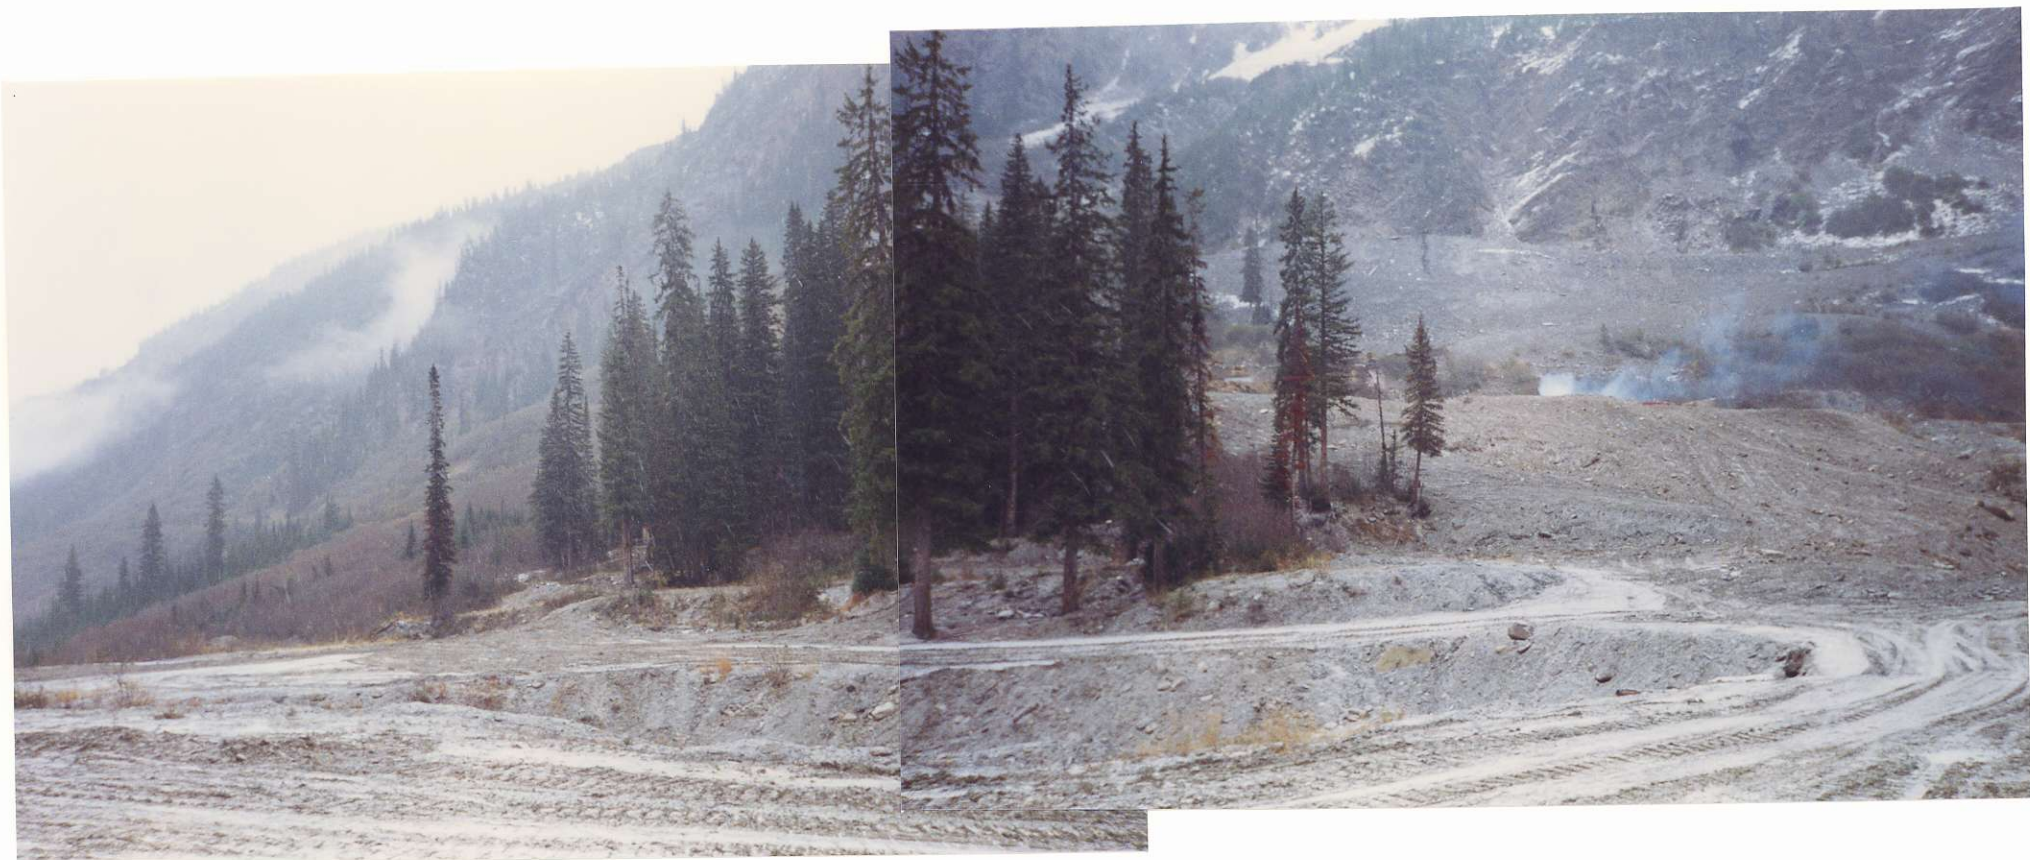
**Figure 18.**

The site graded! This picture shows the minesite looking south from the mine access road. All structures and machinery are gone and the final grade has been established.
