SUBMISSION TO RESOURCE MANAGEMENT BRANCH (INSPECTIONS & ENGINEERING)  
candorado mines ltd. 009009  
09245E 244

Re: Lot 1798 Tailings Pile, Hedley, B.C.  
Lot 3186 Tailings Pile, Hedley, B.C.

**Introduction**

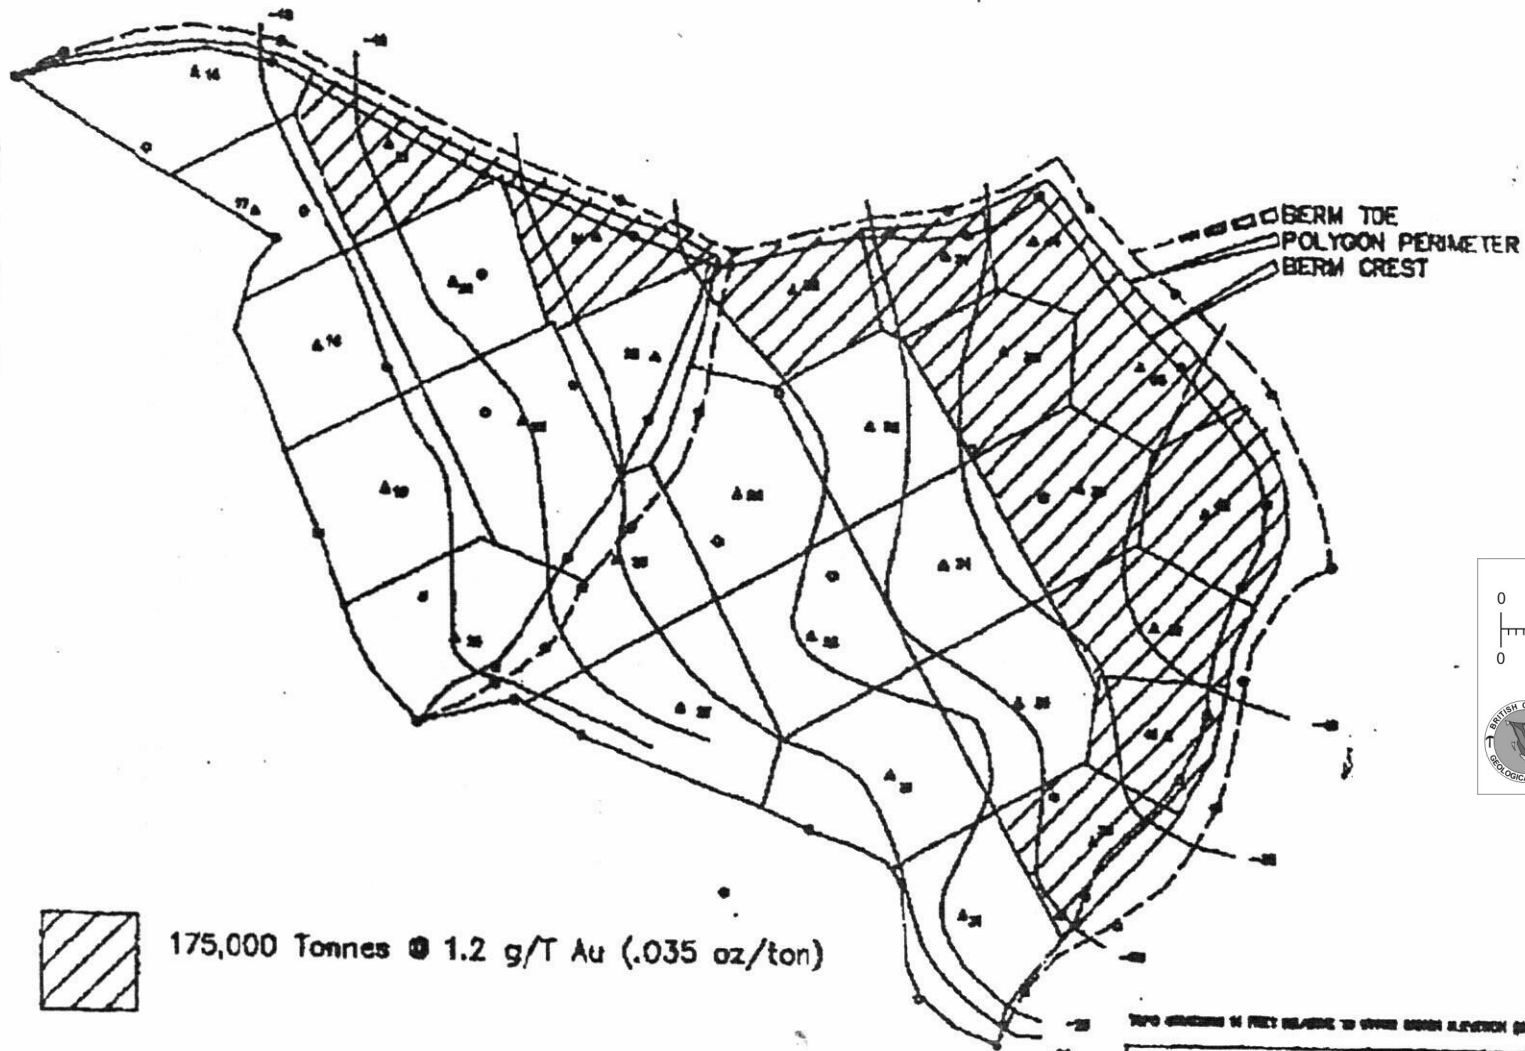
FIGURE 3

0.5 M BASE TOPO CONTOURS

186,000 Tonnes @ 1.35 g/T Au (.04 oz/ton)

PLAN VIEW  
LOT 1796

**Reserves:** The tailings were drill tested in September 1991 and contains a gross mineral inventory of 335,000 tonnes of which 175,000 tonnes grading 1.20 g/T gold is considered ore. It would be our intention to selectively mine the perimeter of the pile as shown in Figure 3 where the grade has been concentrated to economic levels. We assume 80% mining recovery which equates to approximately 140,000 tonnes of material to be removed.
