DOLLY VARDEN MINES LTD

SKEENA MINING DIVISION, BRITISH COLUMBIA

FEASIBILITY STUDY

June 23rd, 1969

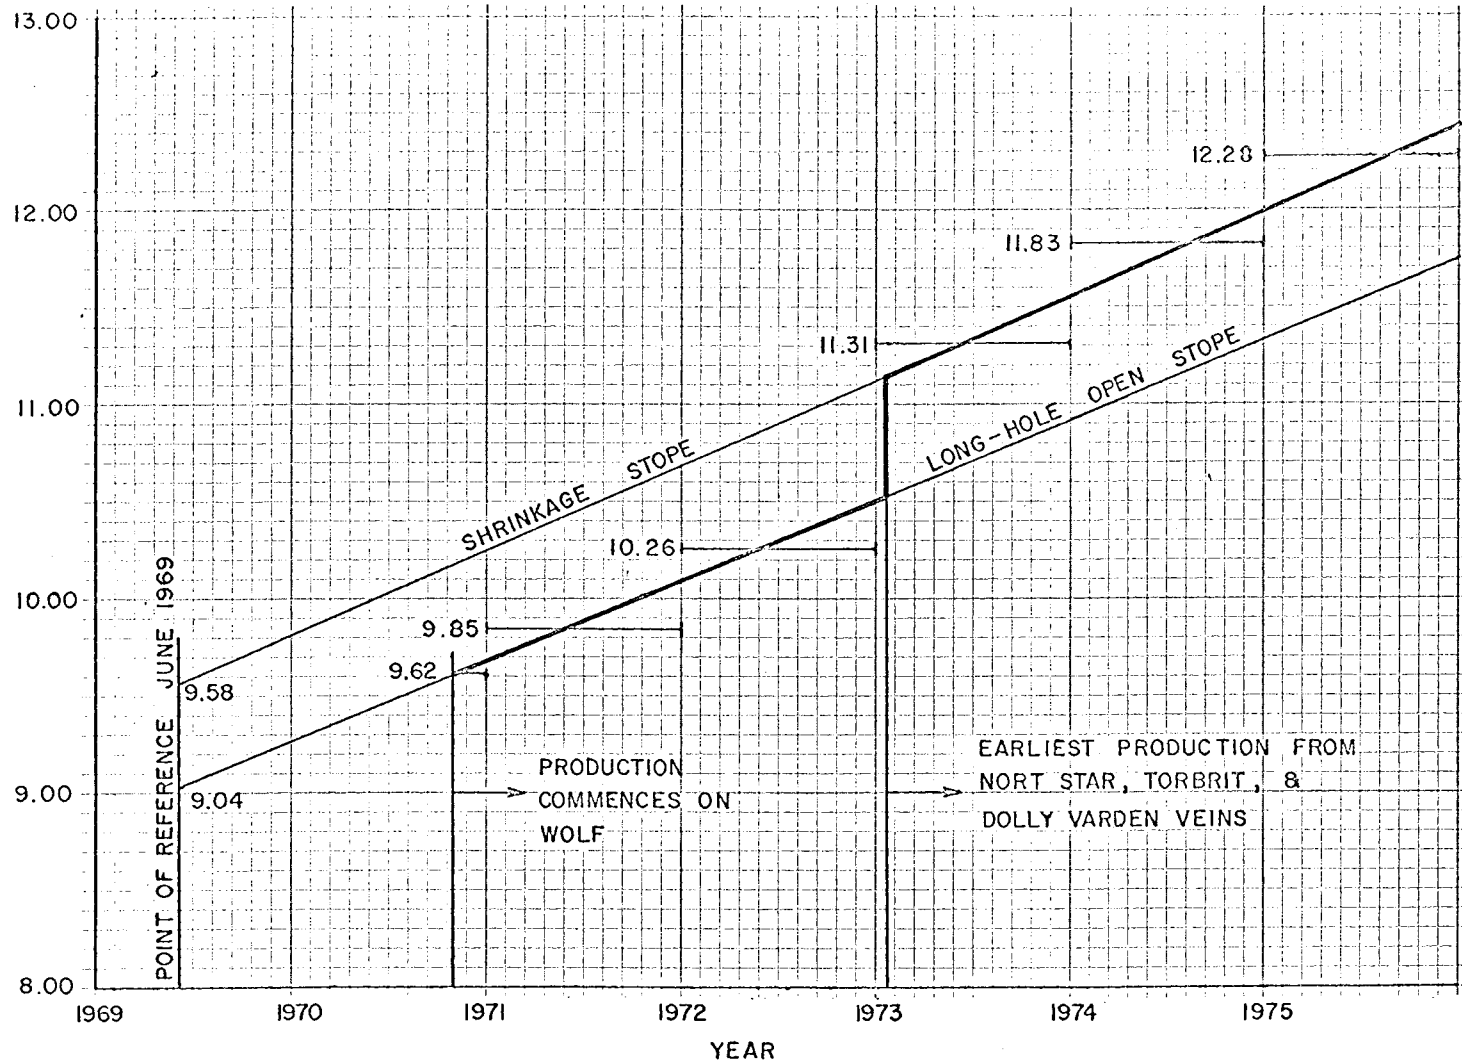
Average yearly costs according to the projected production schedules have been calculated and are presented graphically, with the escalation lines also shown.

COST/TON
MILLED

ESCALATION OF OPERATING COSTS

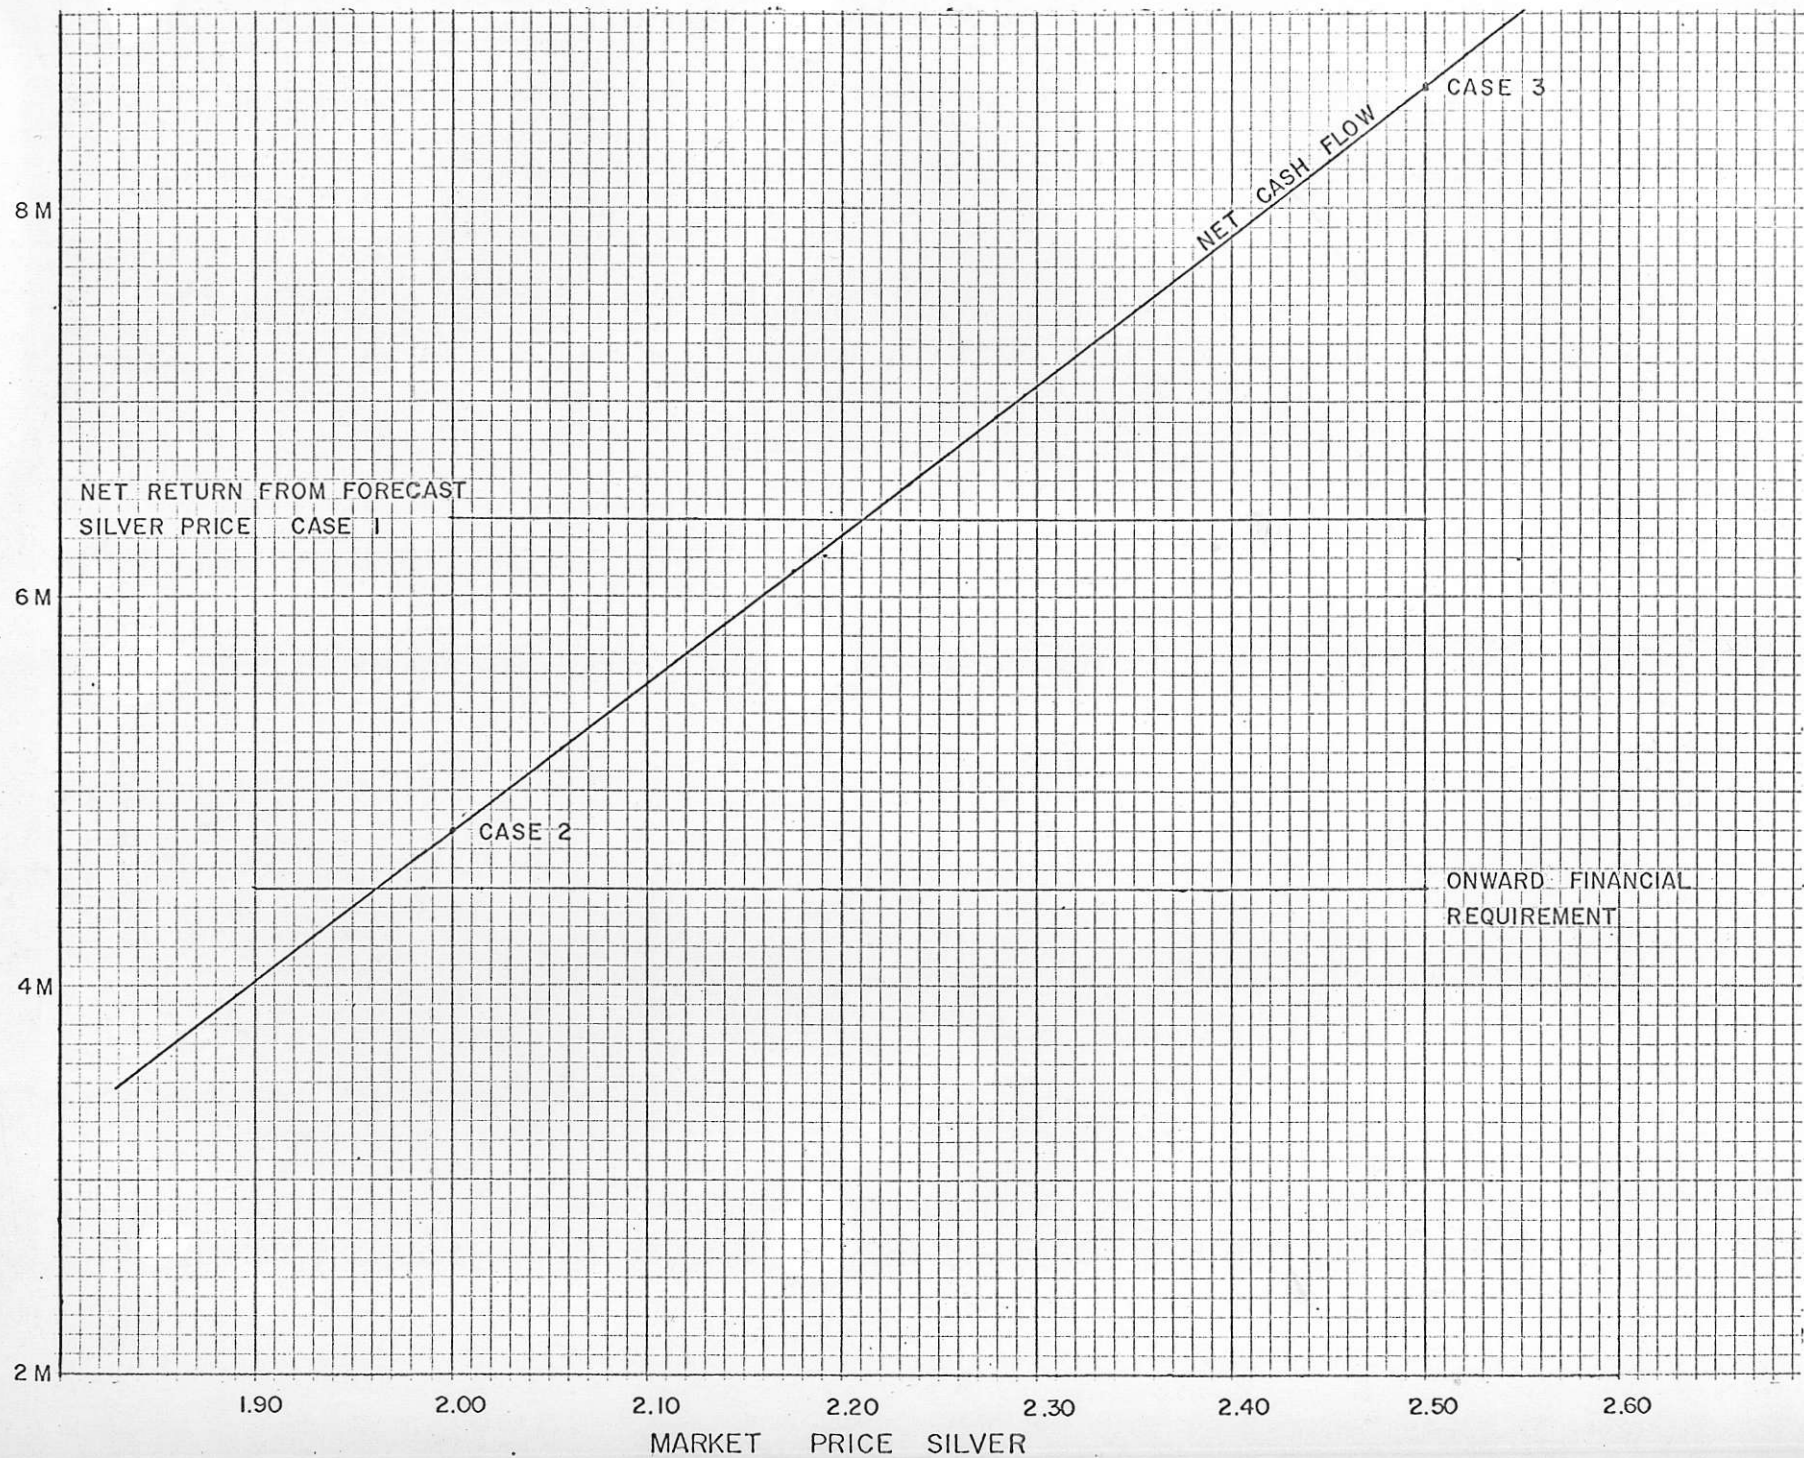
CASH FLOW CUMULATIVE
CANADIAN DOLLARS
