THE BAKER MILL
START-UP AND EARLY OPERATION

W. W. MUIR, C.E.T.
Mill Superintendent
Baker Mine
Du Pont of Canada Exploration Limited

C.I.M. EIGHTH DISTRICT SIX MEETING - 1983
1983 October 26-29
Hudson Bay Lodge
Smithers, BC

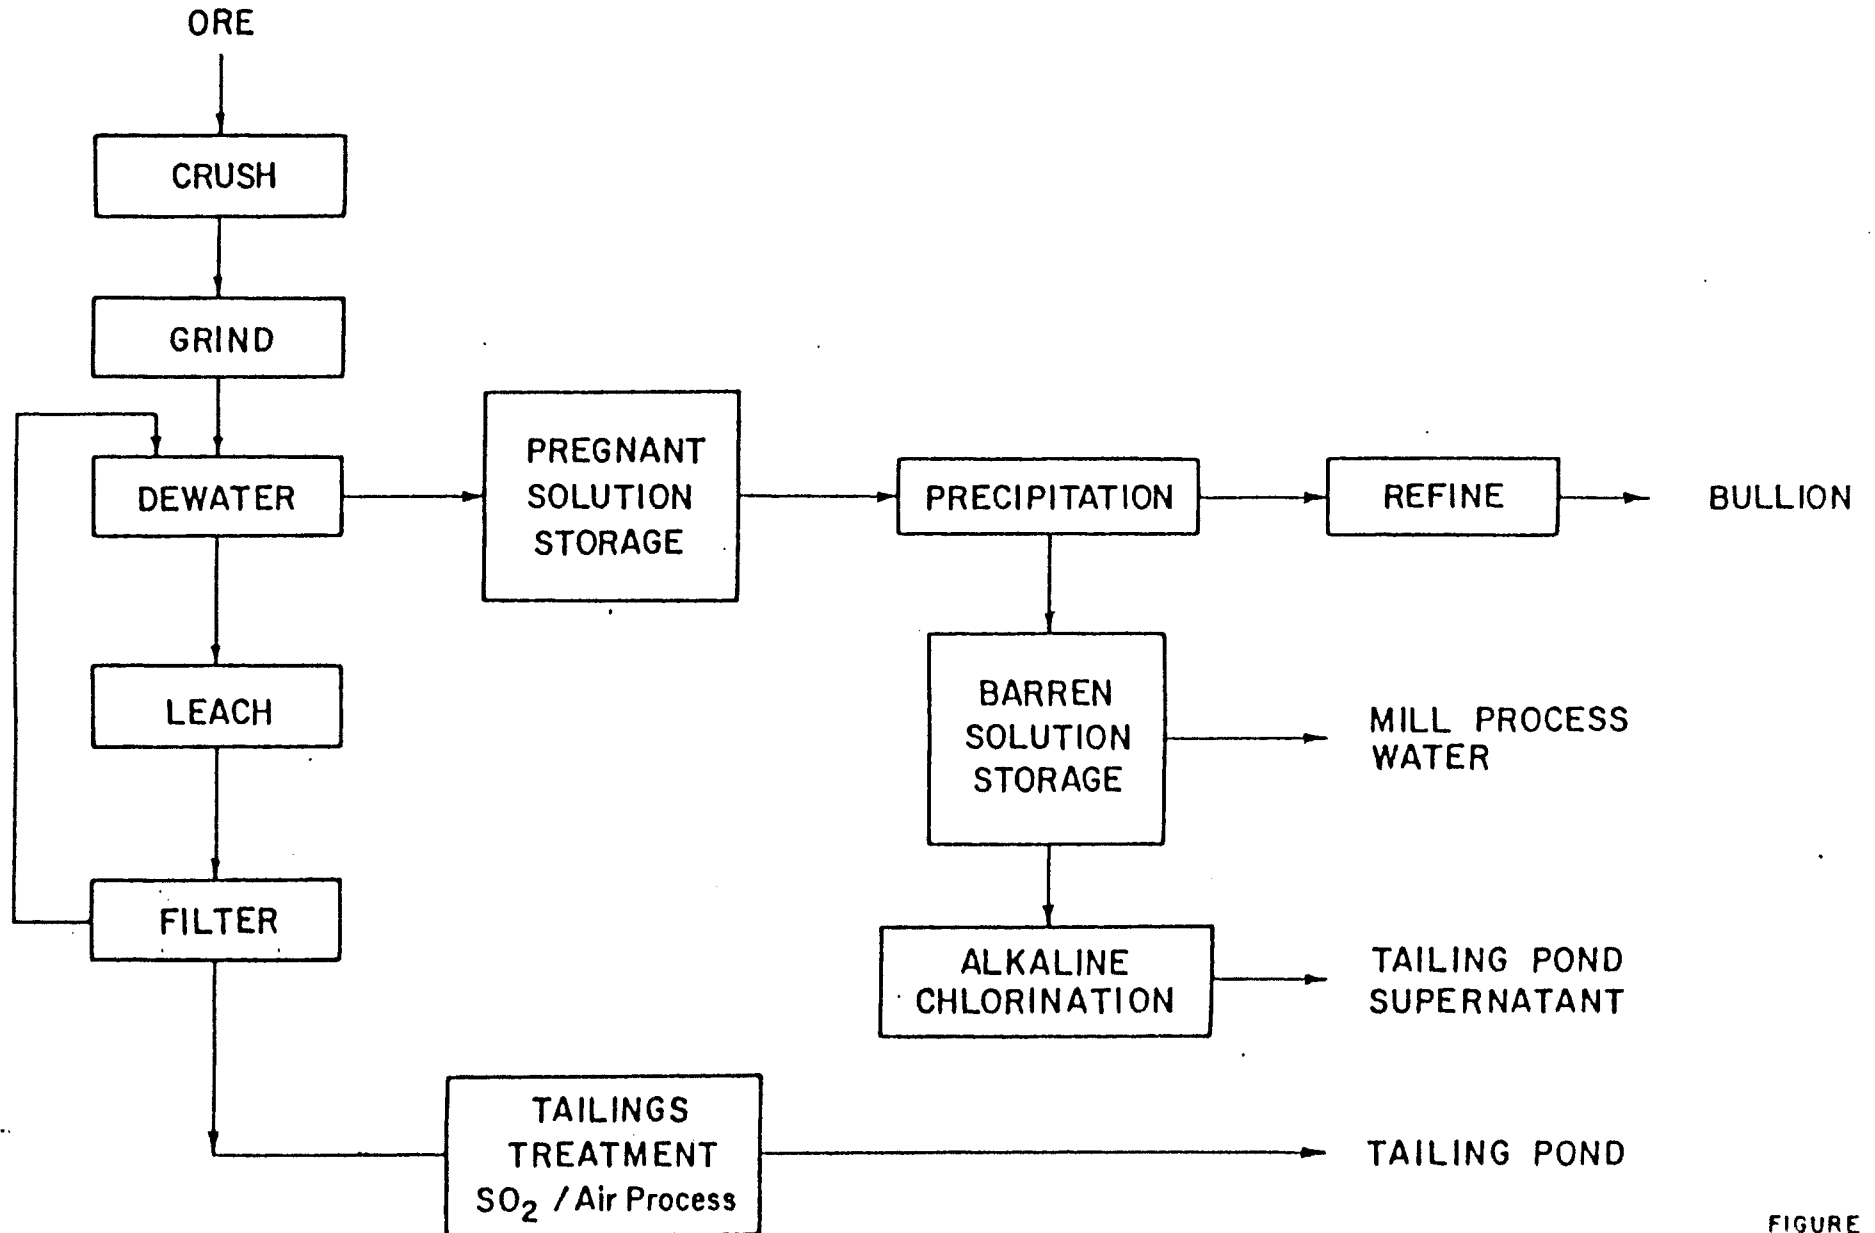
FIGURE 2

BAKER MINE

PROCESS FLOW SHEET

The mill circuit illustrated in Figure 2 is basic in almost every sense.

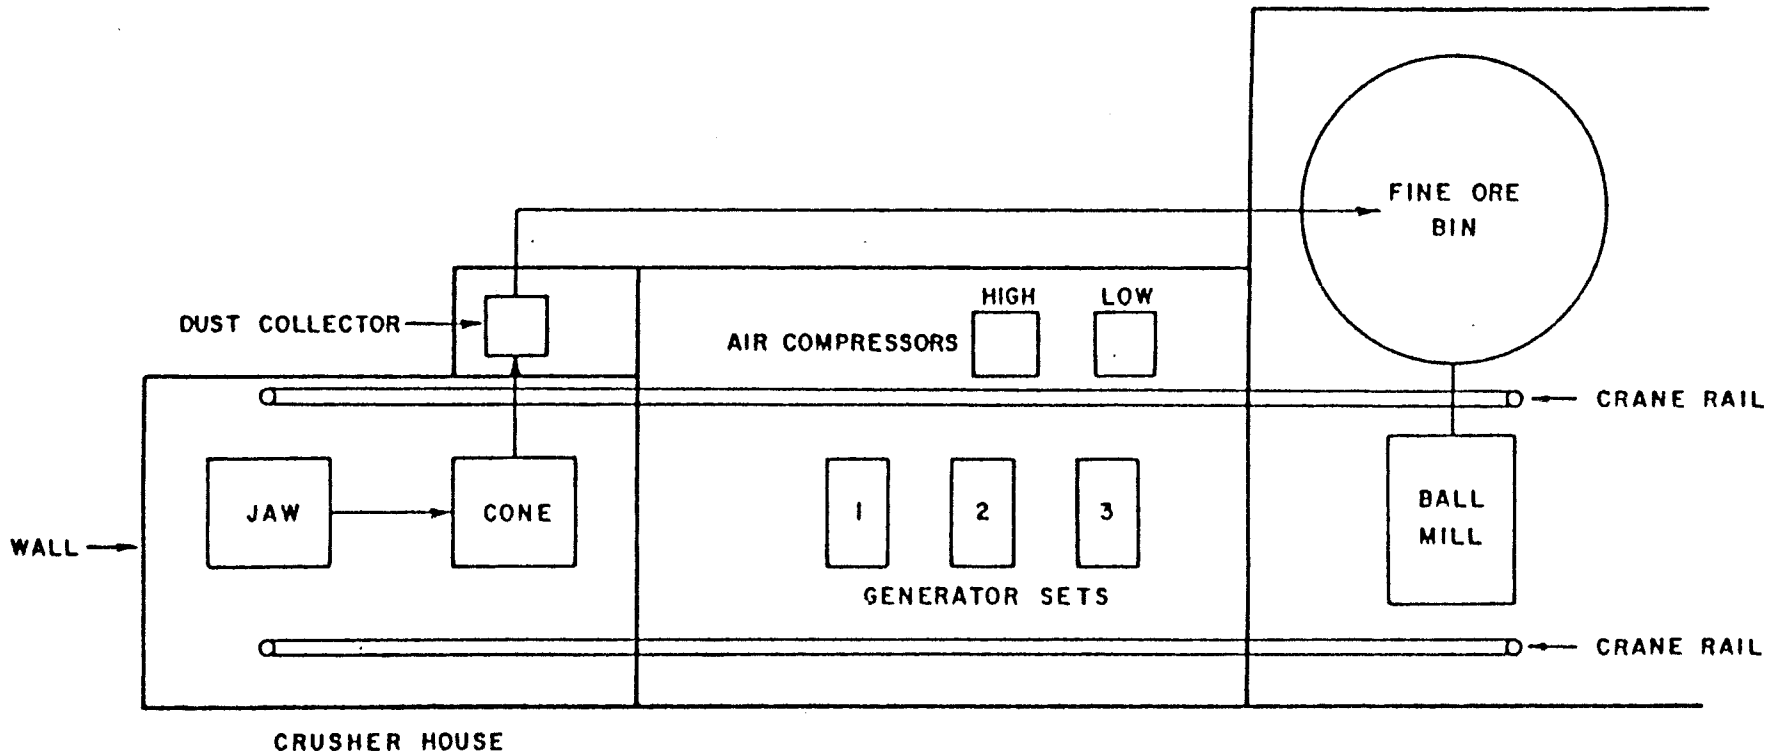
FIGURE 4

NOT TO SCALE

As mentioned in the grinding section discussion, there was no crane in the mill, but a 5-ton crane was installed in the crusher house. From a maintenance standpoint, during emergency repair or overhaul, a crane would be a big plus in working with the generator sets as well as over the ball mill. Based on Baker experience, the idea of designing overhead crane rails to service the crusher house and a service house enclosing the high noise compressors and the generator sets, and the ball mill seems an attractive option for crane utilization. Figure 4.
