Johnny Mountain Gold Mine — The high art of winter construction

Robert C Dick PEng, Geotechnical Engineering Consultant, North Vancouver

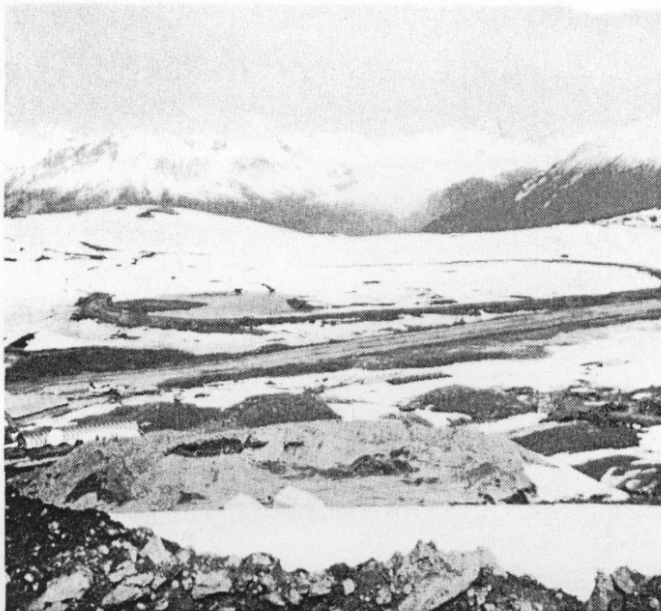
Embankment dykes constructed in winter without negative effect.

The pond is located in a natural depression at the site's plateau, underlain by a dense, impervious basal till. This till was utilized for embankment construction, with as much as possible being taken from within the pond to increase storage capacity. A nearby deposit of gravel provided material for an underdrain.

Mean embankment density was 104.5 percent standard Proctor density, with a standard deviation of 6.2 percent well above the specified 98 percent. Moisture content remained dry of optimum. The completed dykes have a maximum height of 10m, are one kilometre long and contain 60,000m³ of fill, surrounding a 9.65 hectare pond.
