HIGHMONT EAST PIT

STOP 1 - OVERVIEW OF EAST PIT

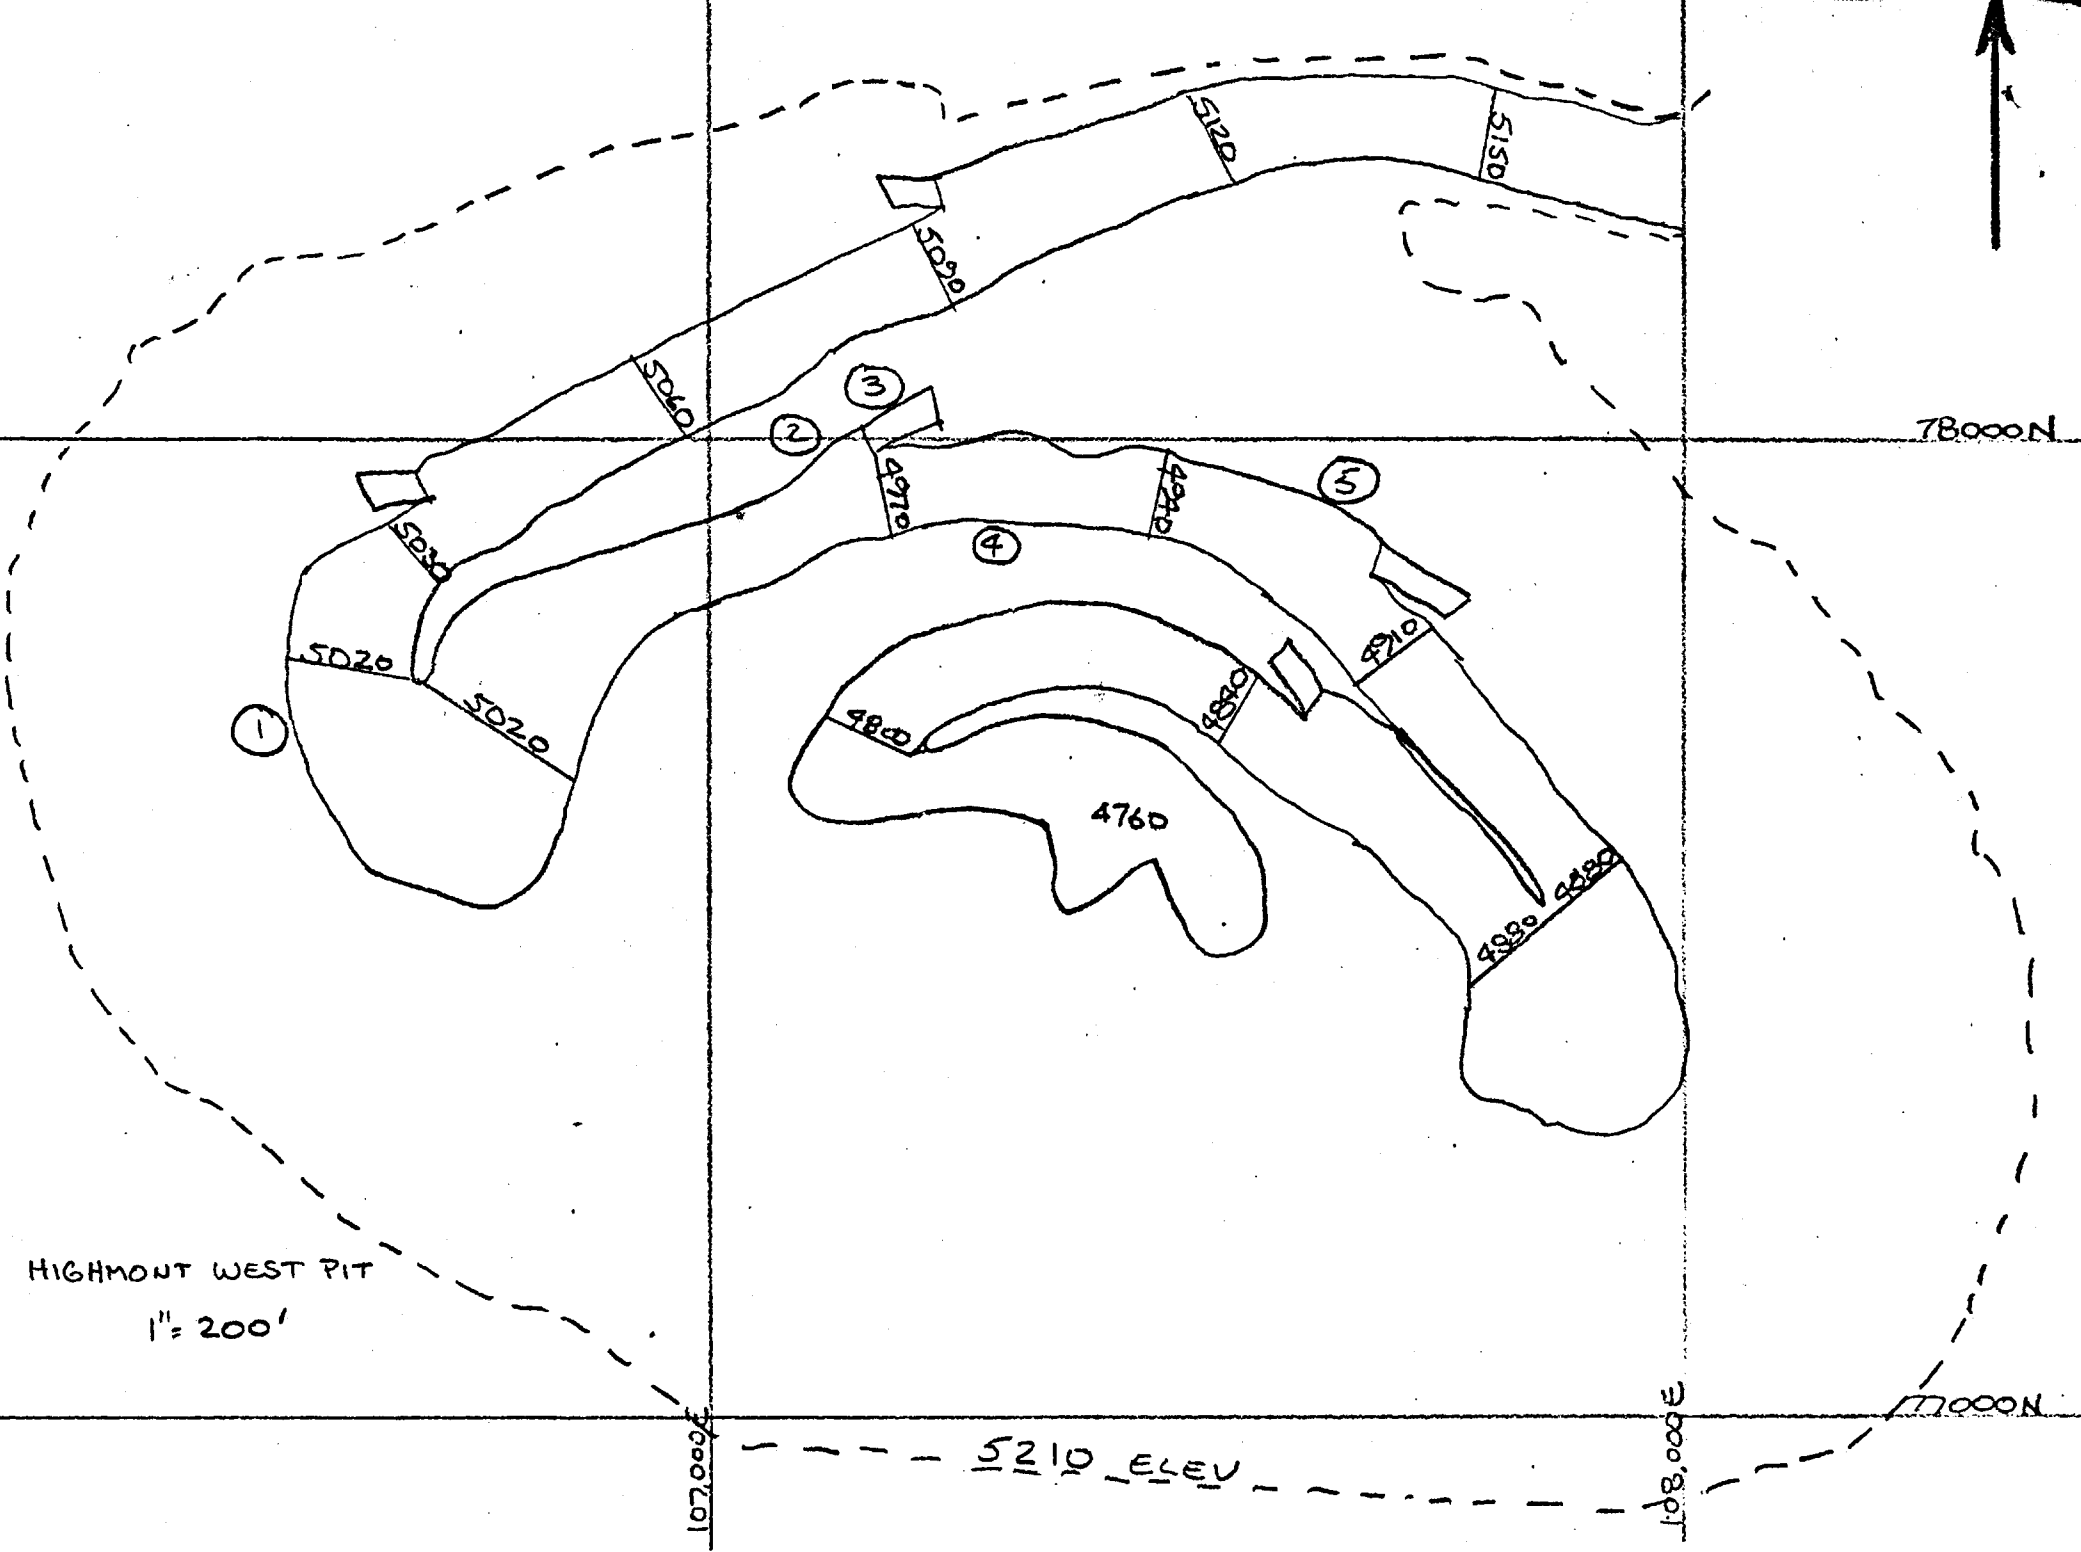
Overview of Pit from Southwall

Notice strong N30E trend and how alterations generally parallel
the structural trend.
