PLACER DEVELOPMENT LIMITED

MEMORANDUM:

то:	D. A. Howard	DATE:	3 February 1981
FROM:	R. H. Pinsent	FILE:	V-164
RE:	MO DISTRIBUTION AT ADANAC.

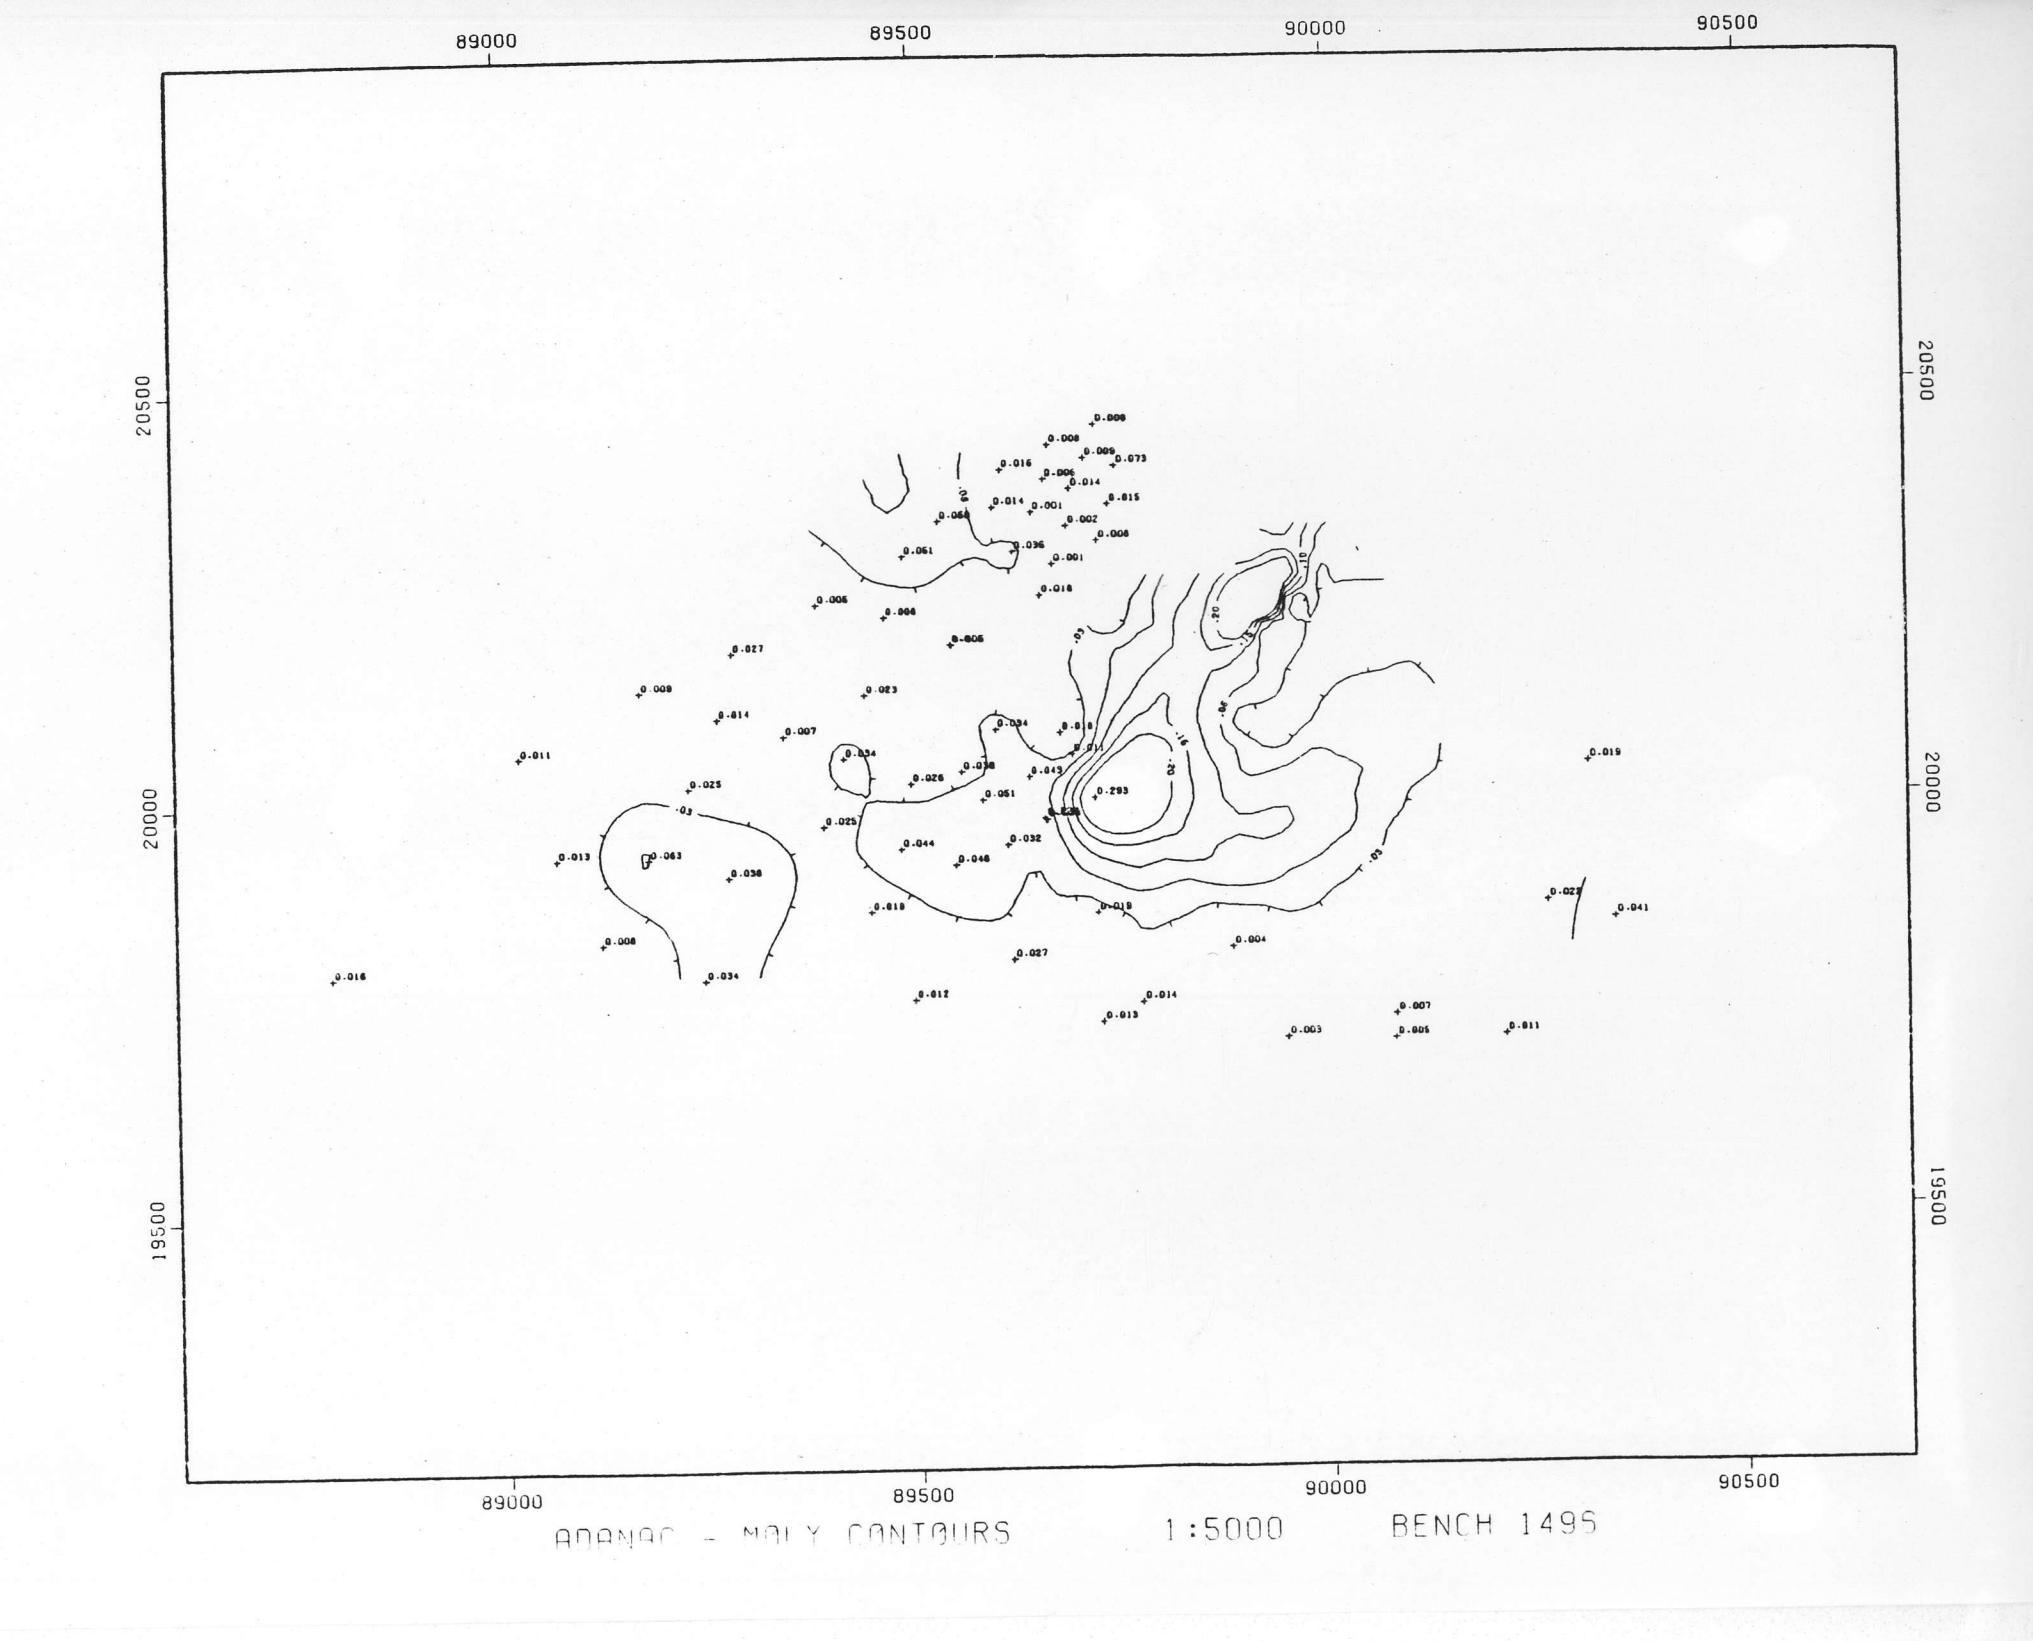
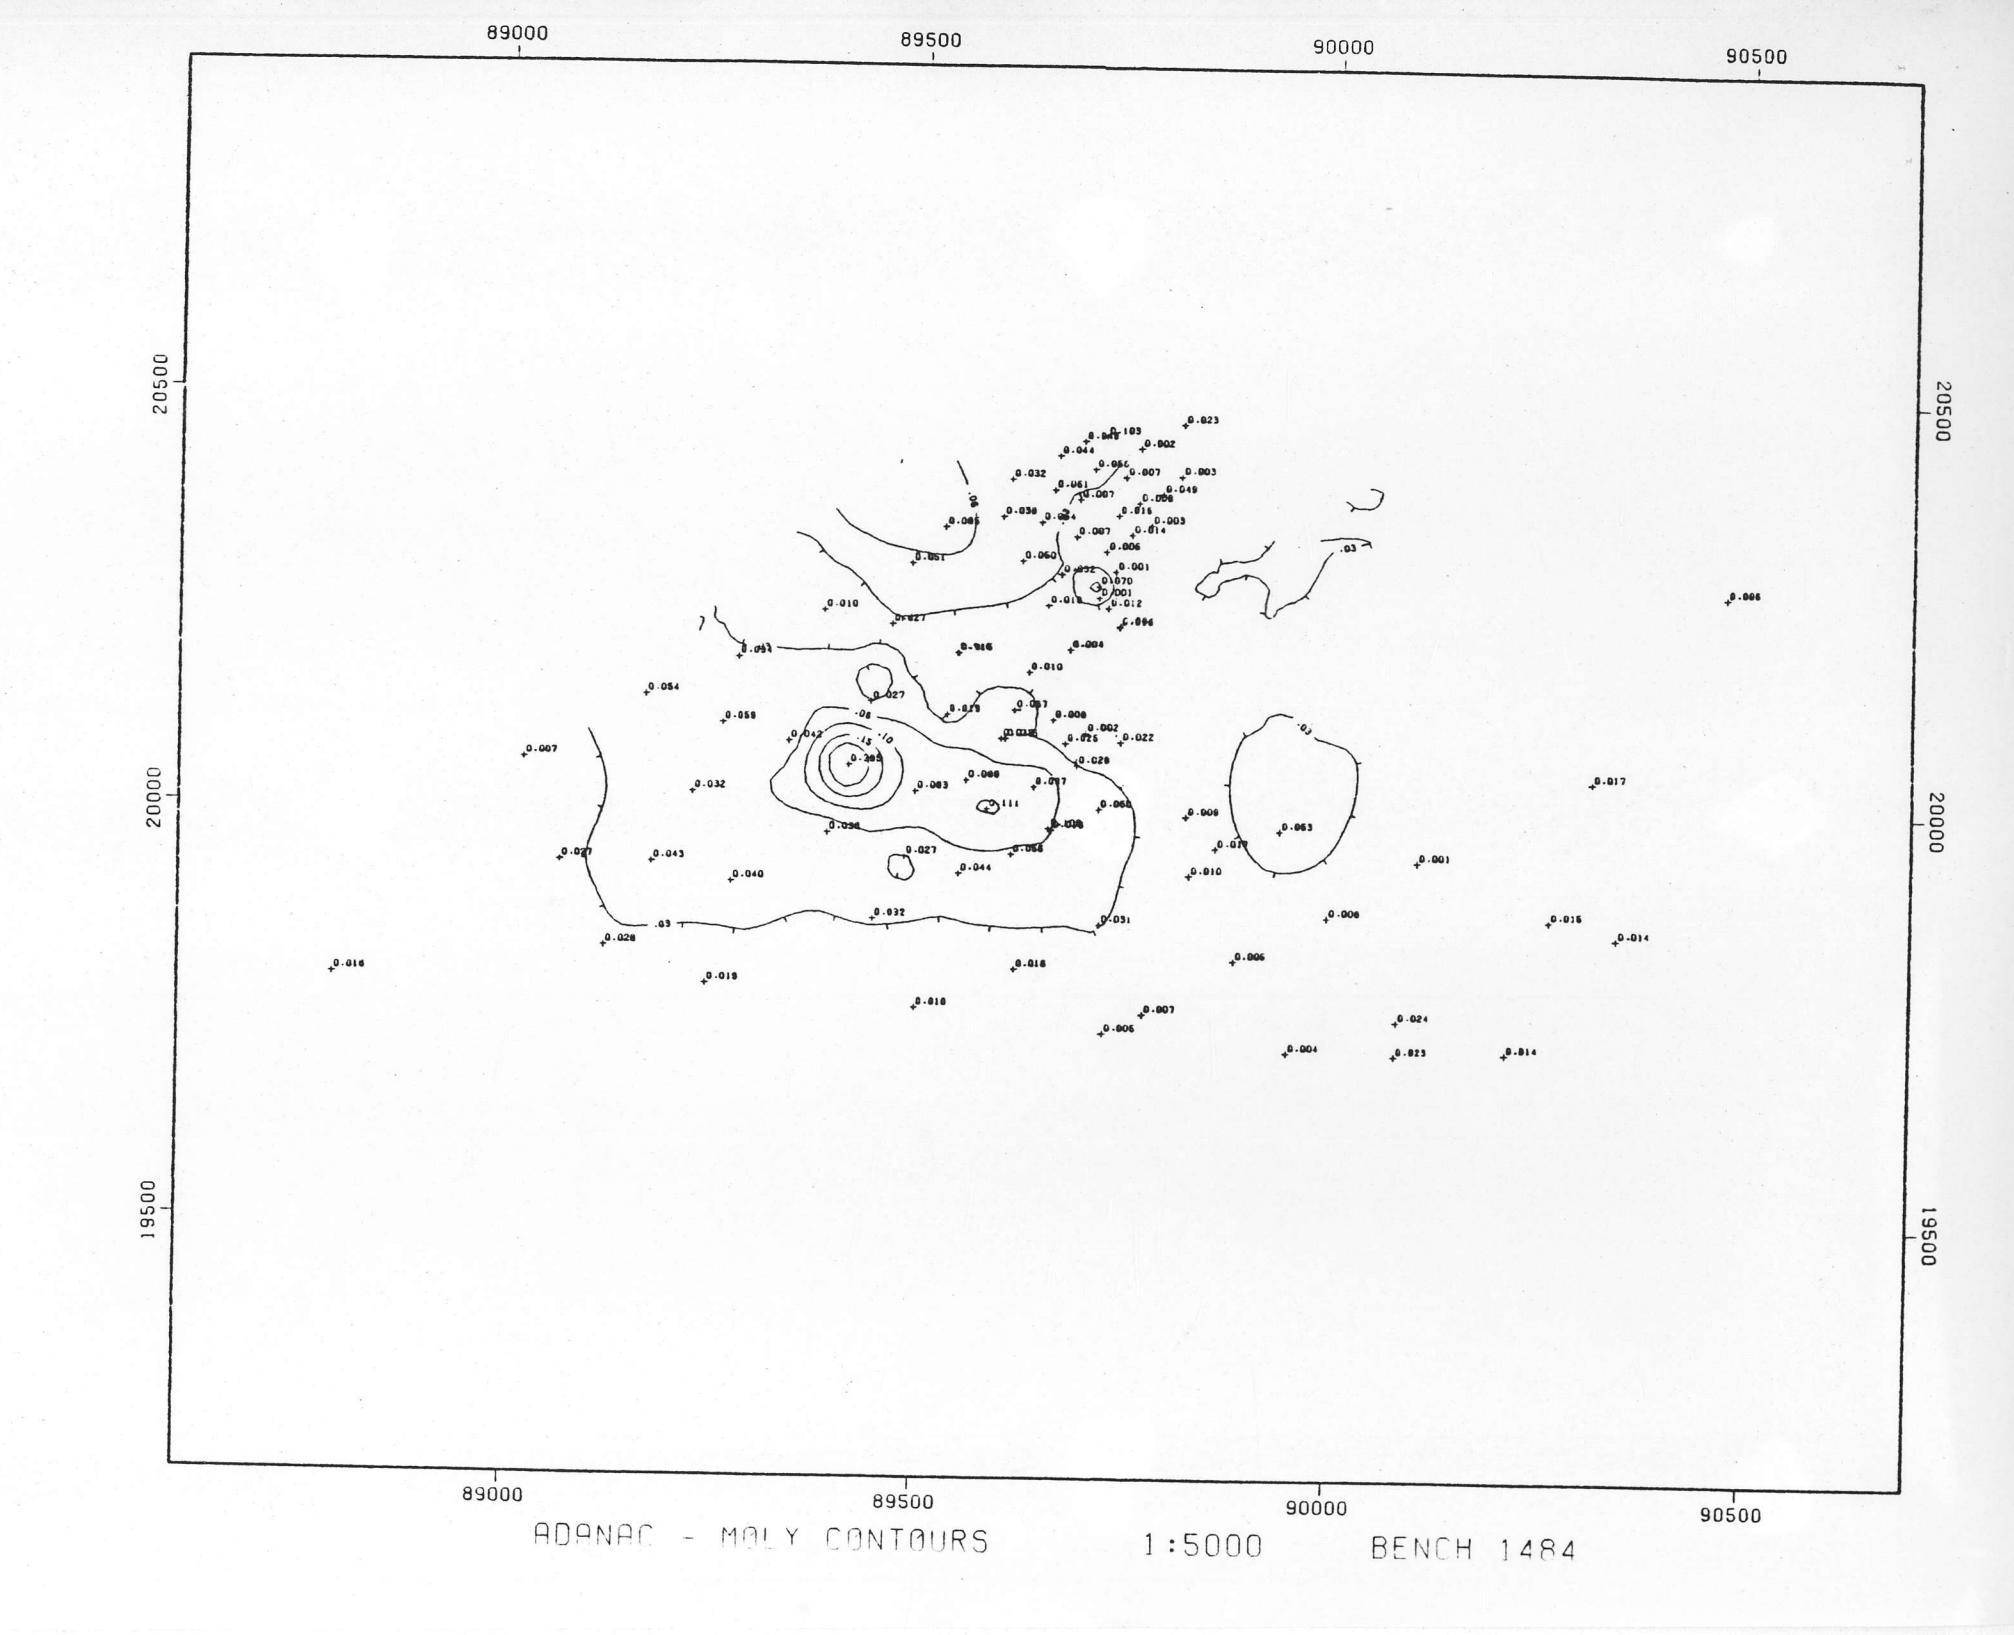
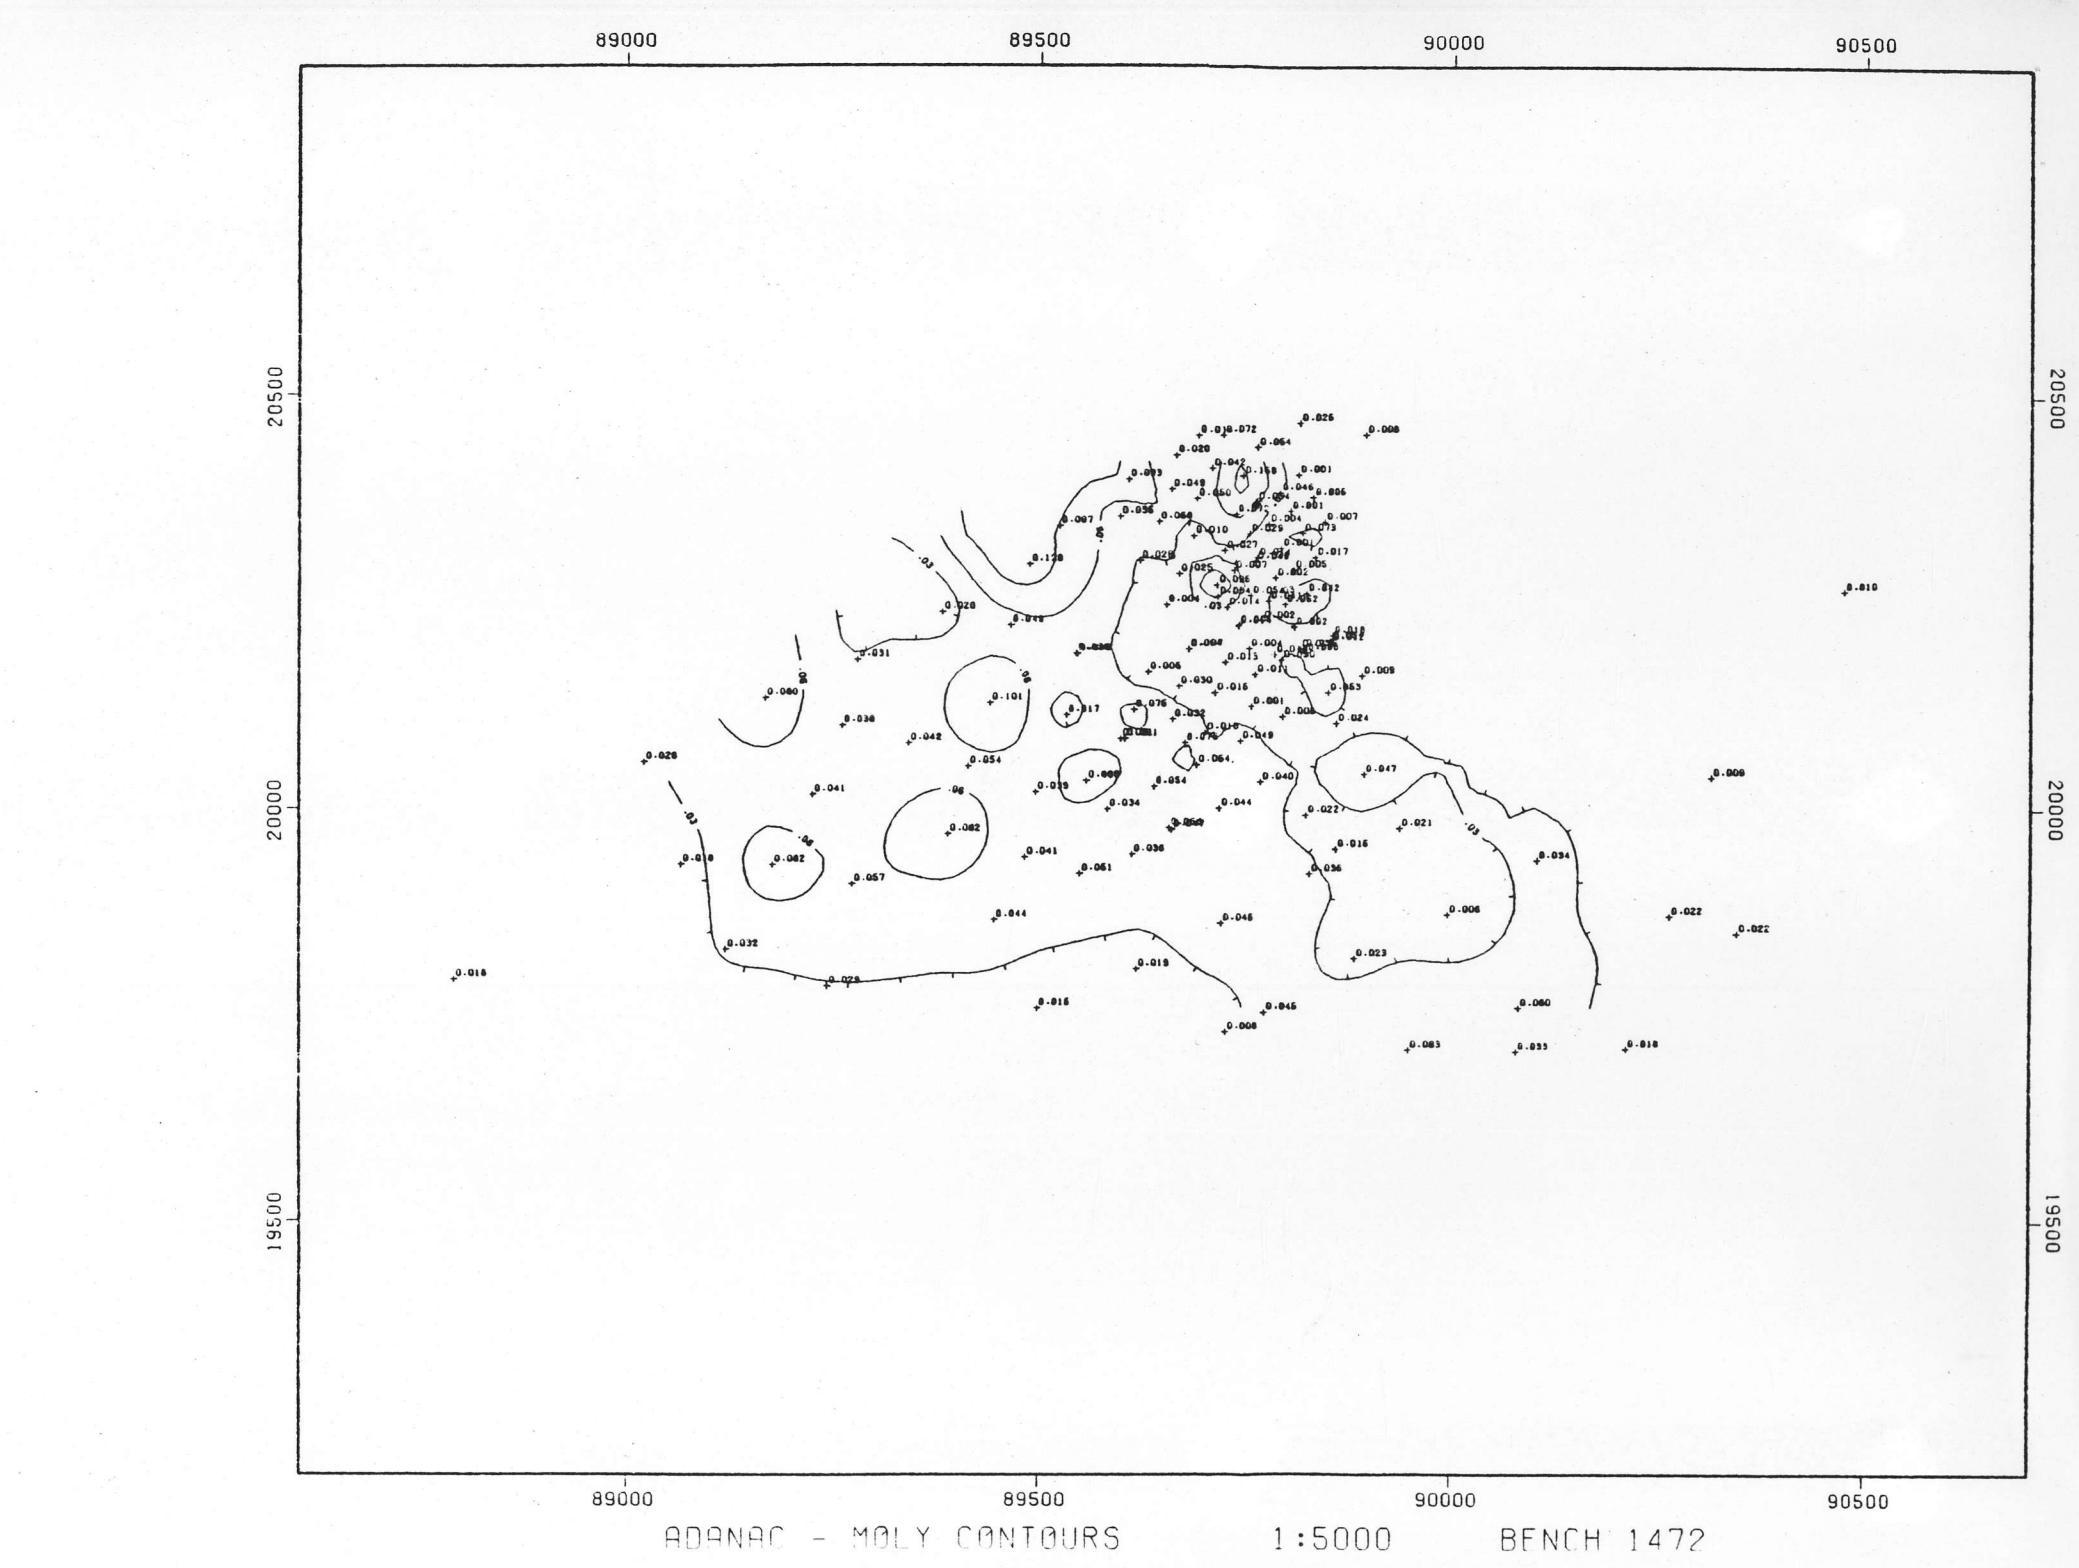
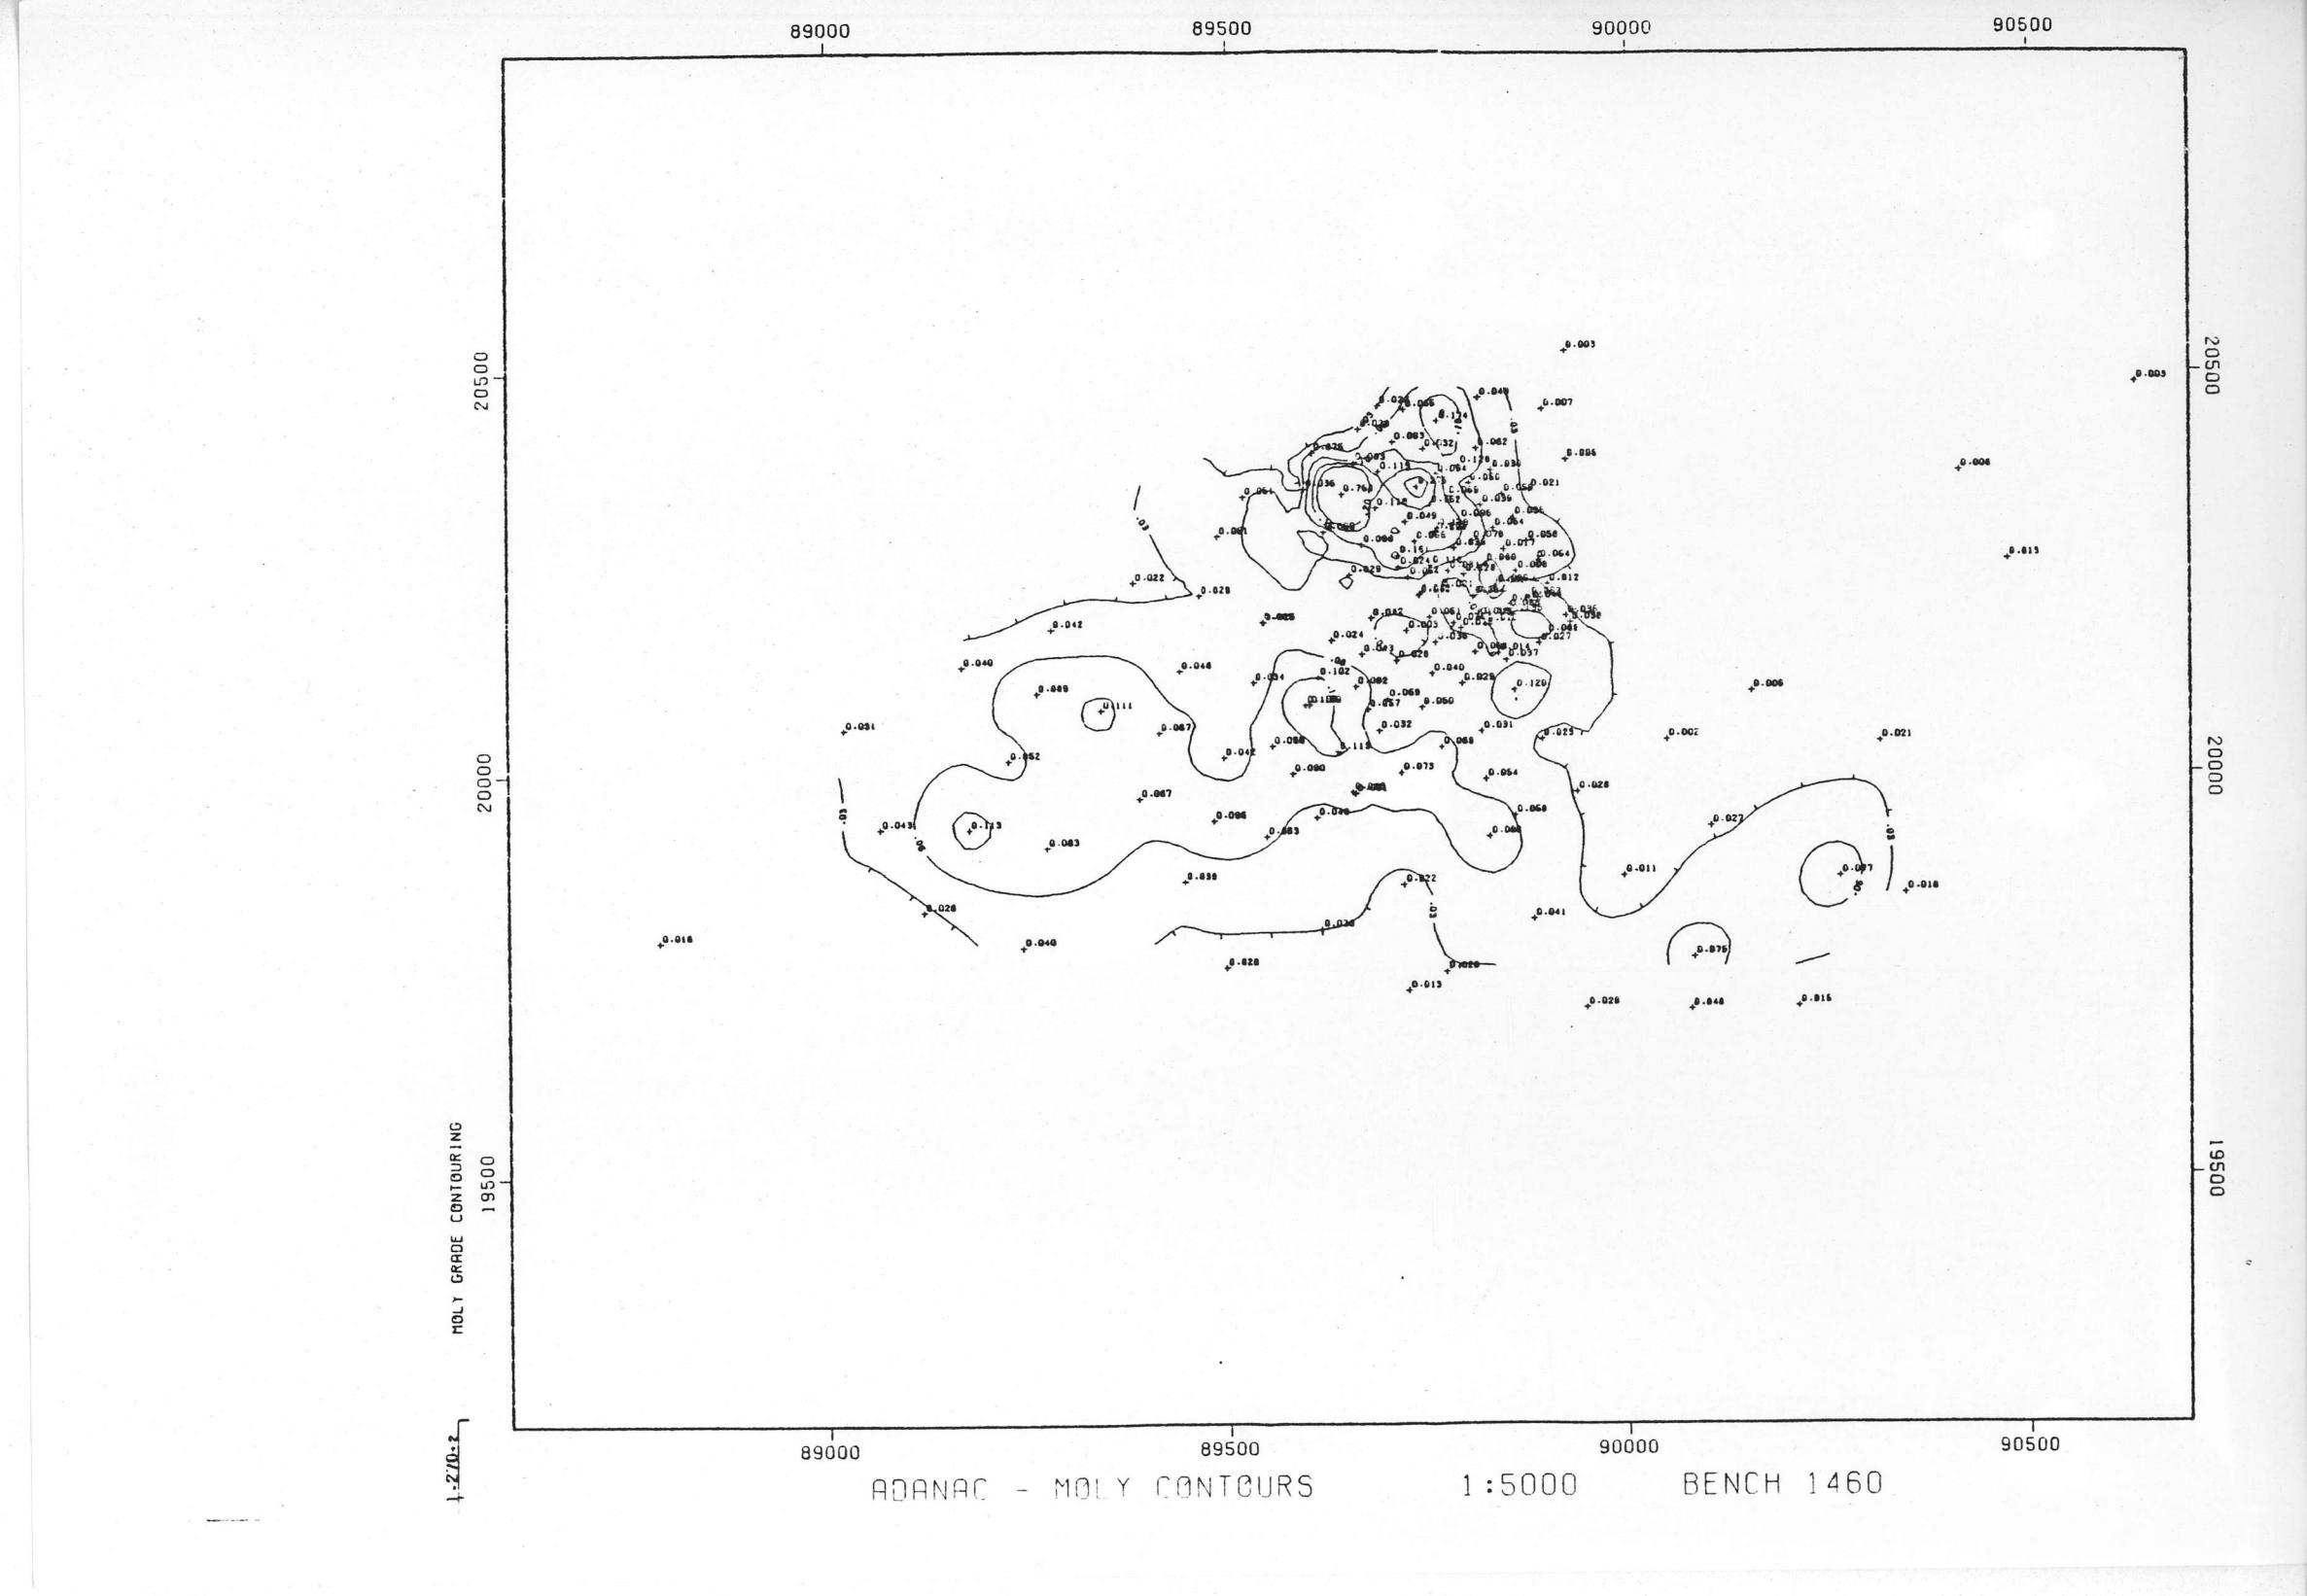
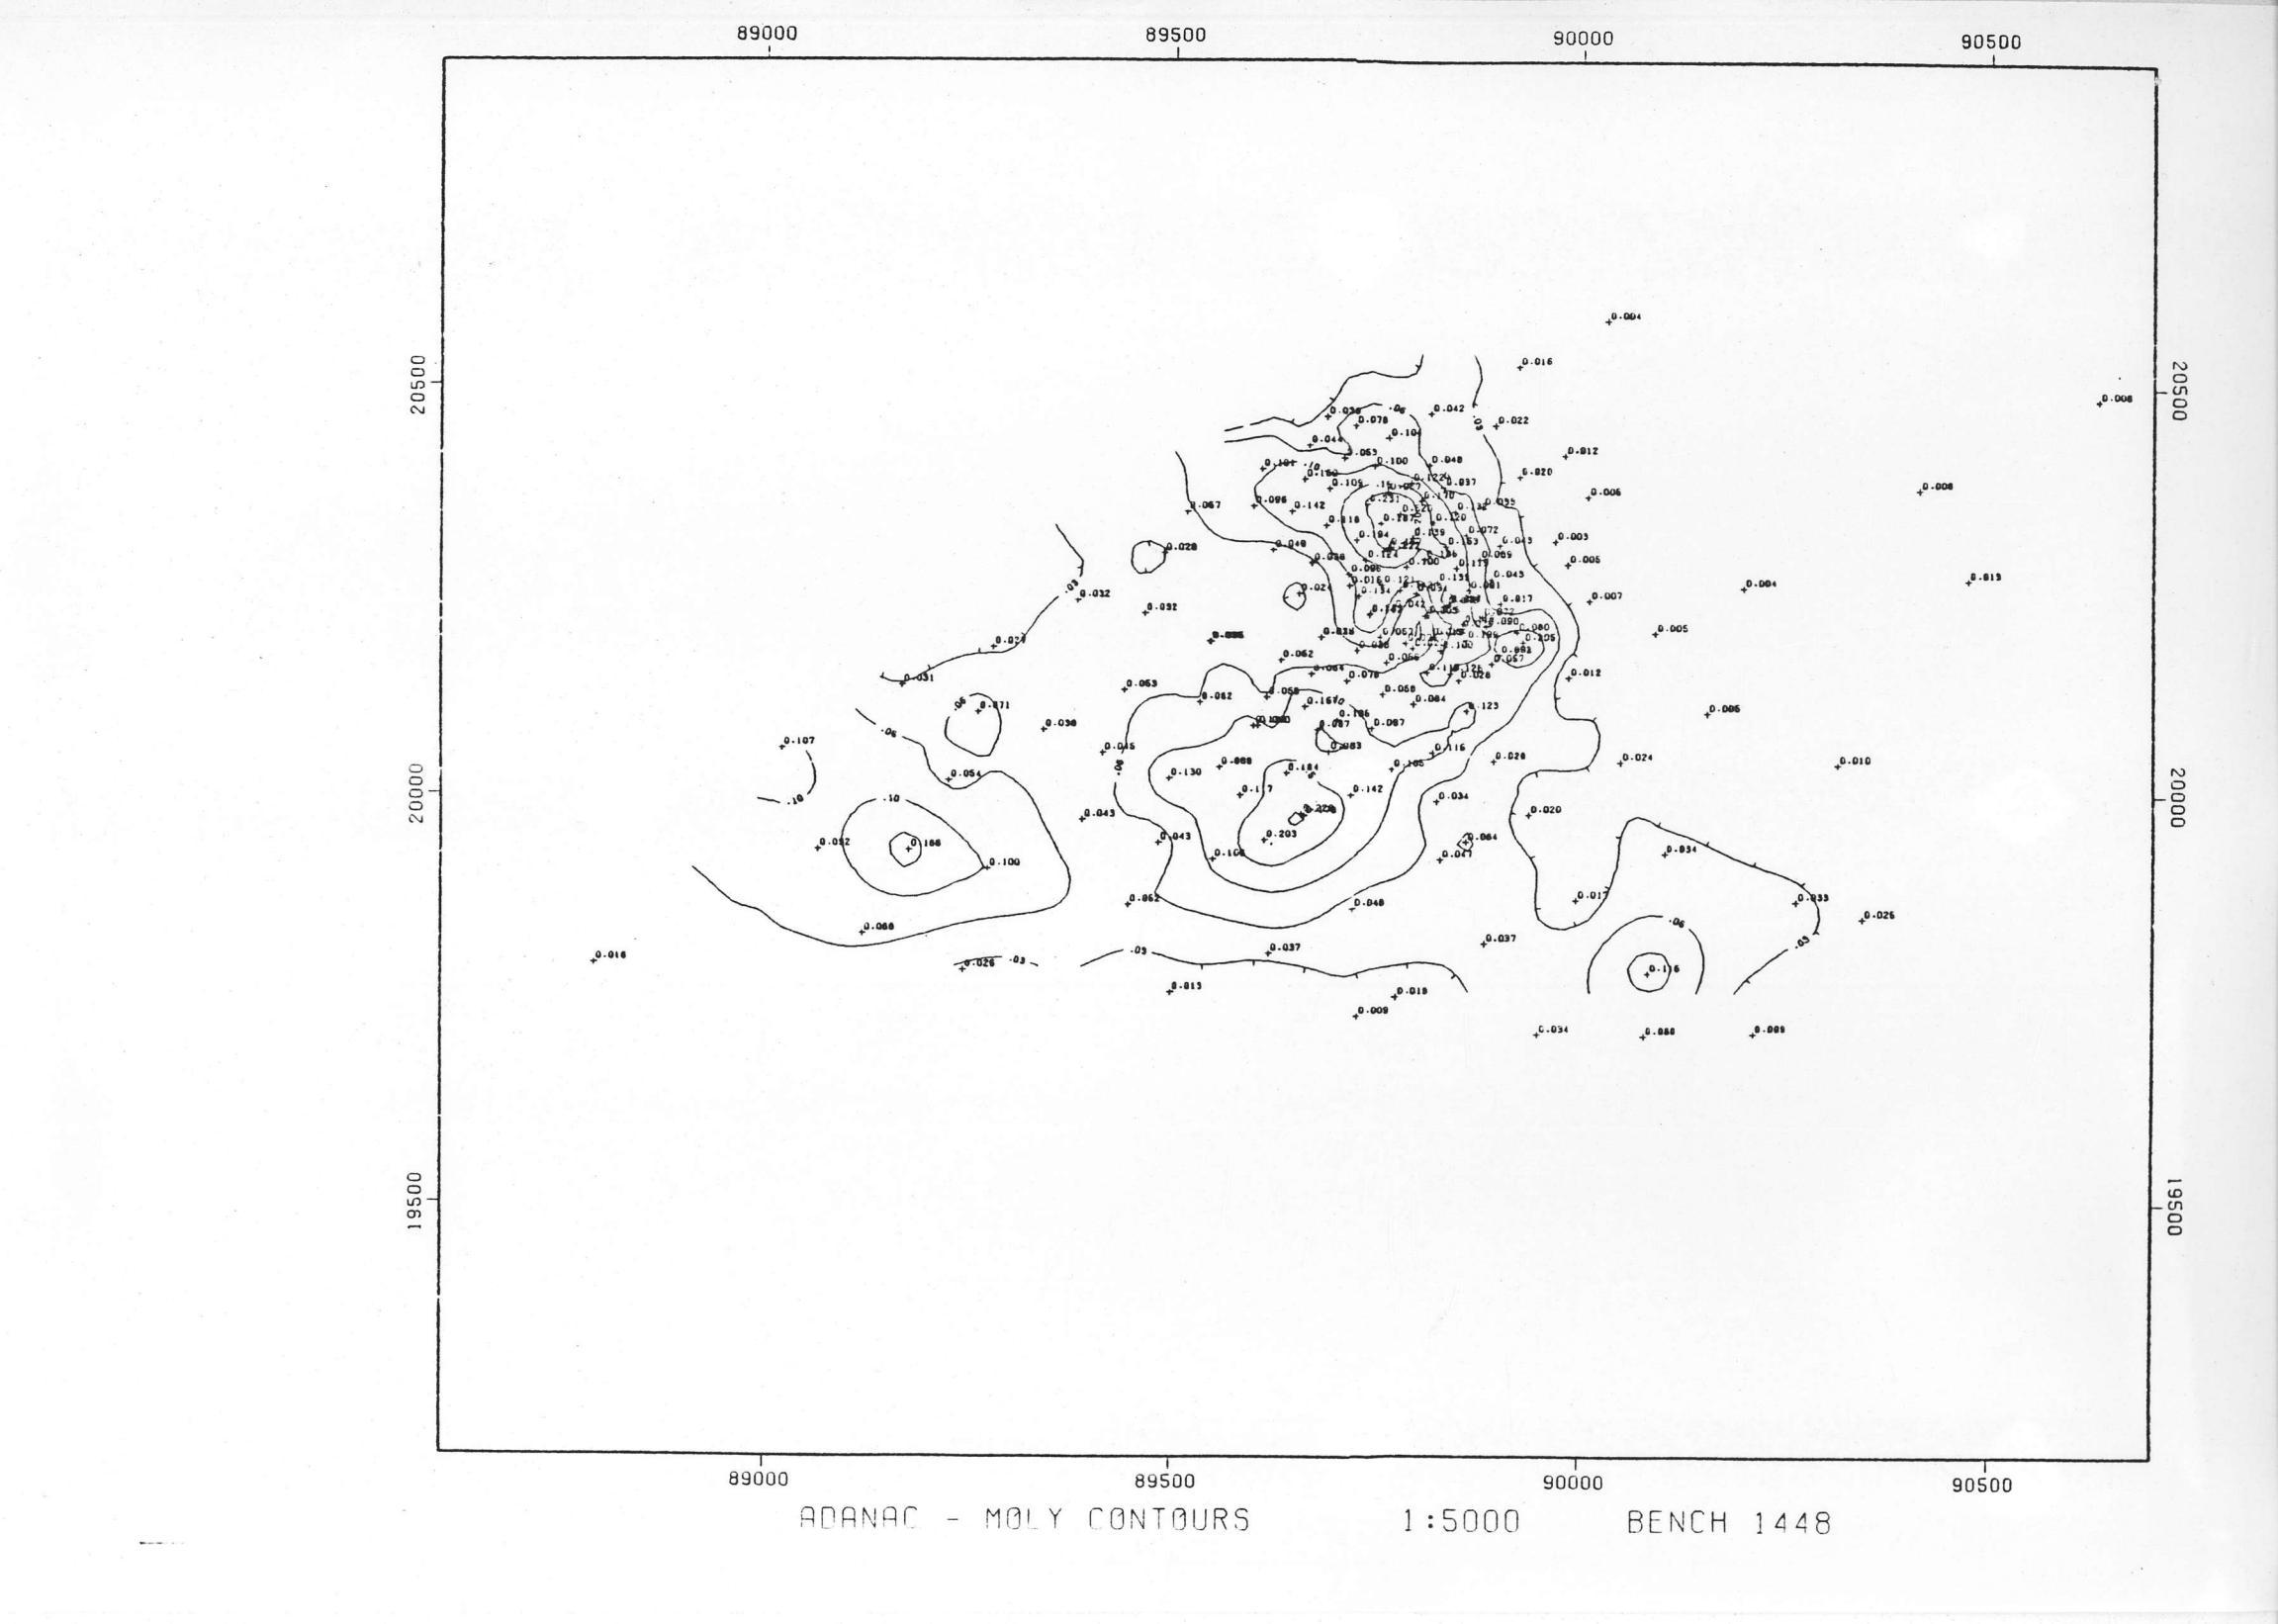
The attached figures are computer contoured 12m bench assay plans for the Adanac molybdenum deposit. The average Mo value attributable to each hole or each production bench has been contoured at 0.03, 0.06, 0.10, 0.15 and >0.2% Mo intervals. The contours have been made to terminate against the Adera fault. There has been no attempt to include drill hole data from the ground to the north of the Adera fault.

The 16 plots cover the production benches between elevations of 1496^{M} and 1316^{M} . They show the change in Mo content and distribution at 12^{m} intervals over a total depth of 192^{m} .

The 1496^A bench shows the effect of topography. Several of the holes in the lower part of the Ruby Creek cirque are collared at a lower elevation and some of the contours are projections. The top three bench plots show the effect of Mo leaching which is known to have occurred over the "high-grade" zone of mineralization.

The structure of the deposit is best shown between the 1460^M and 1388^M bench levels. The plans show the development of a pronounced ring structure to the mineralization, centred on a hidden sparse porphyry cupola. The benches above the dome are weakly mineralized but, below the 1412^M level, the core of the cupola, which increases in size with depth, is barren (< 0.03% Mo). The grade of the mineralization is clearly not uniform around the ring. Better-grade material is found in a trough of deformed coarse-grained quartz monzonite and mafic perphyry on the east side of the mineralized cupola and west of a dome of crowded porphyry. The trough which was drilled off in 1979, was also a centre for minor igneous intrusion prior to mineralization.

The topography rises steeply to the SW and very few holes have penetrated the western part of the mineralized zone below the 1376^M bench. There is, therefore, insufficient data to judge the extent of the mineralization below the SW wall of the Ruby Creek Cirque. It is probable that it does continue, but at only moderate grade and with a prohibitive strip ratio. The general grade of mineralization appears to decrease at depth and below the 1340th bench and the "high-grade" zone becomes diffuse.

The principal observations to be made are (1) that the mineralization is centred about a hidden sparse porphyry cupola, (2) the exposed sparse porphyry cupola south of Ruby Creek, which is probably older, is not mineralized, (3) the Adera fault has removed approximately half the ring of mineralization - assuming an originally symmetrical deposit.
