■ ELKVIEW COAL MINE

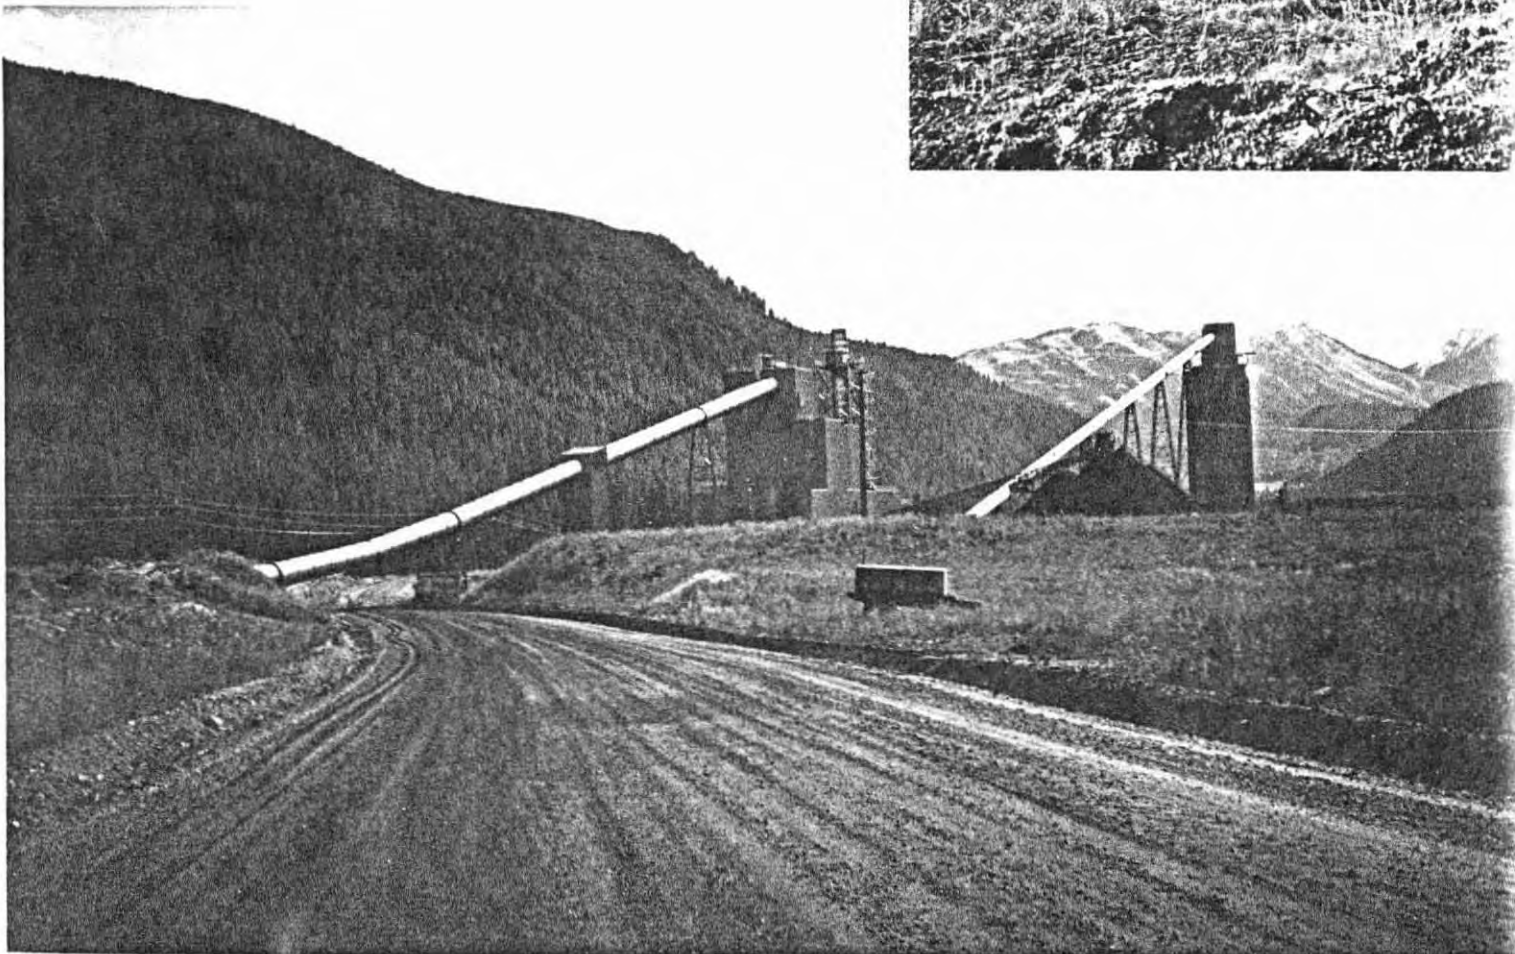
Dryer and loadout facility at the Elkview coal mine *and inset*, part of the large elk population that inhabit the property.

Raw coal will be transported by a 4.0 km overland conveyor to a breaker station. The coal is then transferred to a 2.5 km overland conveyor of which 1.5 km is through a tunnel between the pit and the process plant. The coal is cleaned using heavy media vessels, cyclones, and froth flotation. Clean coal is stored in four 13,600 tonne silos adjacent to the plant, and loaded onto 112 car unit trains for transport to the Roberts Bank coal port in Vancouver.
