Adit Portal
180' above camp
An Camp 4824

92I/11W

92I/NW-38

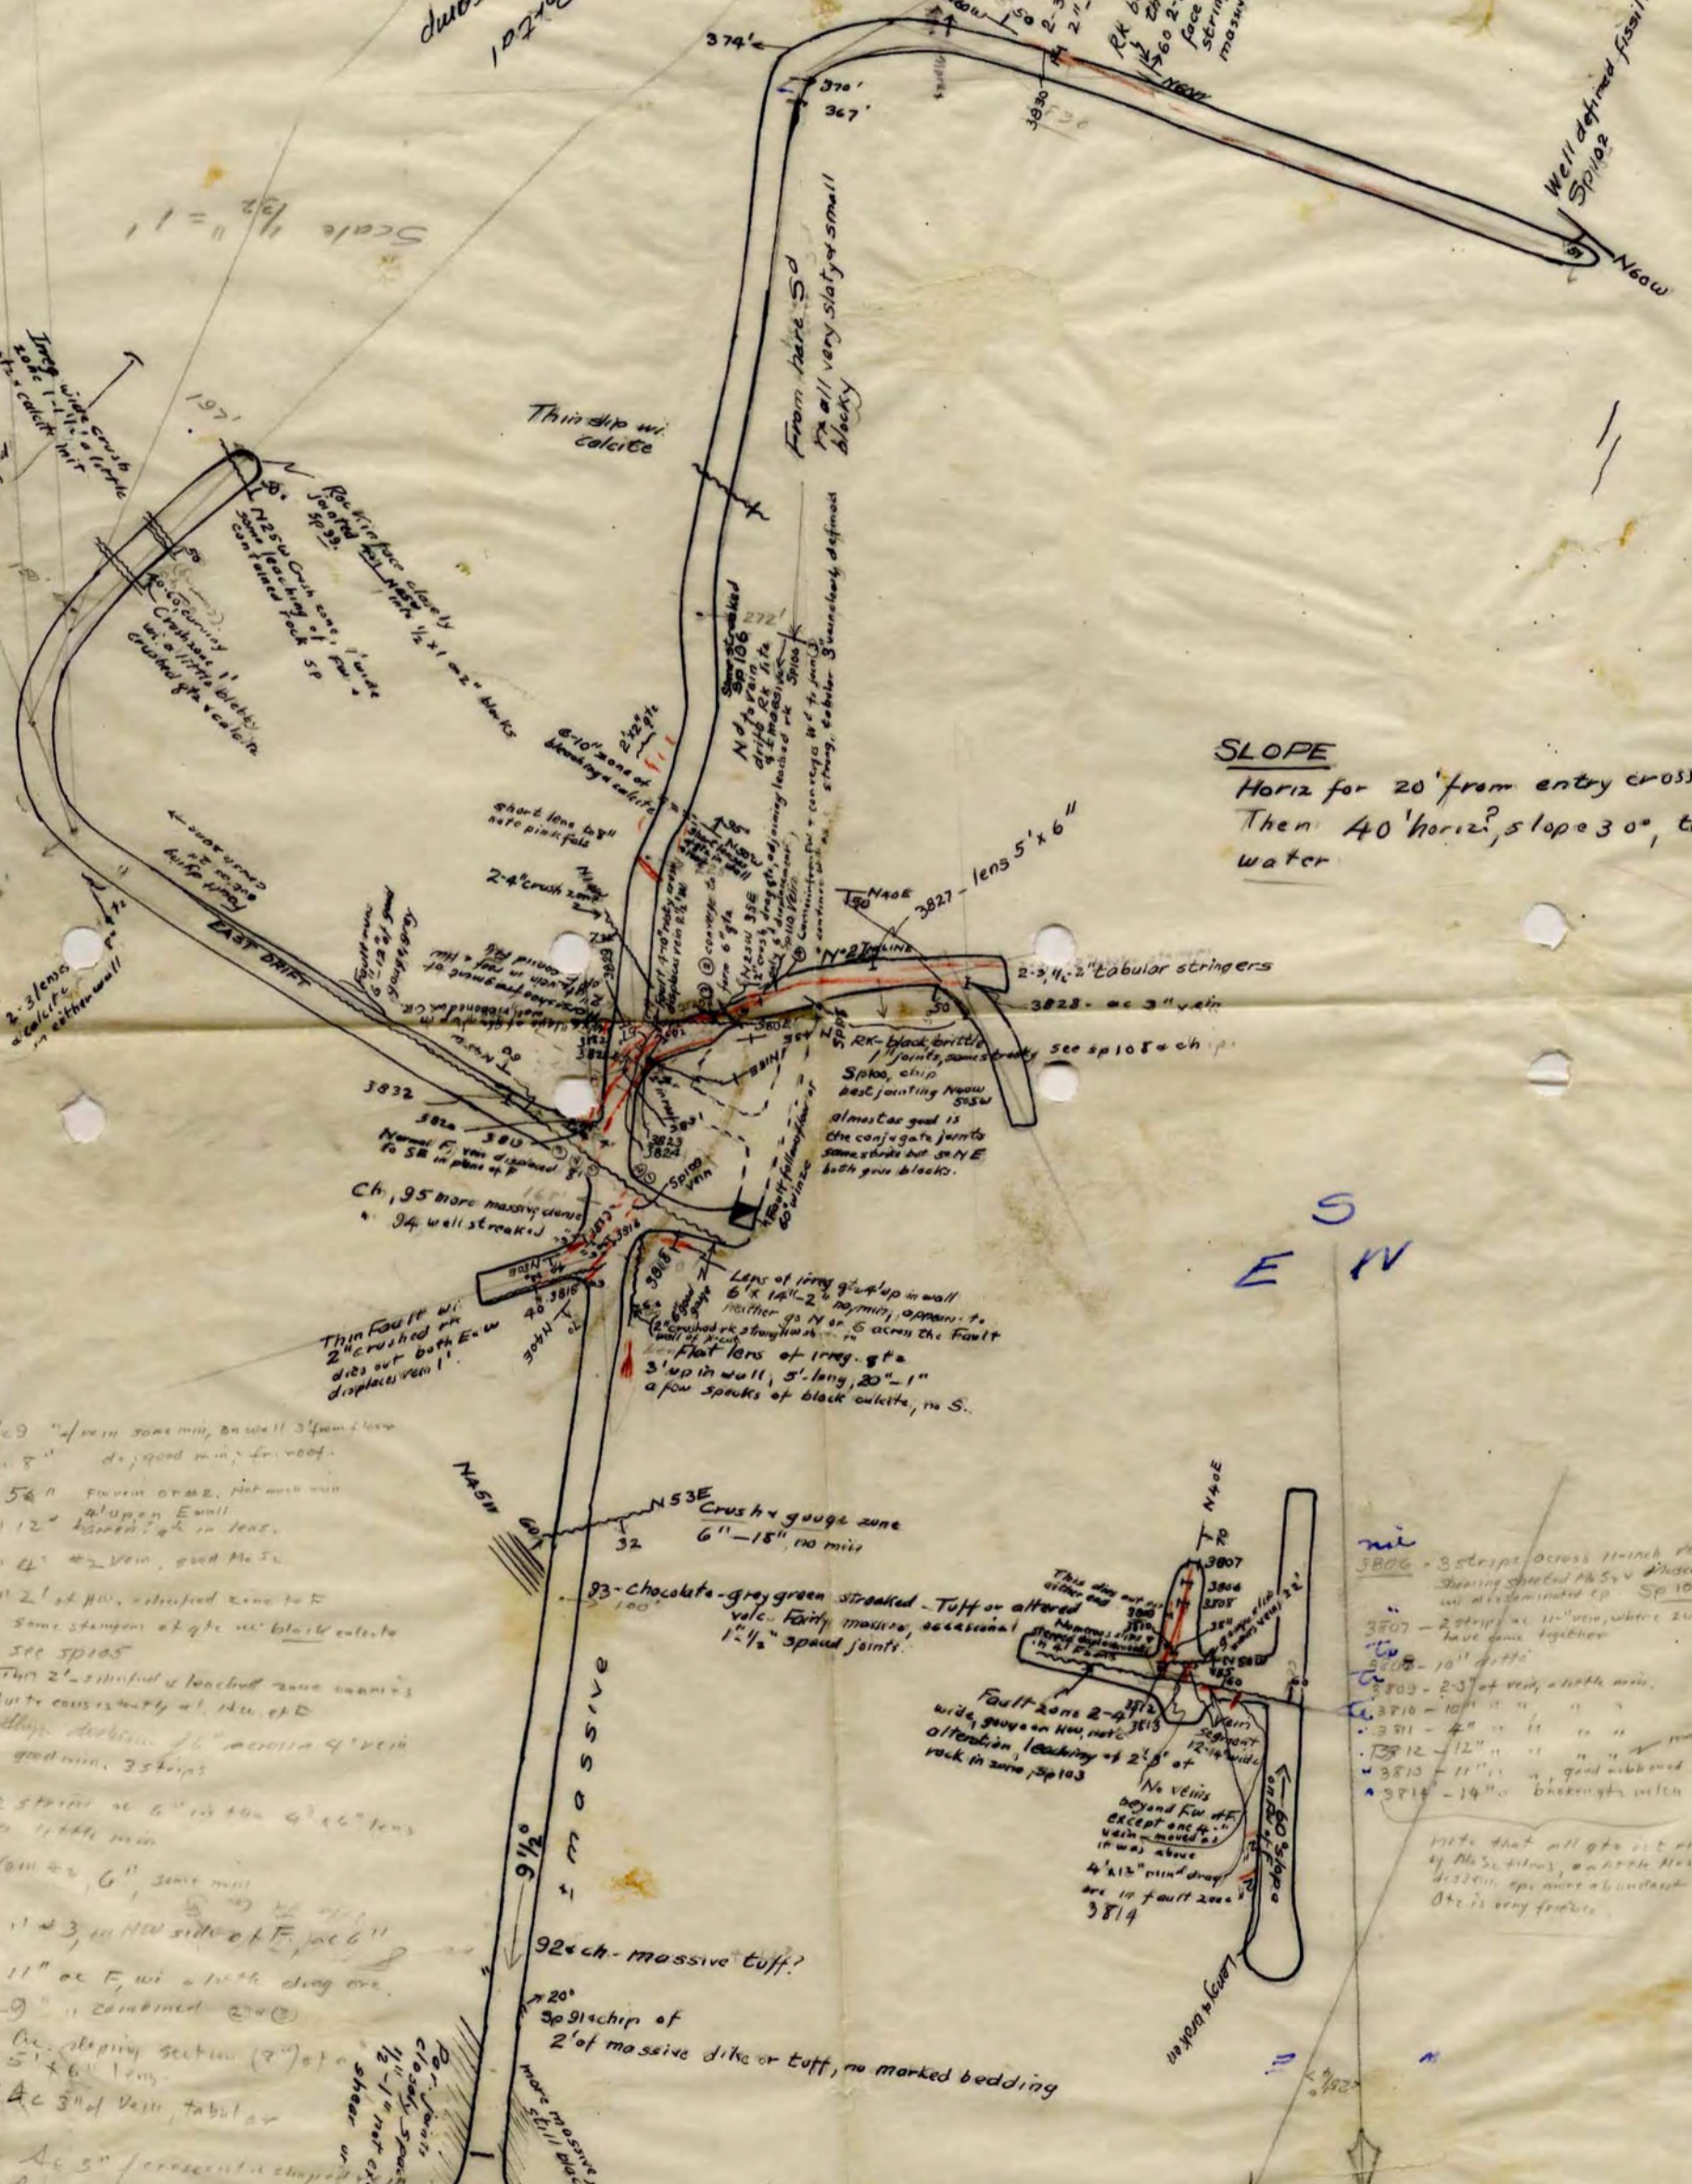
Scale 1/2" = 1'

SLOPE
Horiz for 20' from entry crosscut
Then 40' horiz, slope 30°, to water

- 3815 - 40' 1/2" vein some mill, on wall 3' from base
- to 3816 " 5" do, good mill, fair roof.
- to 3817 " 5 1/2" fine iron ore, rich with mill
- to 3818 " 12" brown, 1/2" in lens.
- to 3819 " 4" 2 vein, good mill
- to 3820 " 2 1/2" of NW, striated zone to E
some stringers of grey calcite
see sp105
This 2' striated & leached zone carries
quite consistently at NW, etc
- 3821 " 1 1/2" of NW, massive 4' vein
good mill, 35 strips
- 3822 2 stringers of 6" in NW, 4' of lens
on 1/2" mill
- to 3823 vein of 6" some mill
- to 3824 " 3" in NW side of F, of 6"
- 3825 - 11" of F, with 1/2" drag ore.
- to - 26 - 9" " contained 2000
- 0.2 3827 - Cu, steeping section (?) of 5' x 6" lens.
- to 3828 - Ac 3 1/2" vein, tabular
- to 3829 - Ac 5" fragment in chip
- to 3830 - Ac 2-2' vein in main
- 3831 - Ac 1' of CE, thin film
of py in NW of #3 vein
- 3832 - Ac 10' of F, gouge, away
from zone of drag ore

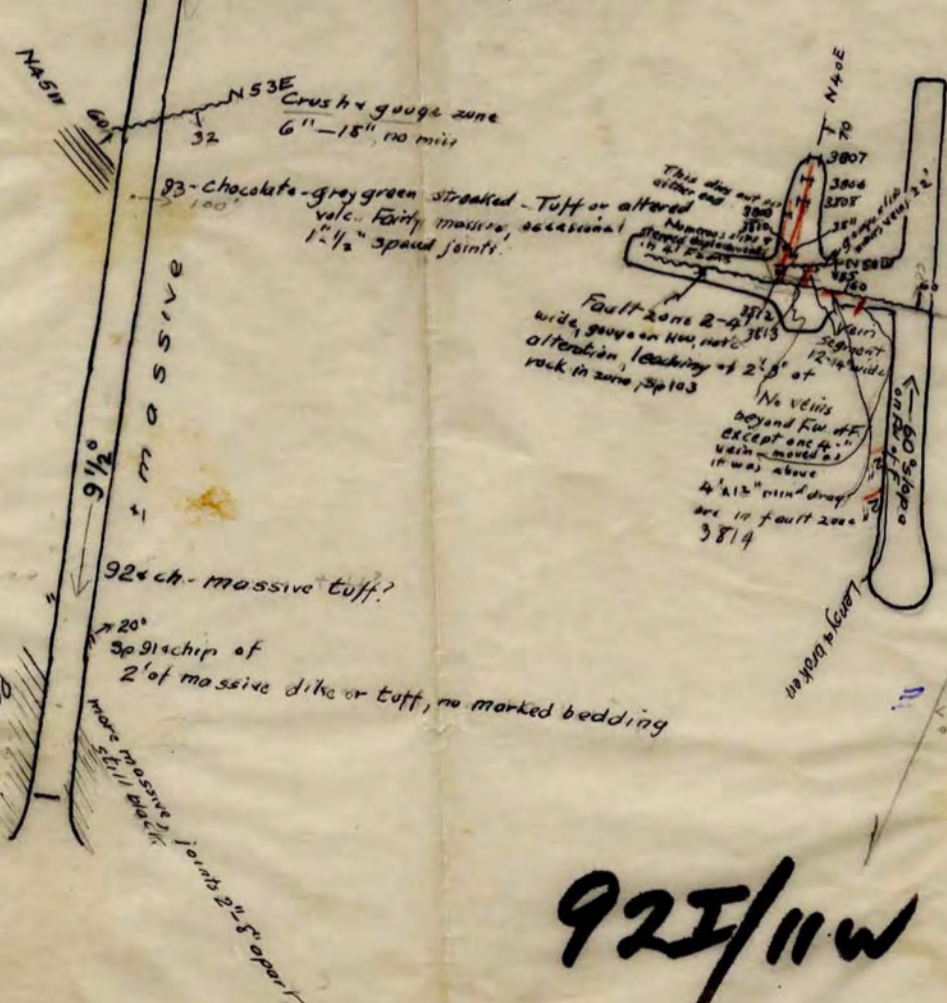
- 3806 - 3 strips across 11-inch vein
striated, streaked 1/2" vein
with discontinuous to SP 104
 - 3807 - 2 strips, ac 11" vein, where 2 veins
have come together
 - 3808 - 10" of tuff
 - 3809 - 2-3' of vein, with mill.
 - 3810 - 10" " " "
 - 3811 - 4" " " "
 - 3812 - 12" " " "
 - 3813 - 11" " " " good ribboned plate
 - 3814 - 14" " " " broken into mill
- note that all gte is ribboned
by the S. vein, with the exception of
3820, etc. more abundant than by
etc. is very fine.
