HAT CREEK PROJECT

FINAL REPORT

BULK SAMPLE PROGRAM

AUGUST 1978

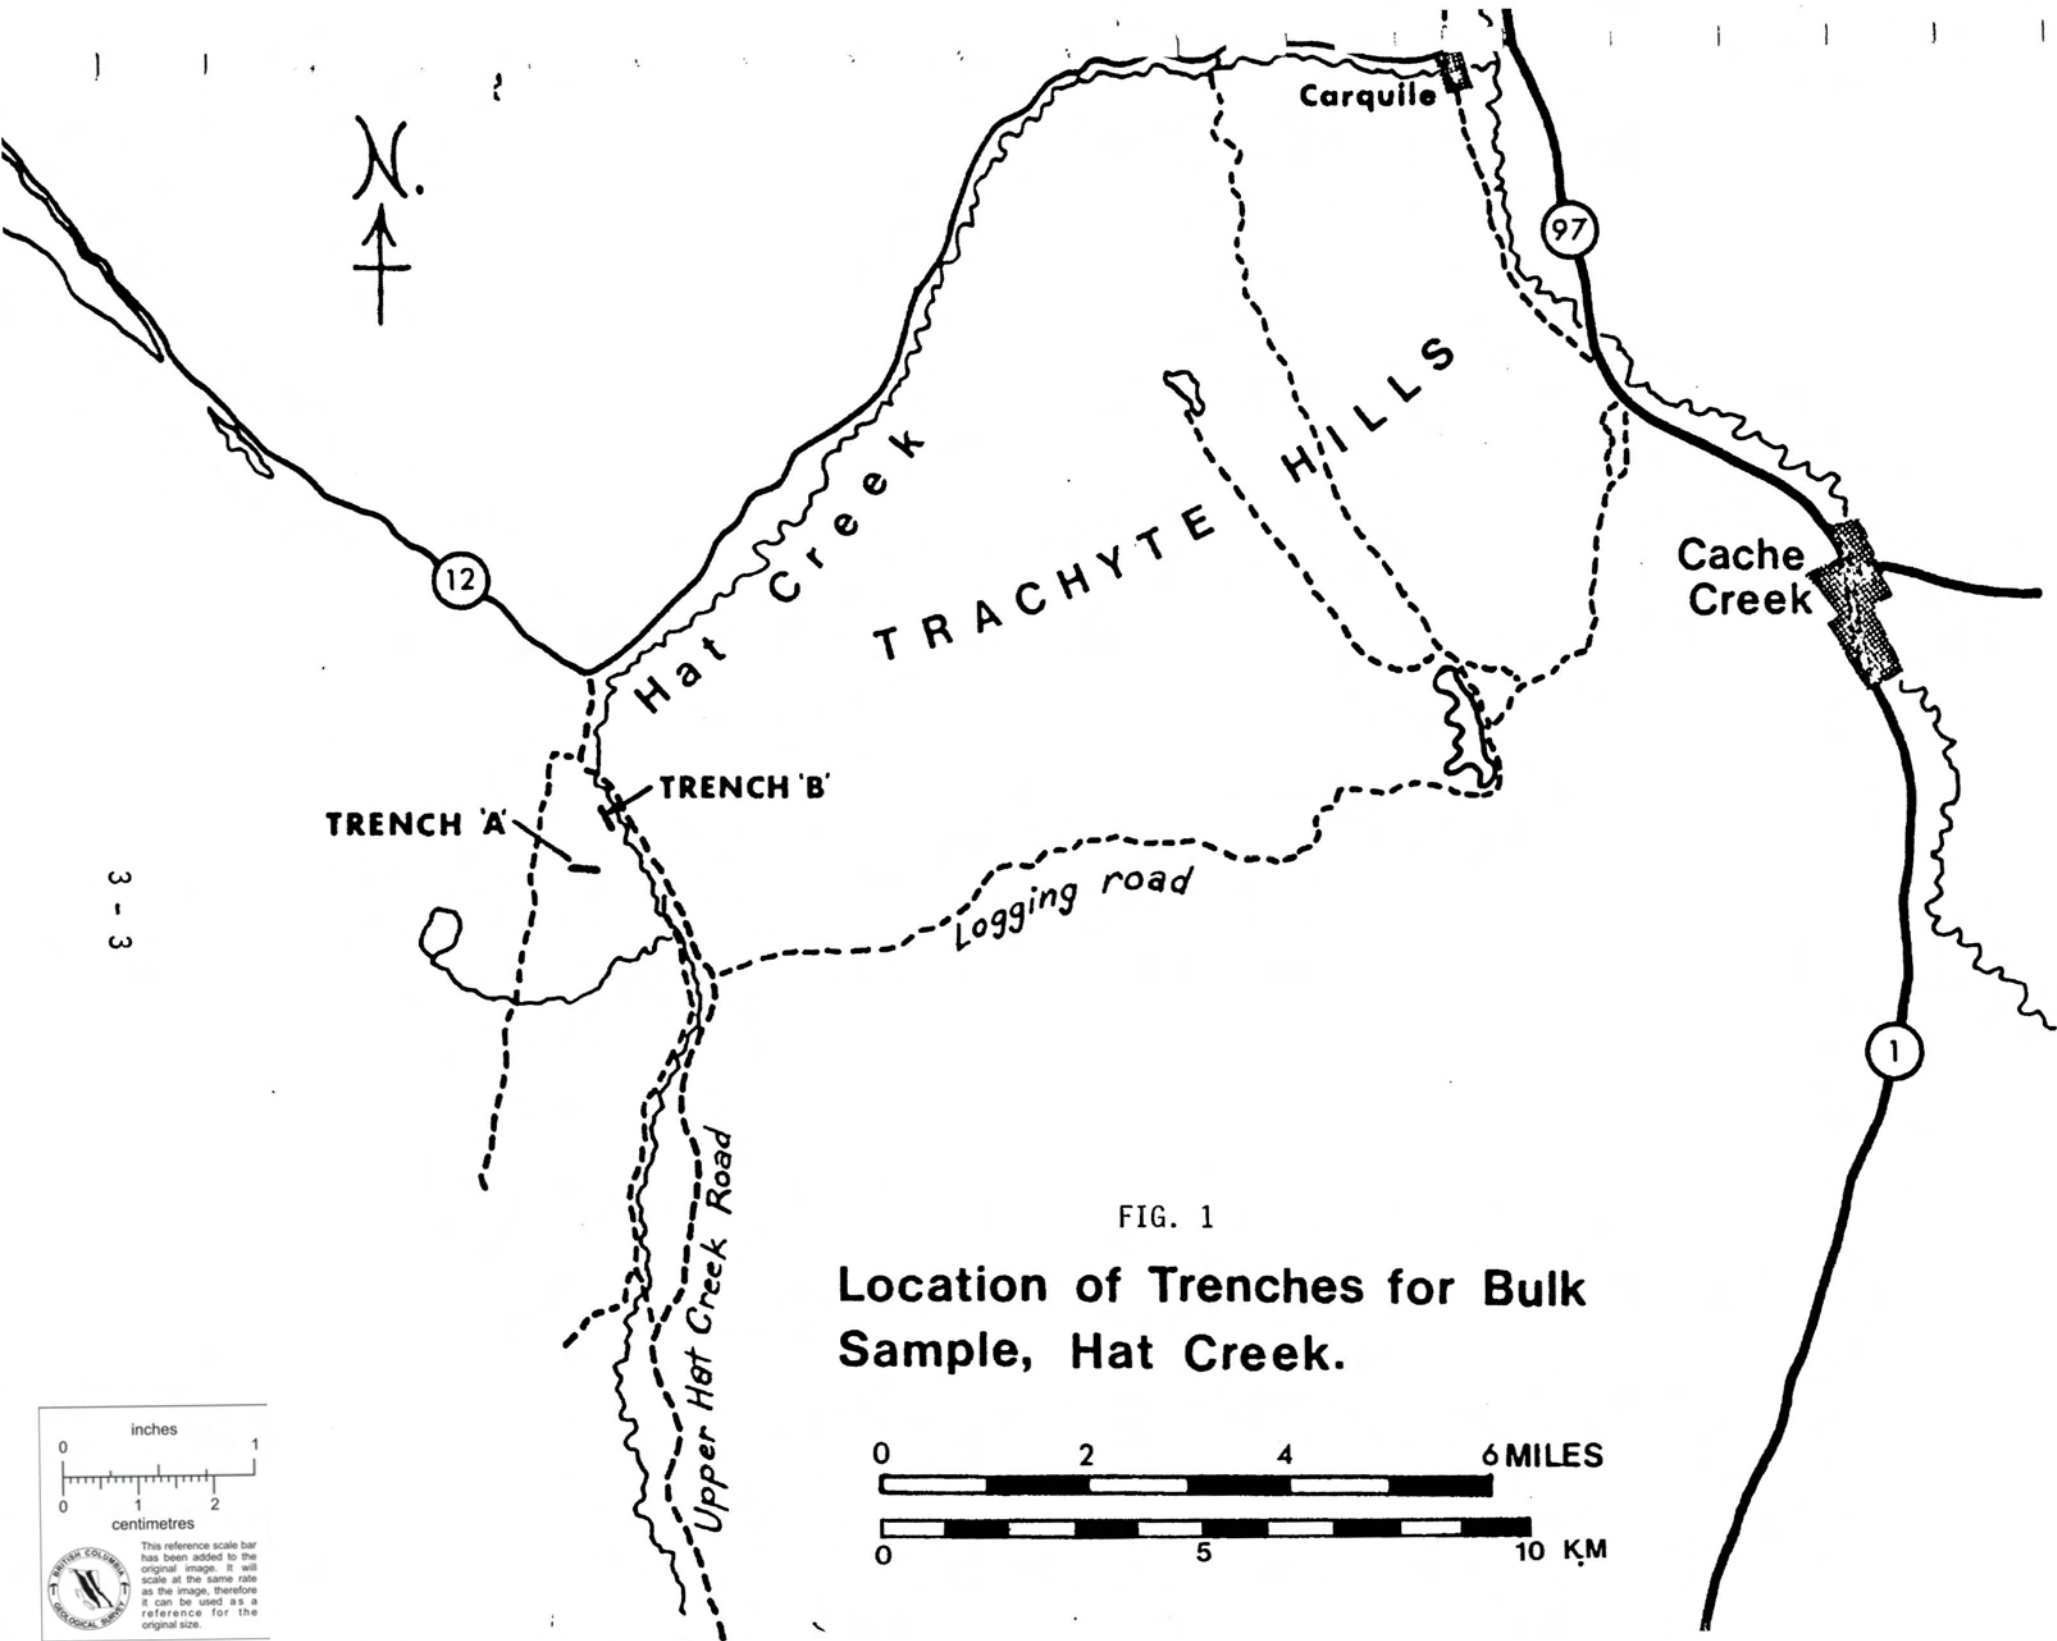
FIG. 1
 Location of Trenches for Bulk
 Sample, Hat Creek.

Fig. 1 indicates the location of the trenches within the Hat Creek Valley.

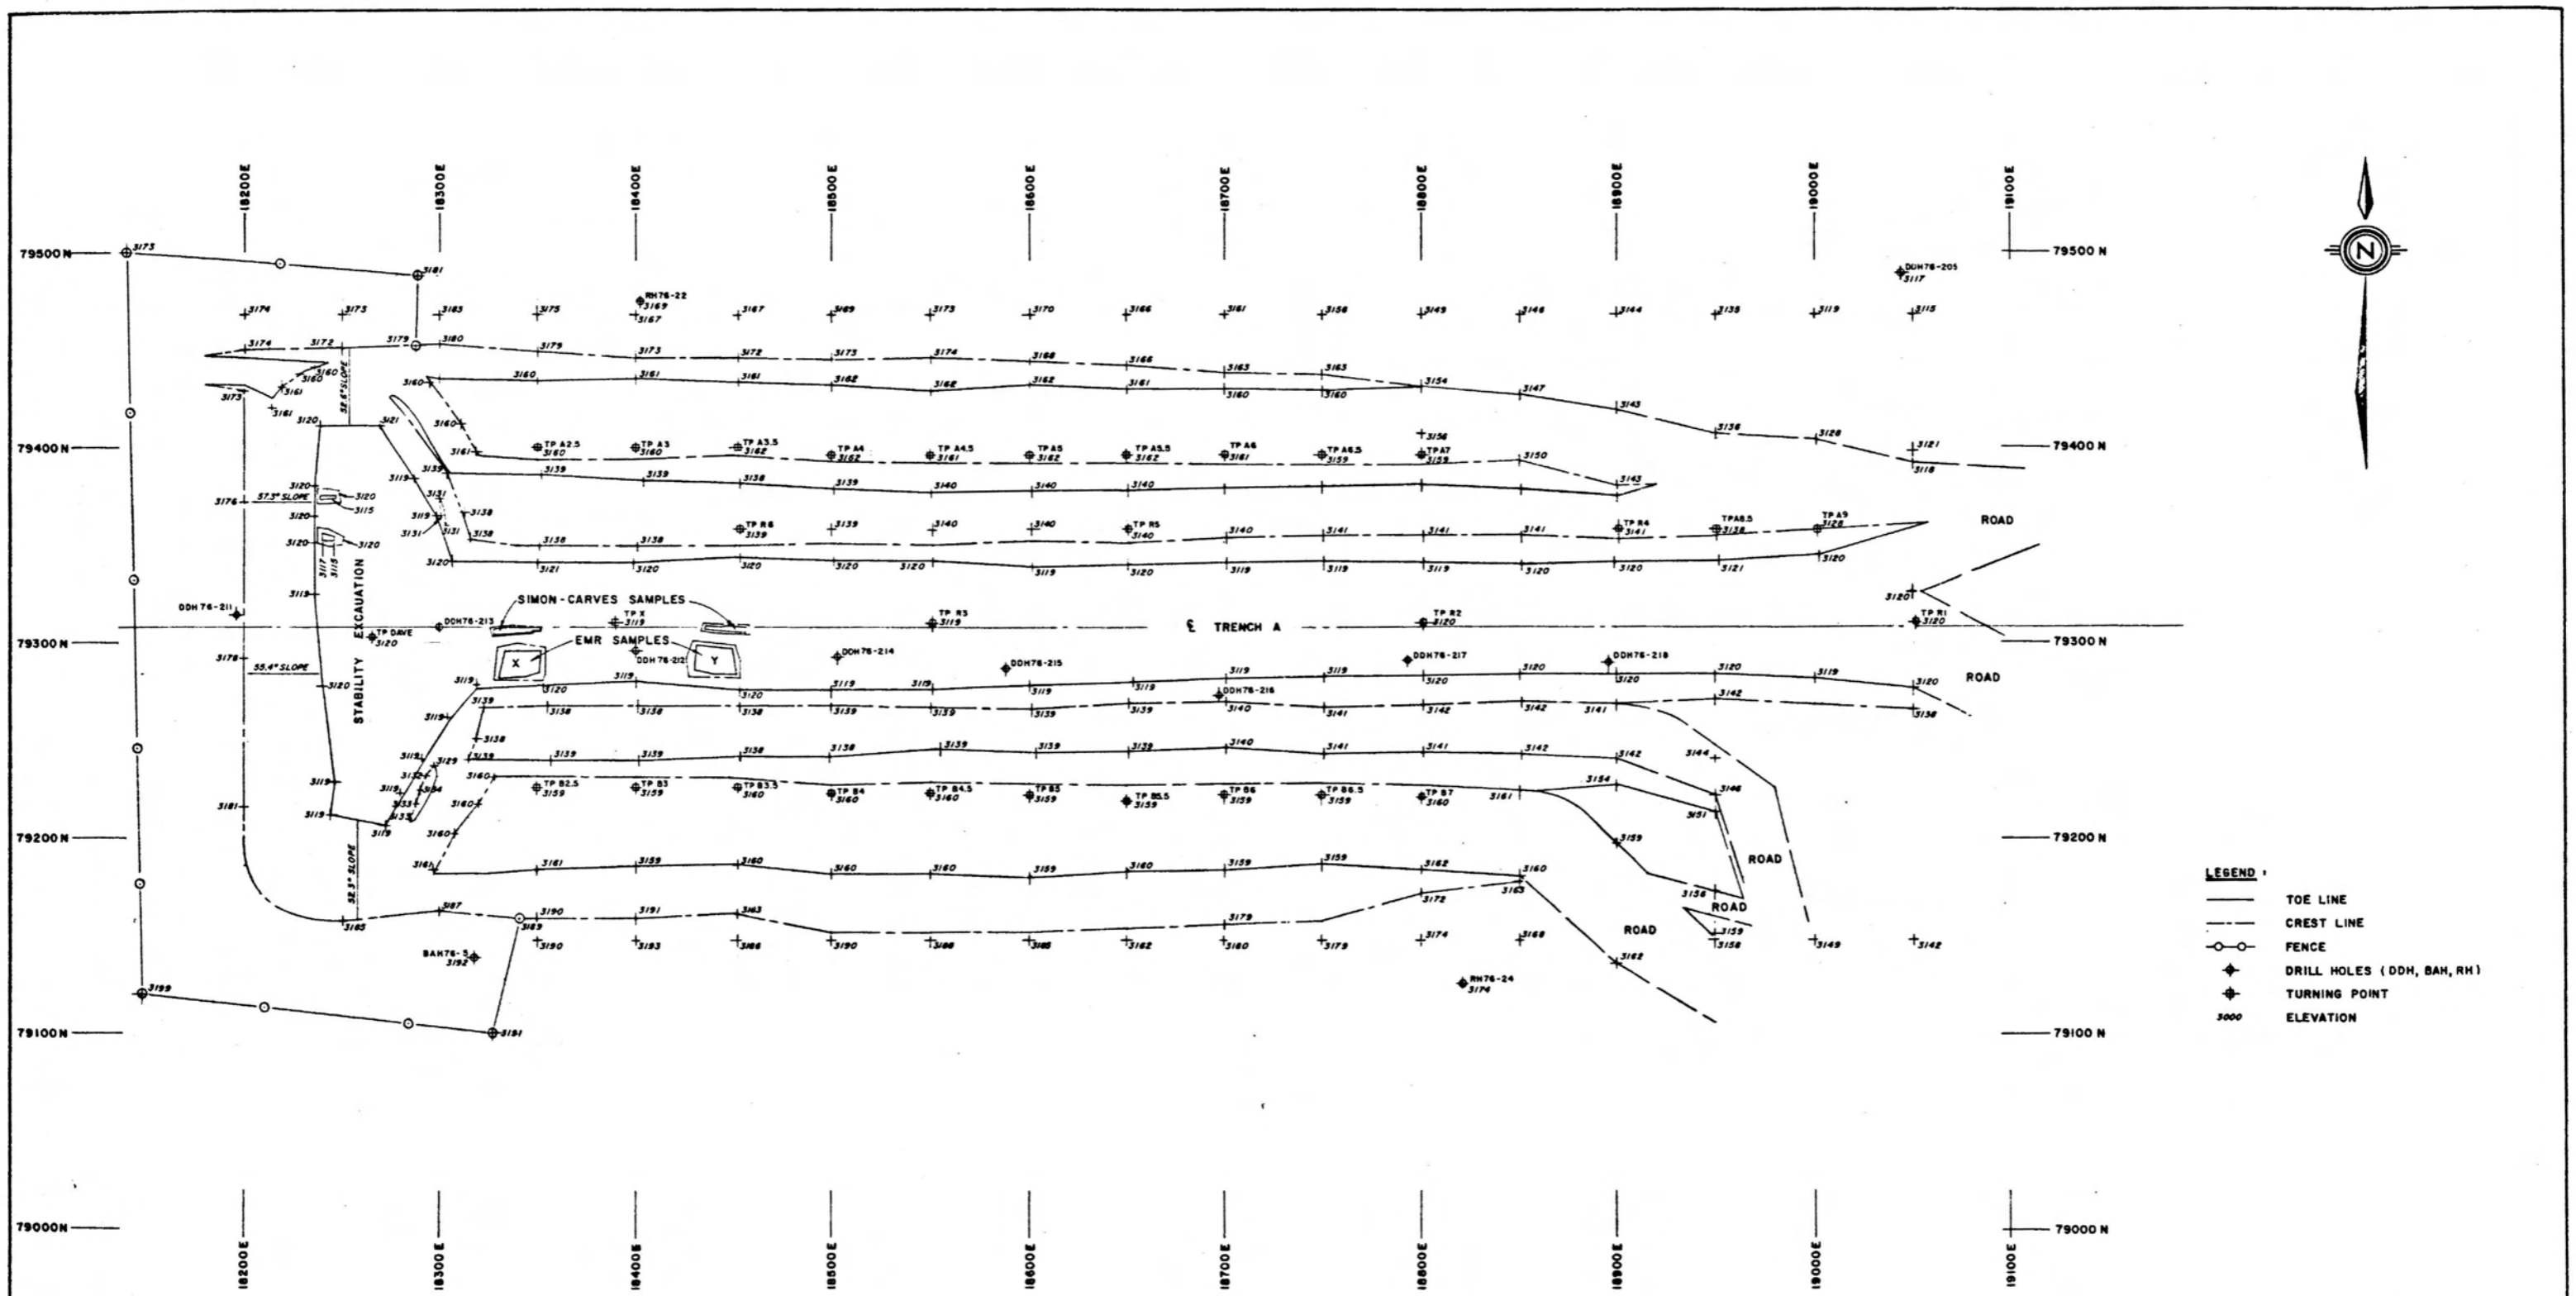
REVISION	DATE	DESCRIPTION	DRWN	APPD
British Columbia Hydro and Power Authority				
HAT CREEK PROJECT				
TRENCH 'A'				
DATE NOV 29, 1977		APPROVED D.F.		FIG No 2
DRAWN P.W.		DESIGNED

Trench A was excavated parallel to Section P at holes 211 to 218 and 190 (refer to Fig. 2) in the burnt zone and coal of A and/or B zones. The materials and pit were dry as the excavation was above the water table.

The trench, excluding the extension for slope stability, was a maximum of 274 m long, 90 m wide and 24 m deep. The excavation consisted of removing the surficial and coaly waste materials down to the 3160 level, then two 20 foot benches in the burnt zone and coal down to the 3120 level. Berms were left on the 3160 and 3140 benches; the walls on each bench were sloped to 60°. Four dumps were established, three for

overburden and burnt zone material and one for the coaly waste. The overburden dumps were terraced on the slope of the hillside east of the trench to approximately coincide with the bench levels in the pit such that minimum grades were maintained on the haul roads.

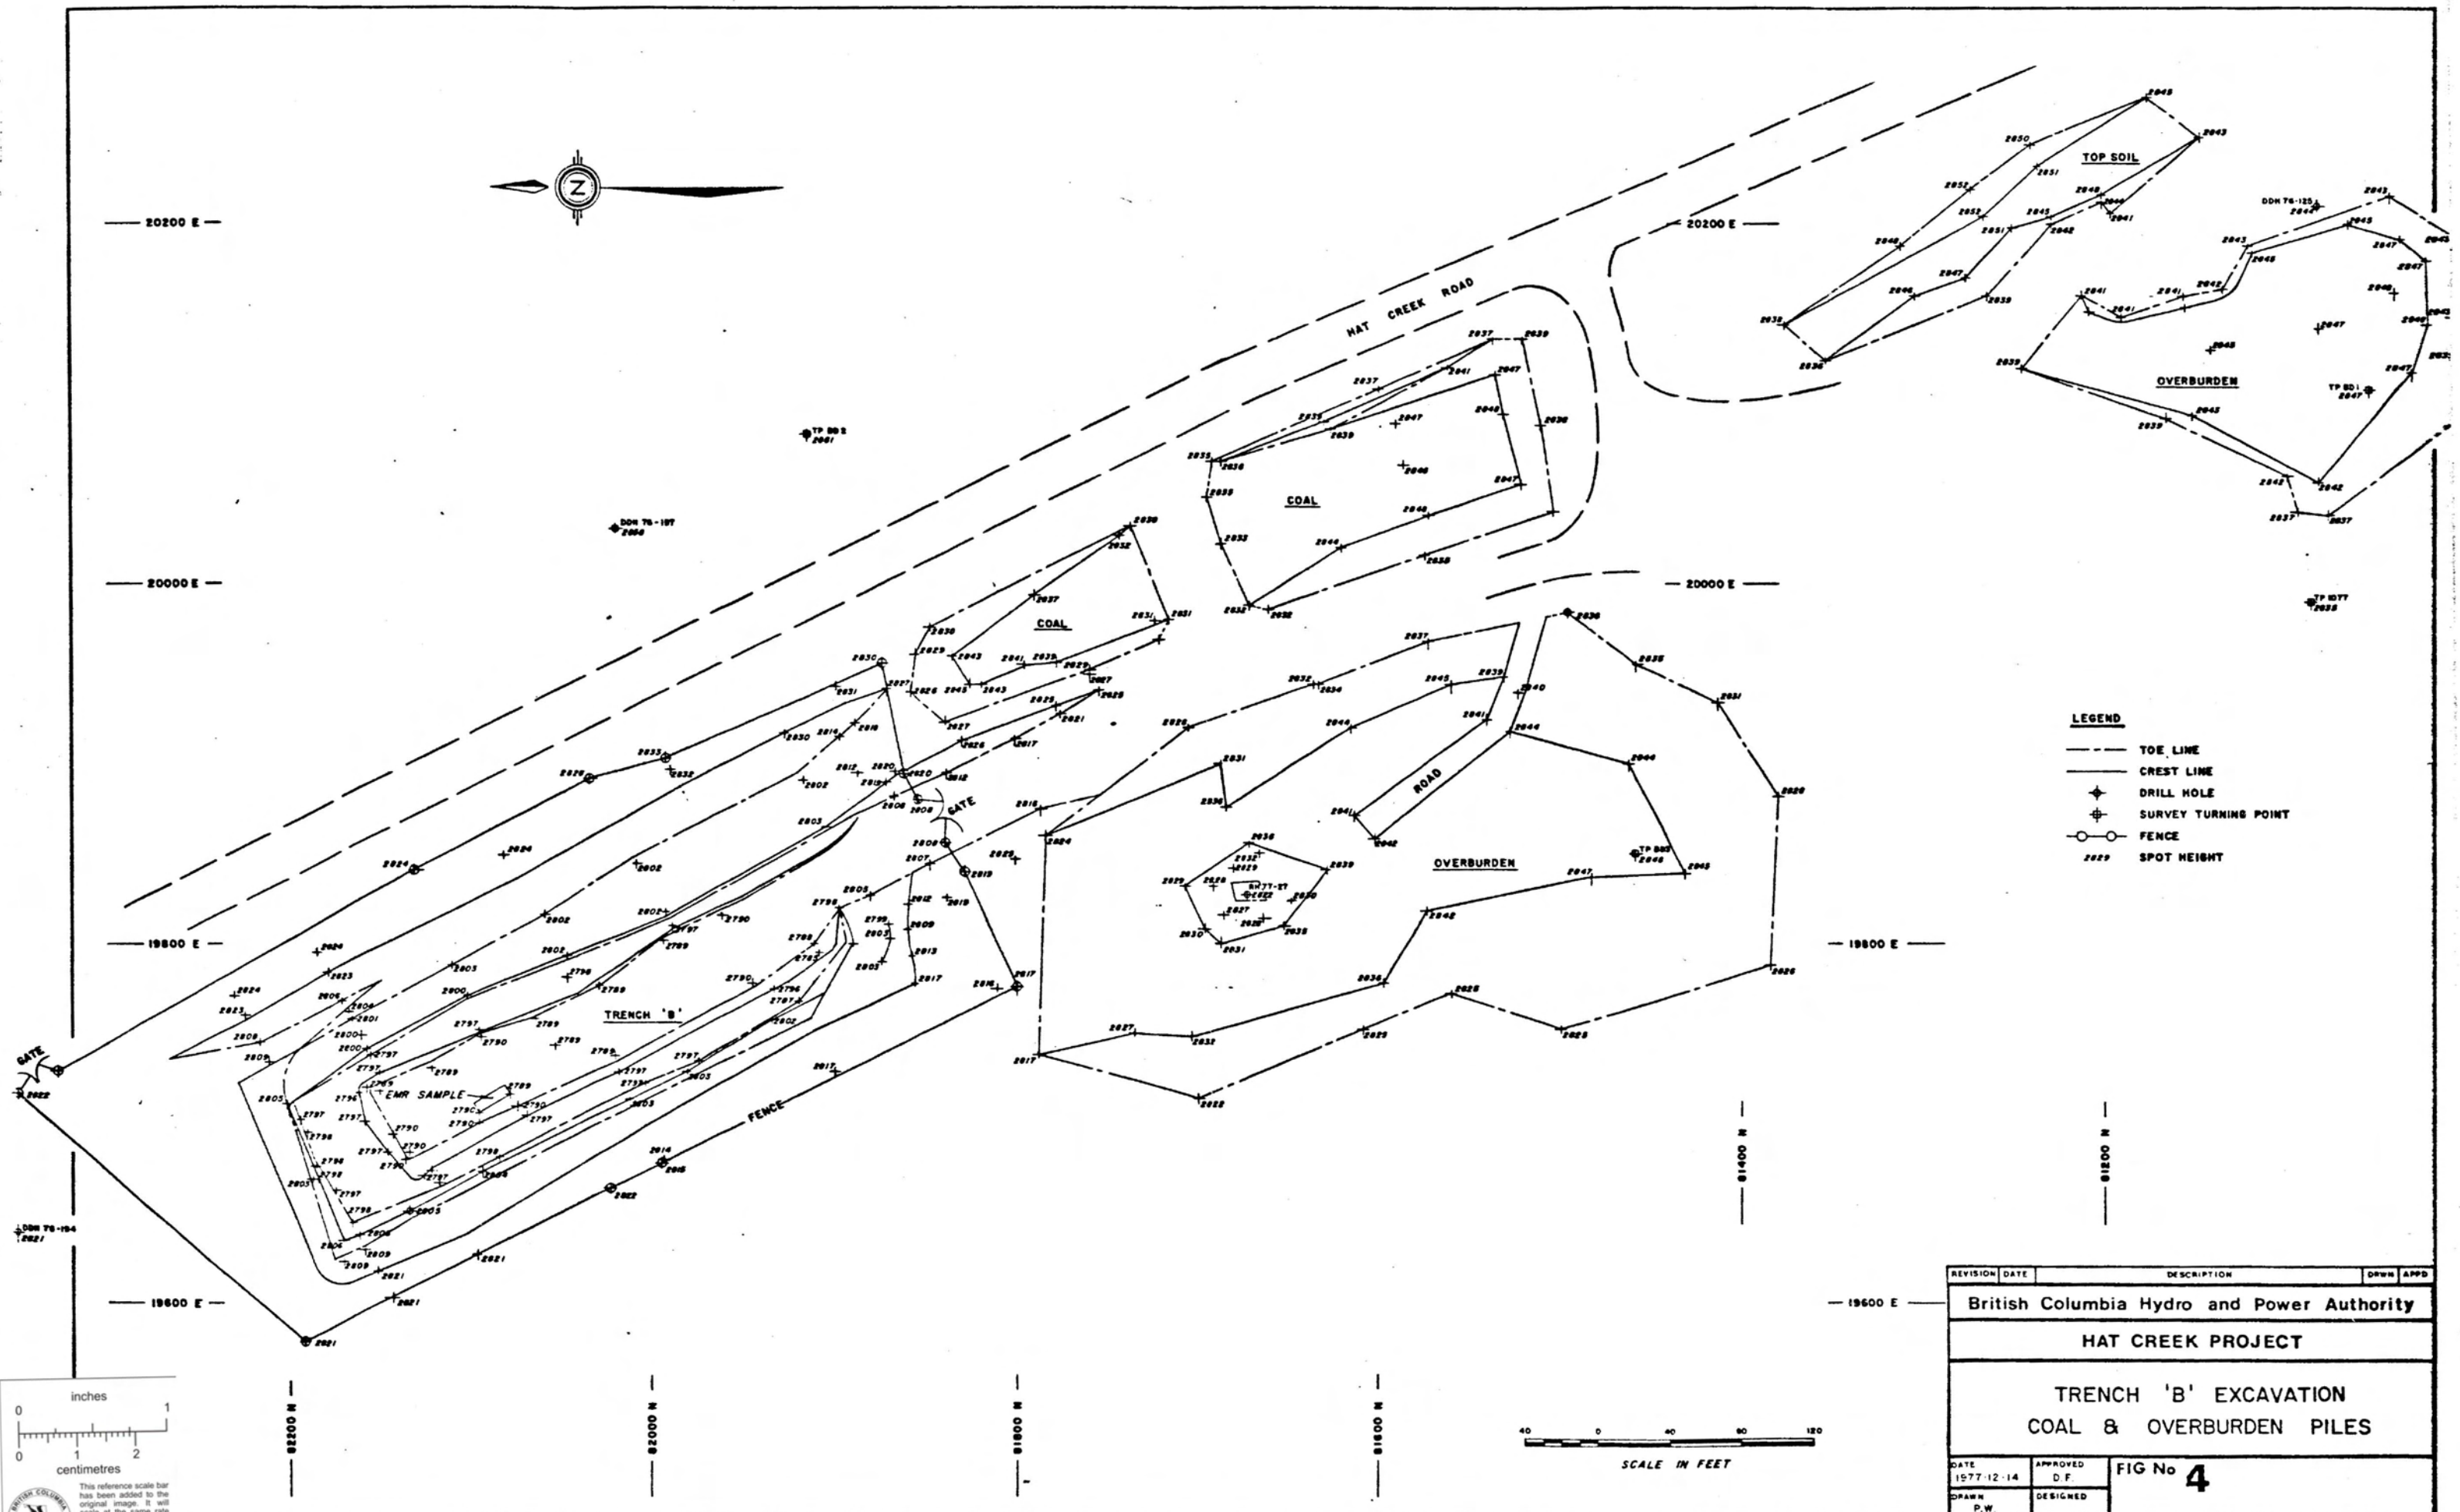
A plan of the final pit and dump locations is shown on Fig. 4; it varied from the original in that the lower bench was moved approximately 3 to 4.5 m off center to take advantage of the additional coal on the west side of the pit. The excavation consisted of an

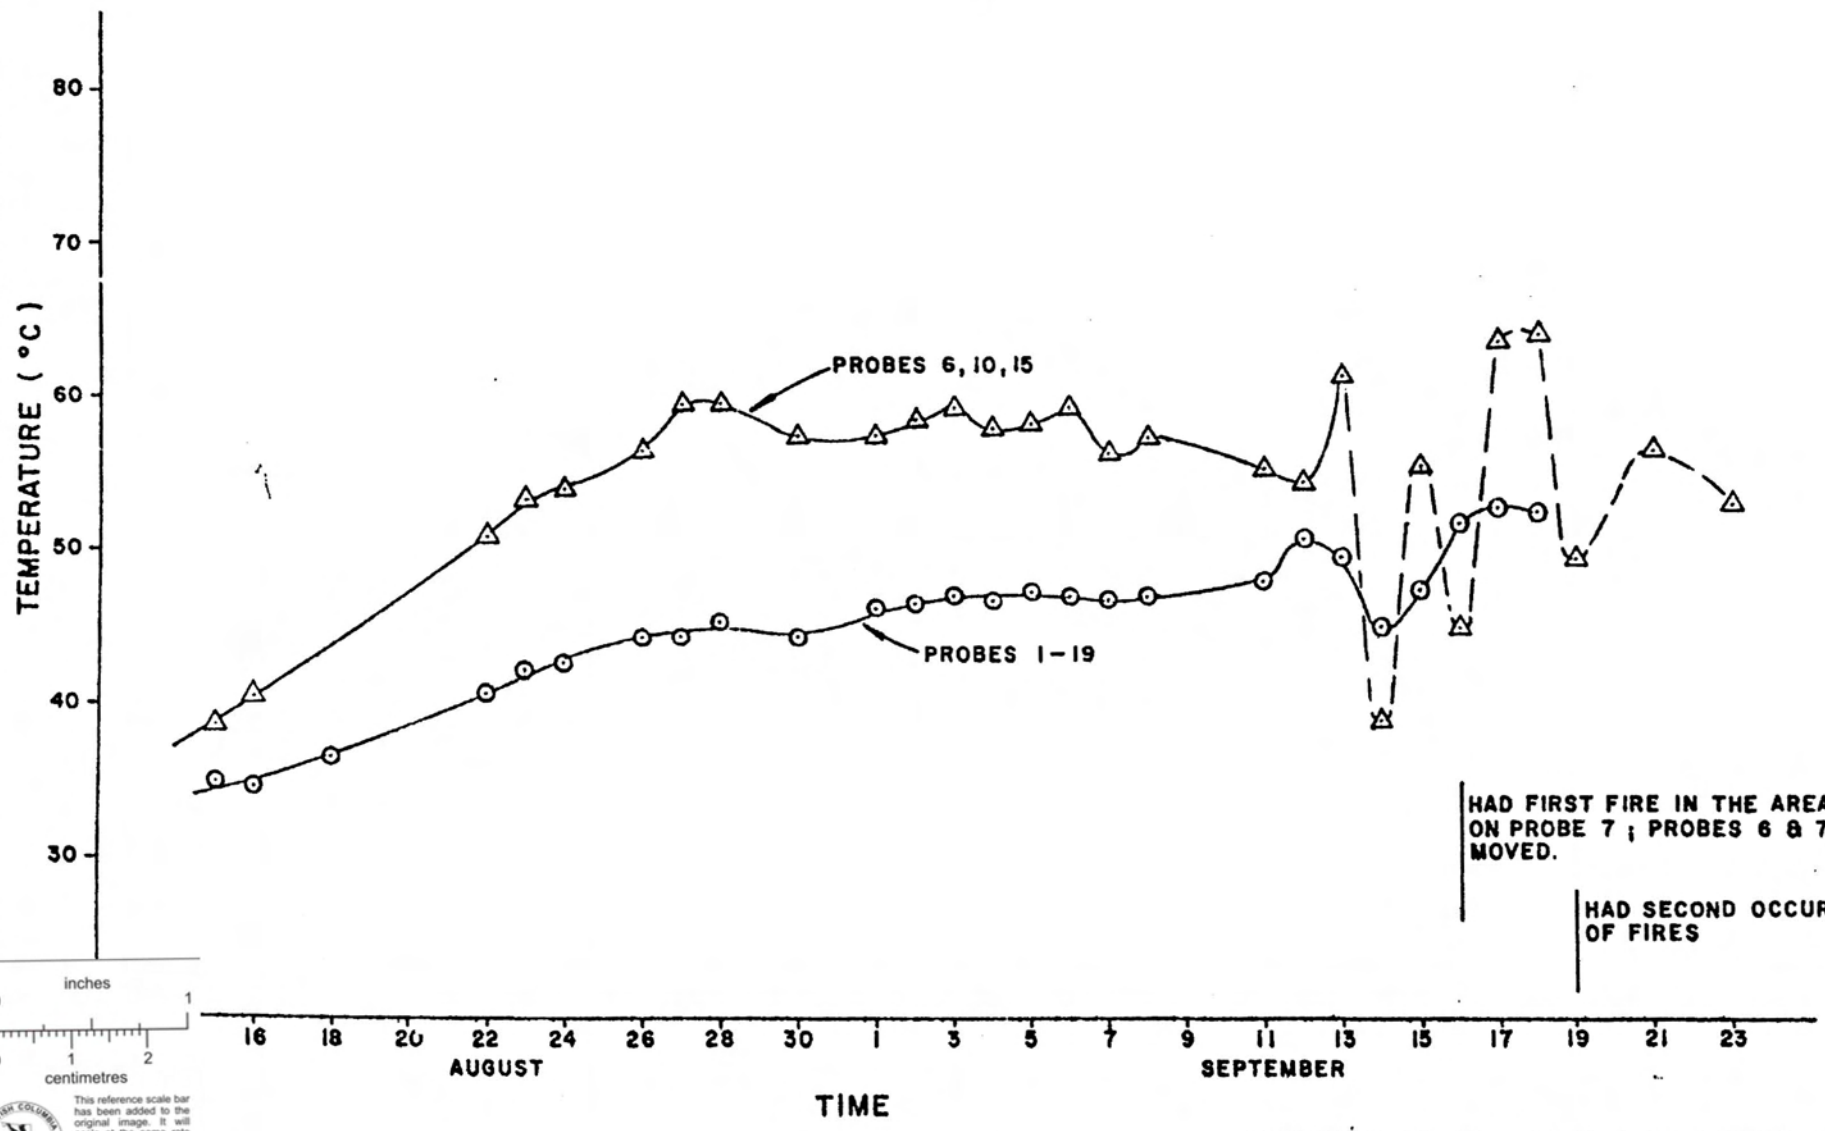
Figure 6
TEMPERATURE RISE Vs TIME
TRENCH A CRUSHED LOOSE PILE

HAD FIRST FIRE IN THE AREA
ON PROBE 7 ; PROBES 6 & 7
MOVED.

HAD SECOND OCCURANCE
OF FIRES

the crushed coal test piles, the compacted test piles and the low grade pile (in a local area where the heat build-up was observed and monitored). The graphs for the crushed loose piles show a rapid temperature rise during the first 2 weeks with a levelling off for approximately 2 weeks before fires started occurring. The reason for this levelling off is not known at the present time although the weather may have had some influence as there was a rainy, cooler period coinciding with the levelling off in temperature rise. This same phenomenon also occurred in the low grade pile but here was only a brief period of rain when the area monitored in the stockpile had reached the 70 to 75°C range. The heating was not detected in this zone until after the period of rapid temperature rise.

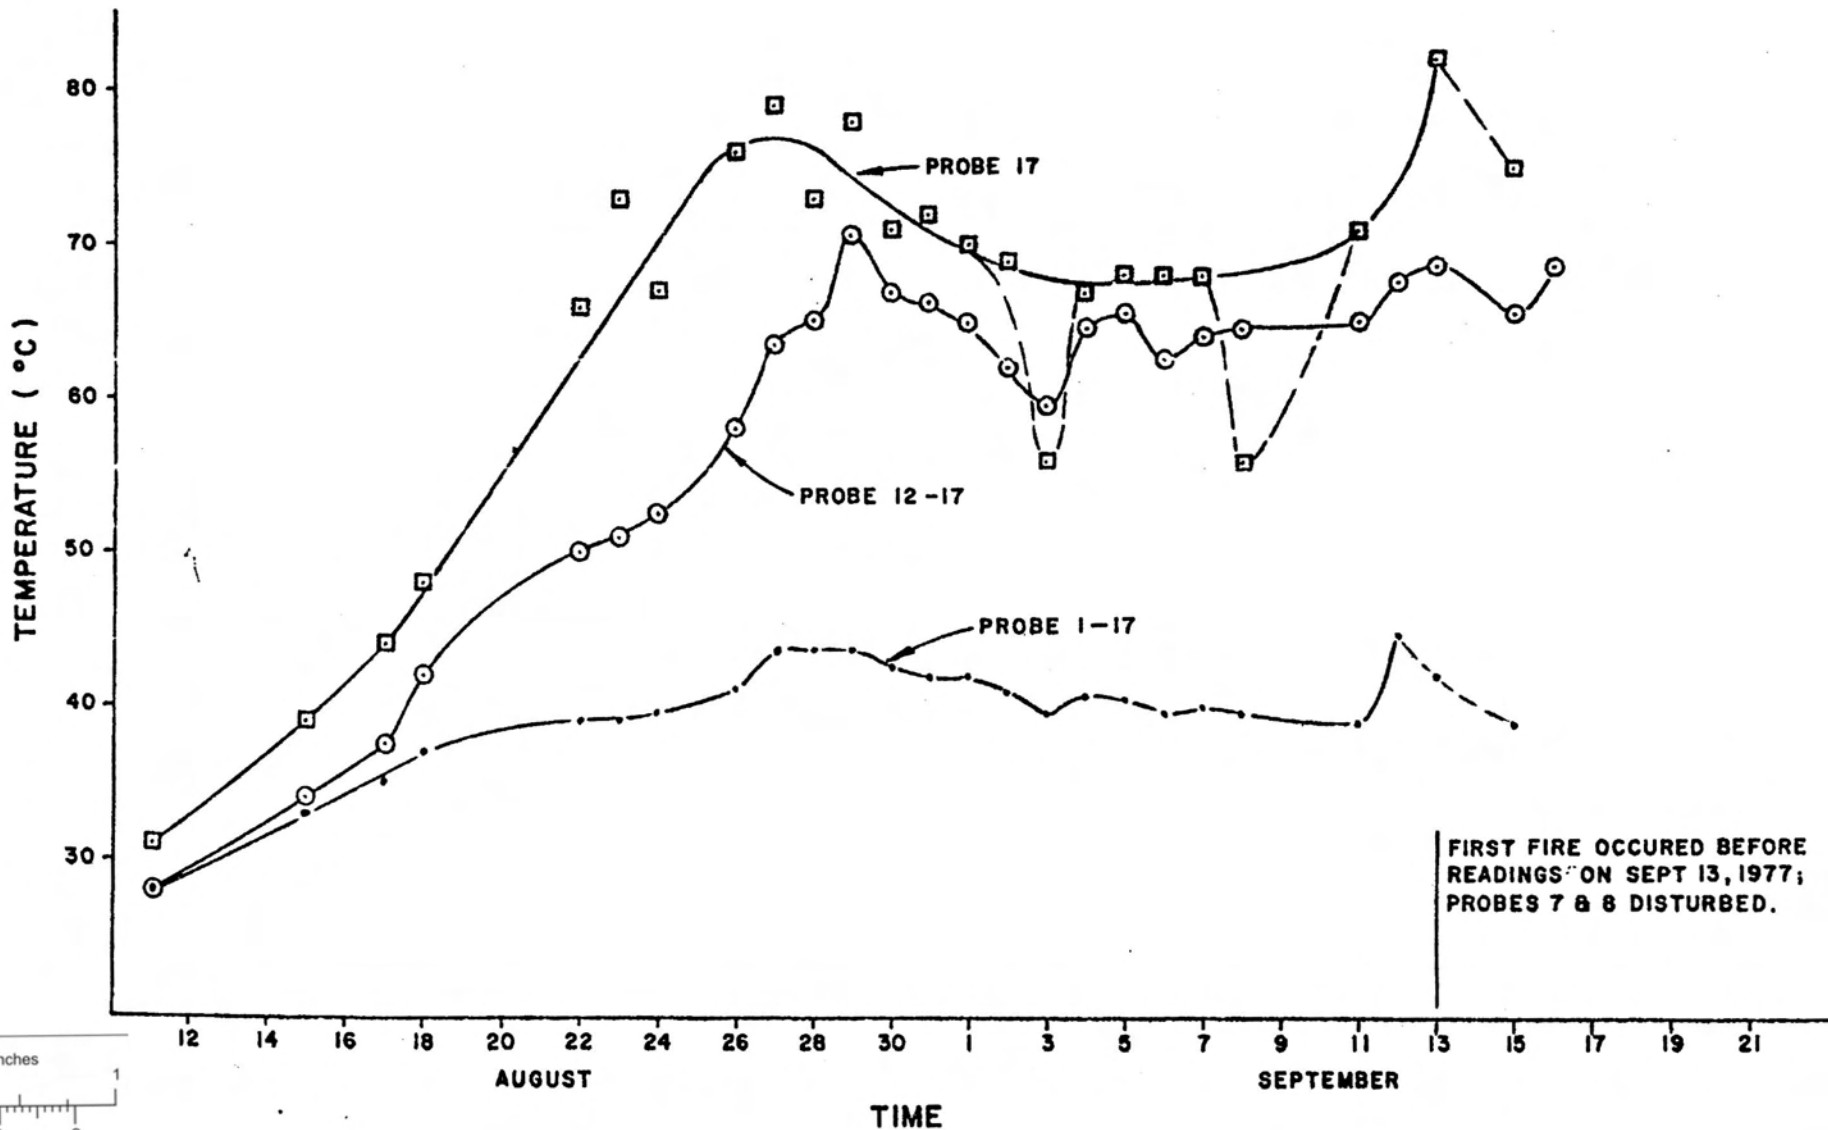
Figure 7
 TEMPERATURE RISE Vs TIME
 TRENCH B CRUSHED LOOSE PILE

FIRST FIRE OCCURED BEFORE READINGS ON SEPT 13, 1977; PROBES 7 & 8 DISTURBED.

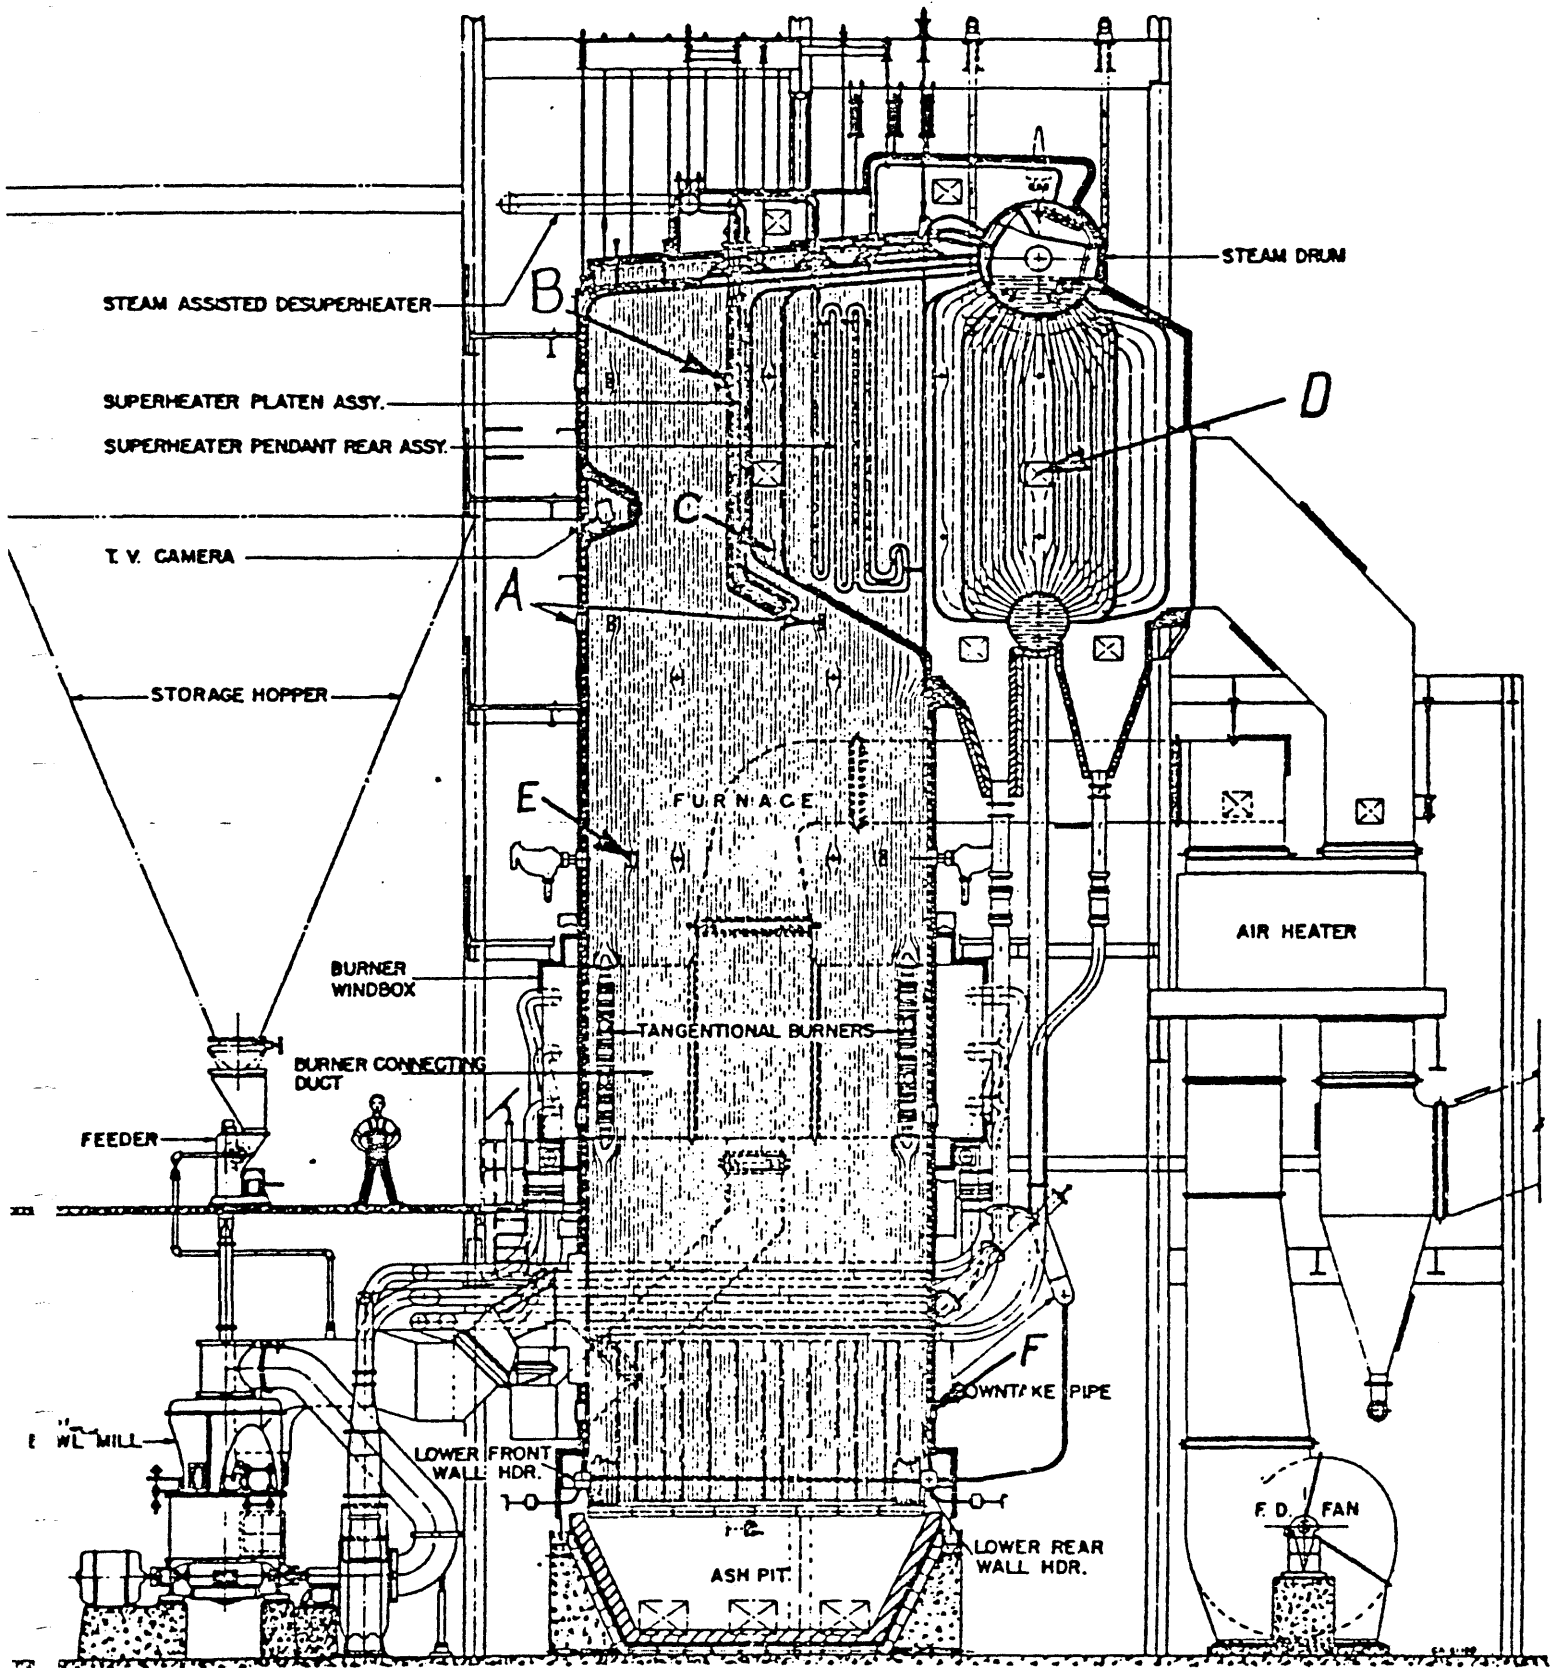
FIG. 11 - BATTLE RIVER BOILER - GENERAL ARRANGEMENT

Nominal rating	32 MW (Brown Boveri non-reheat)
Maximum continuous rated steam flow	172 350 kg/hr (Combustion-Engineering blr)
Furnace Width	6.5 m
Furnace Depth	5.6 m
Furnace Plan Area	36.2 m ²
Furnace Volume	577.3 m ³
Furnace Project Area	470.3 m ²
Superheater outlet pressure	4300 kPa (625 psi)
Superheater outlet temperature	400 ⁰ C (825 ⁰ F)
Number and type of pulverizers	3 Raymond Bowl
Number of burners	3 levels of 4
Firing type	corner-tangential

A, B, C, D, E and F = ASH DEPOSIT PROBE LOCATIONS.

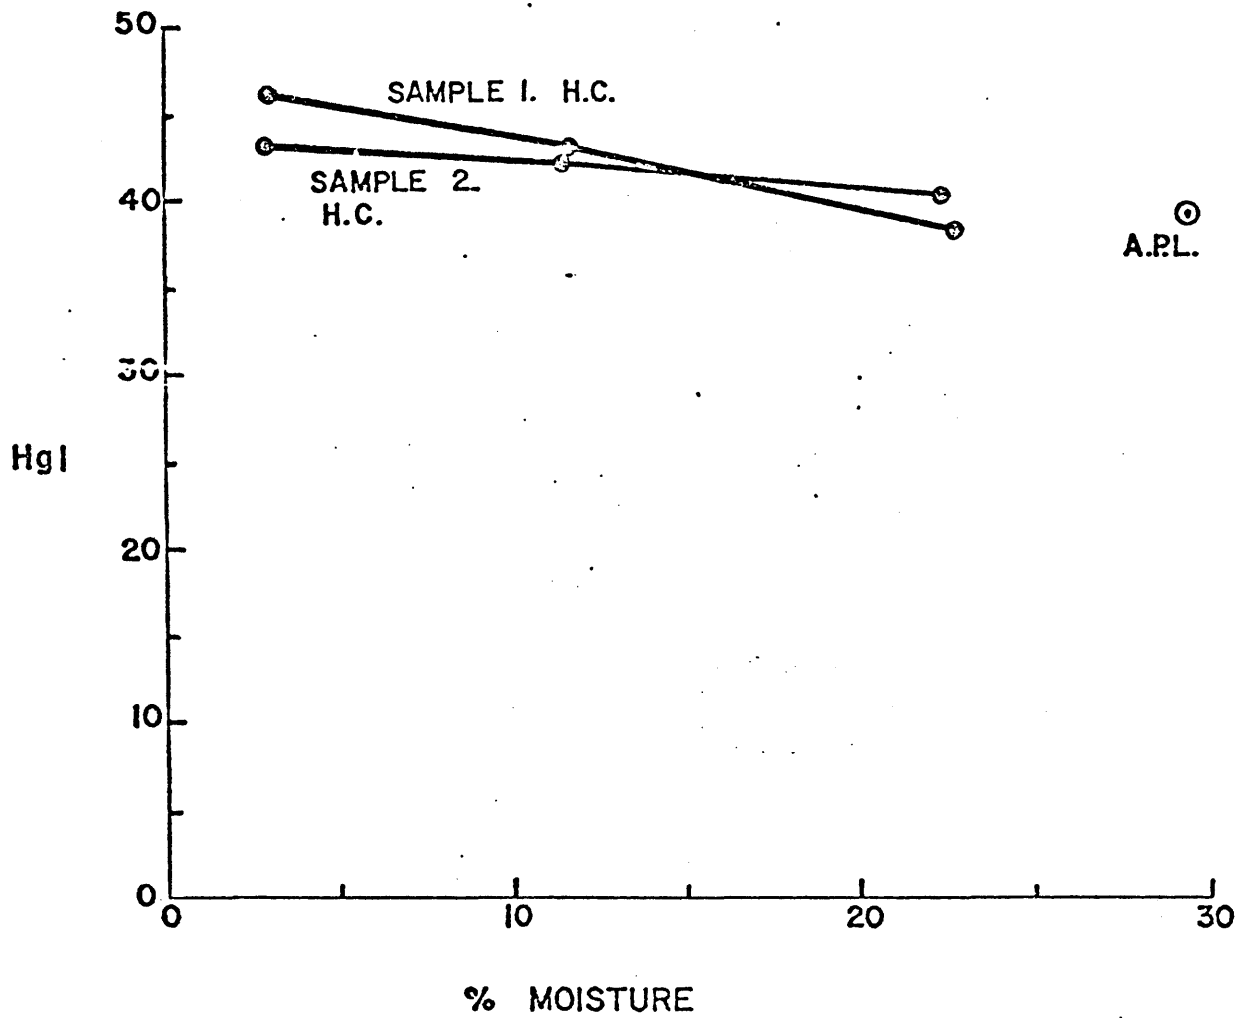
Figure 13

GRINDABILITY AND MOISTURE

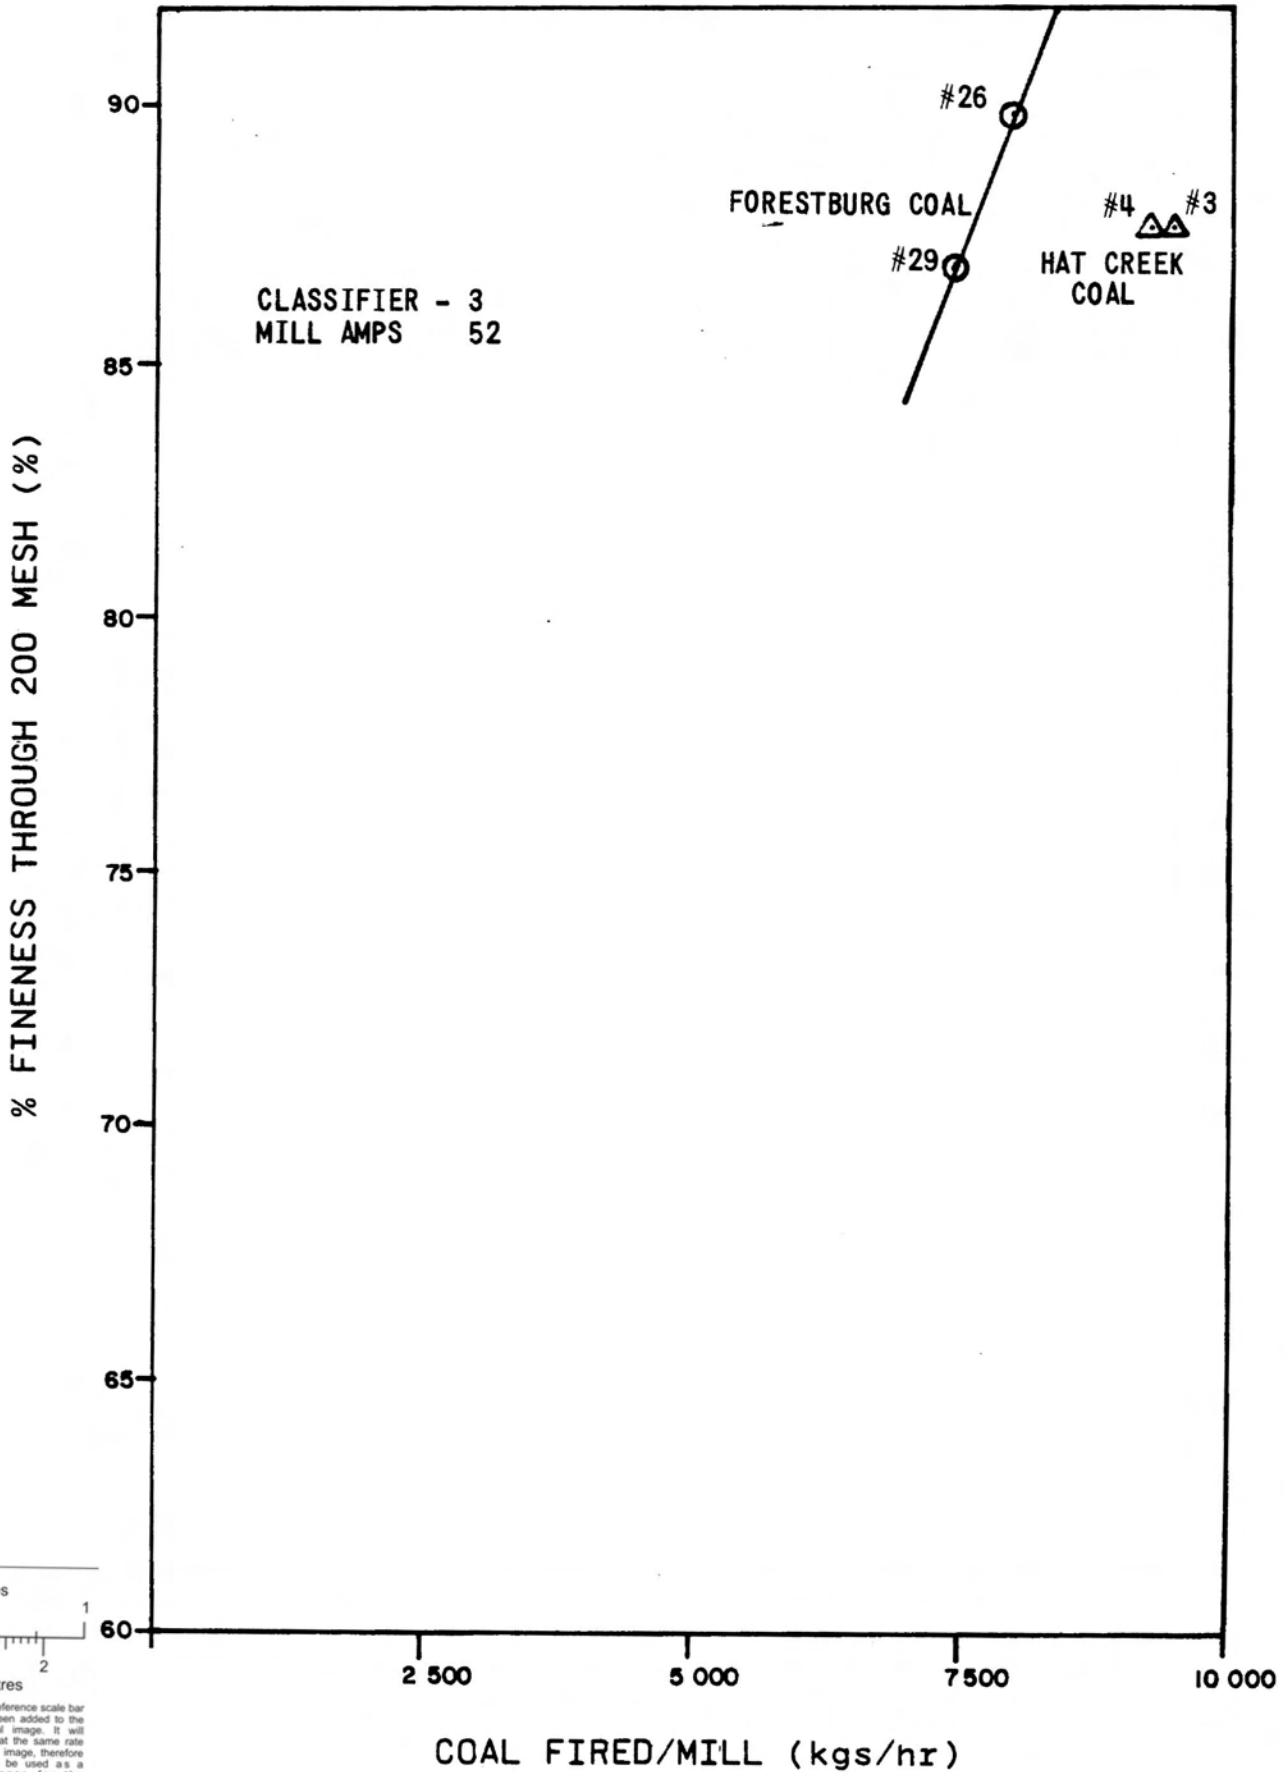
FIGURE 14

AVERAGE % FINENESS THROUGH 200 MESH
VS
AVERAGE COAL FIRED PER MILL

It was observed that at the same throughput the Battle River pulverizers produced a higher degree of fineness when utilizing Hat Creek coal as compared to APL coal. Fig. 14 compares tests 3 and 4 on Hat Creek coal, and tests 26 and 29 on Forestburg coal. At the same fineness to -200 mesh, the Hat Creek coal has a higher throughput indicating it is easier to grind. The increased capacity is approximately 25 percent at 87.5 percent through 200 mesh.
