HAT CREEK PROJECT

FINAL REPORT

BULK SAMPLE PROGRAM

AUGUST 1978

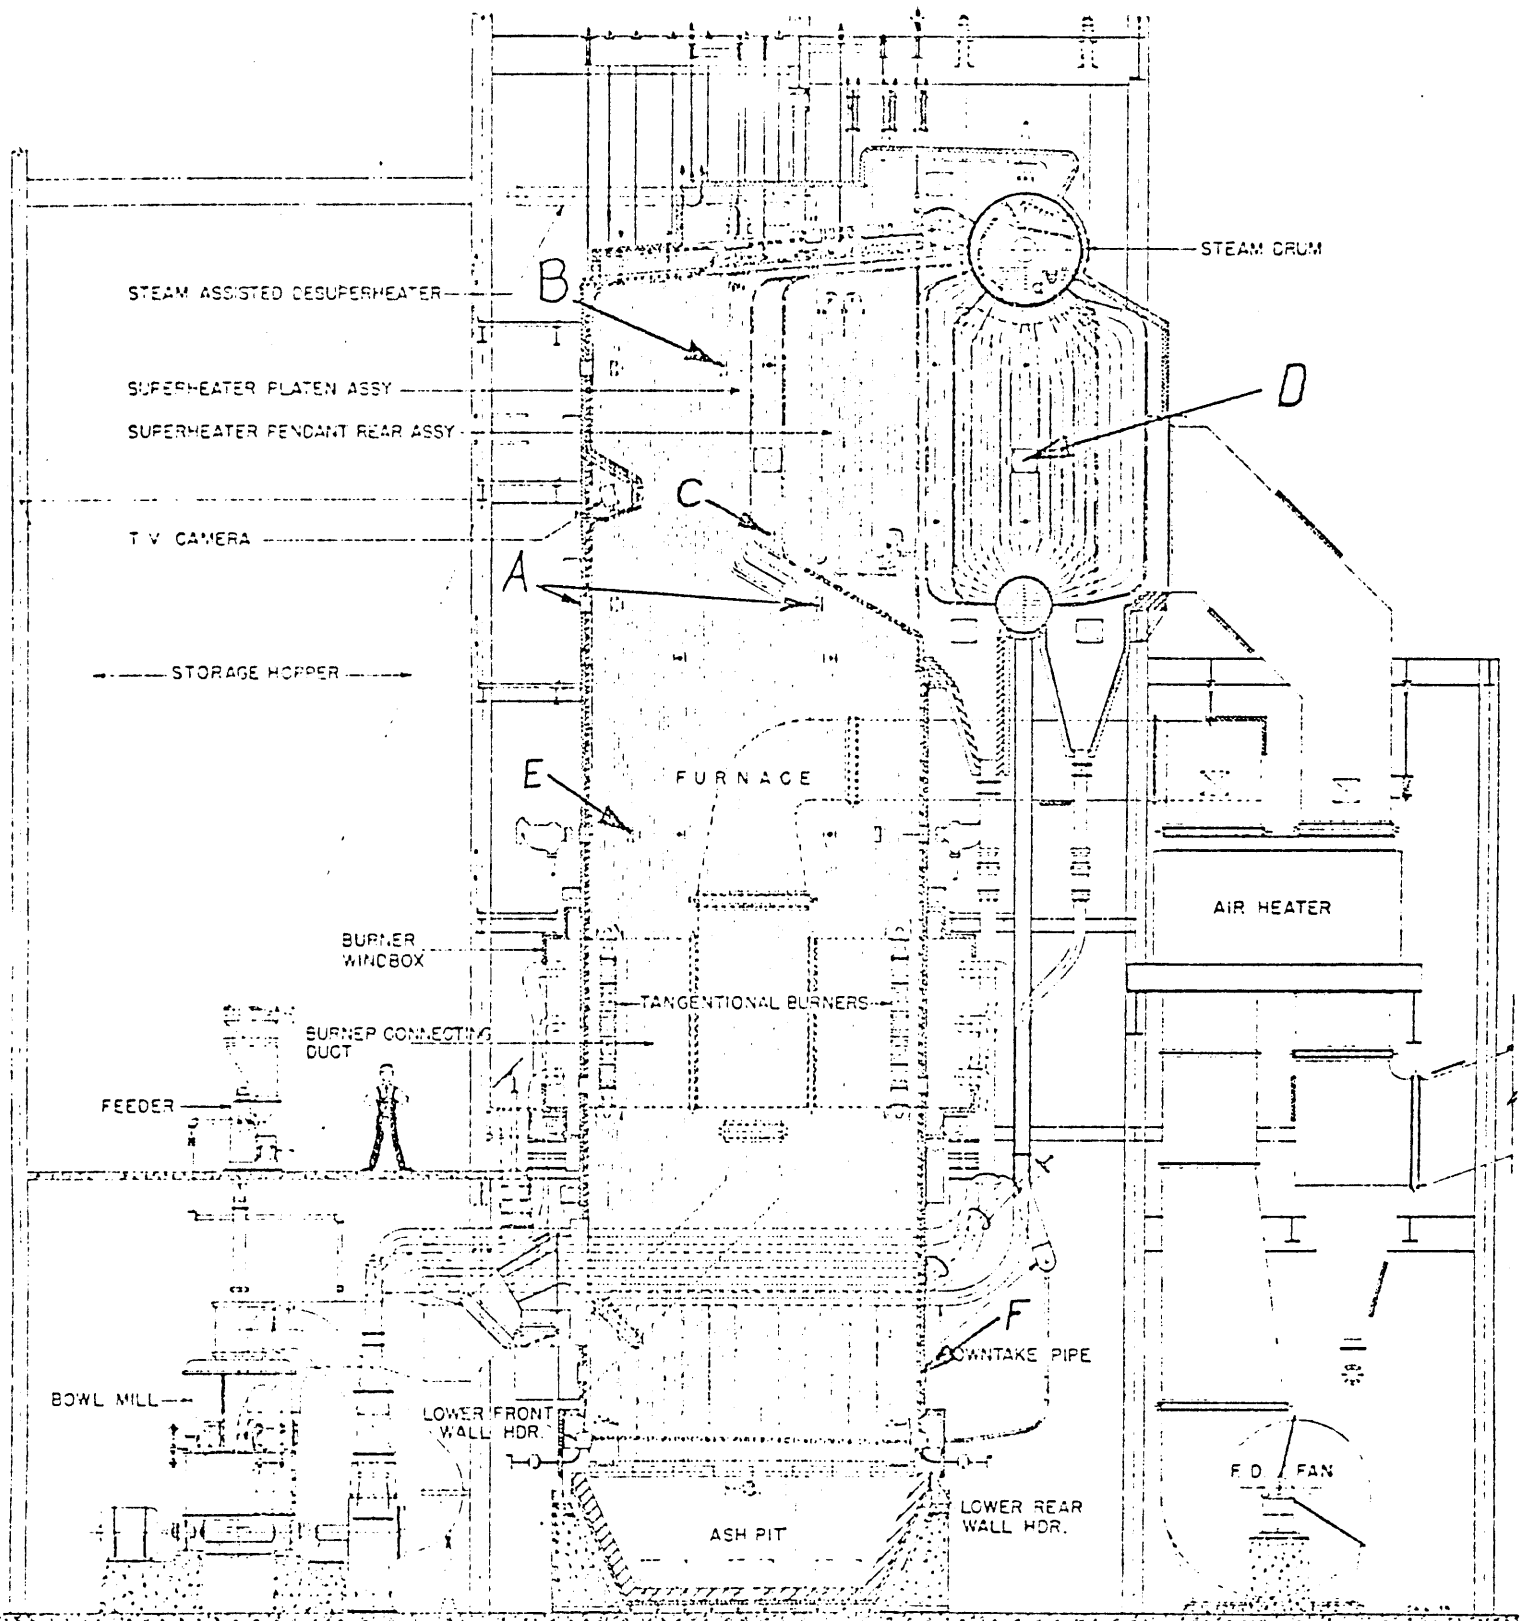
Figure 15

LOCATION OF WATER-COOLED TEMPERATURE
PROBES AND ASH DEPOSITION PROBES

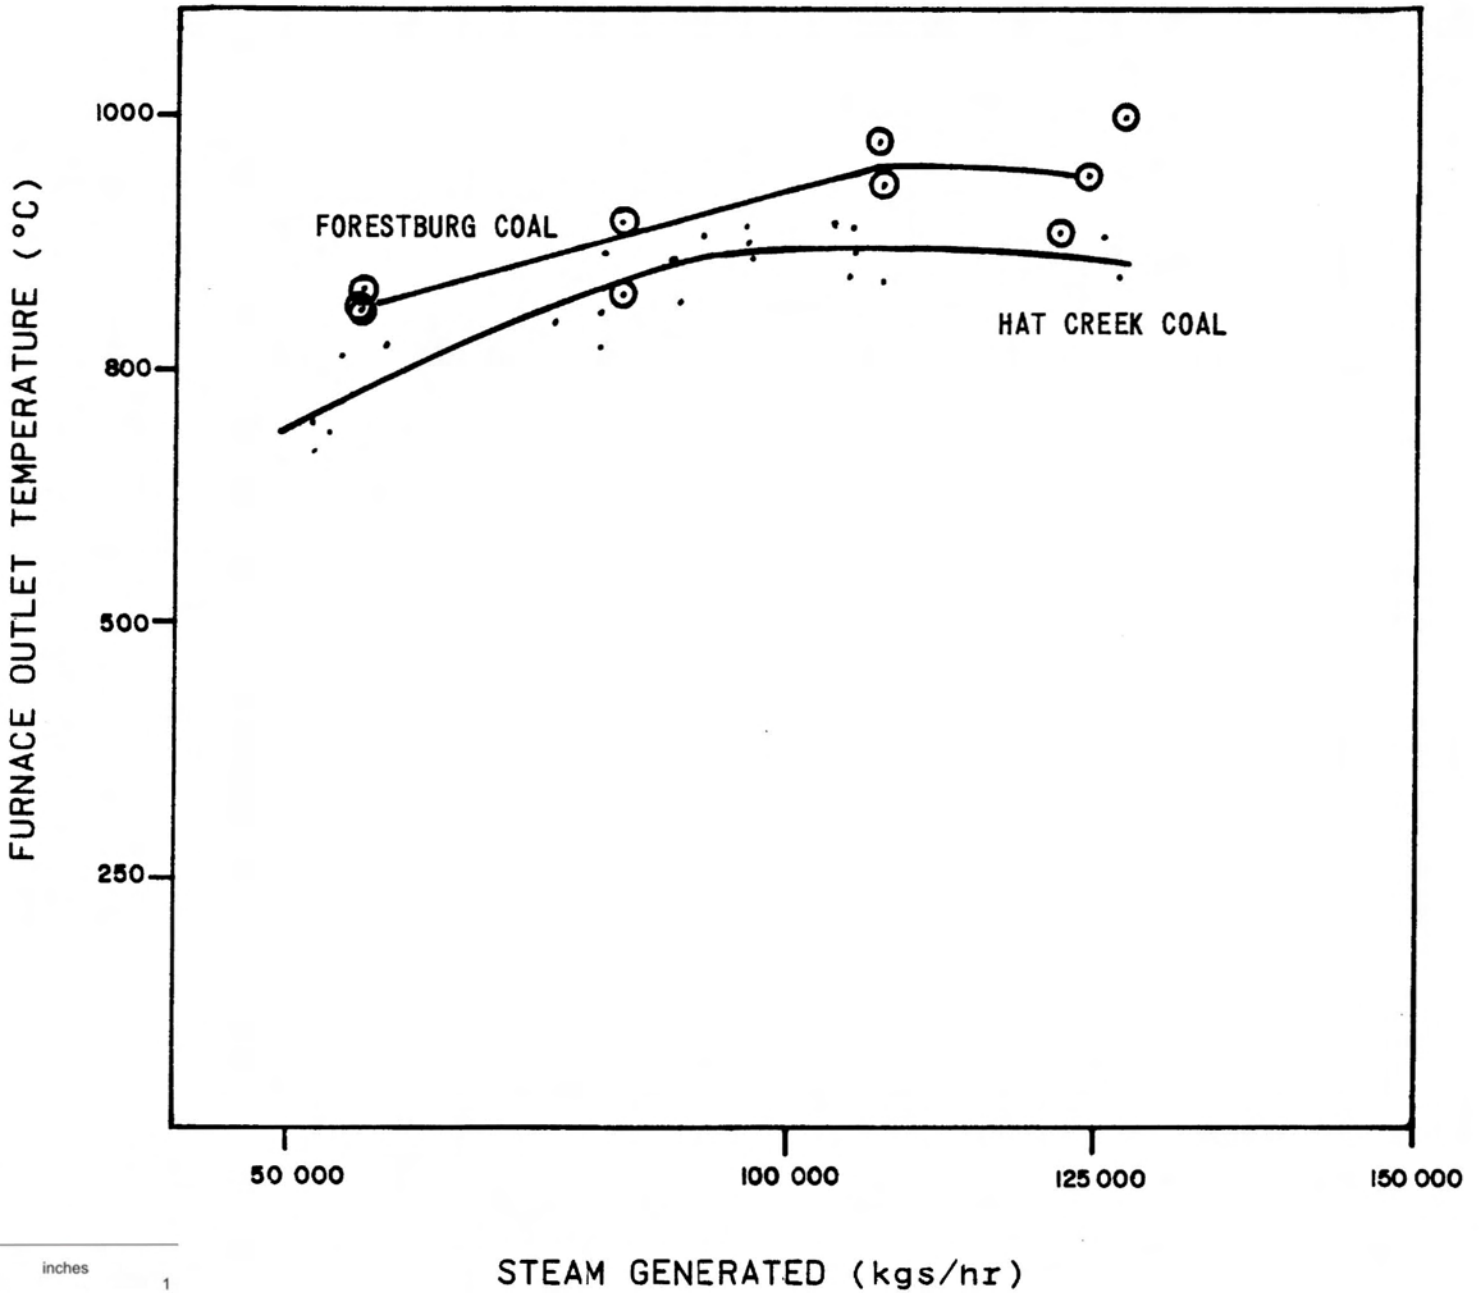
FIGURE 16

FURNACE OUTLET TEMPERATURE
BELOW SUPERHEATER NOSE
VS
STEAM GENERATED

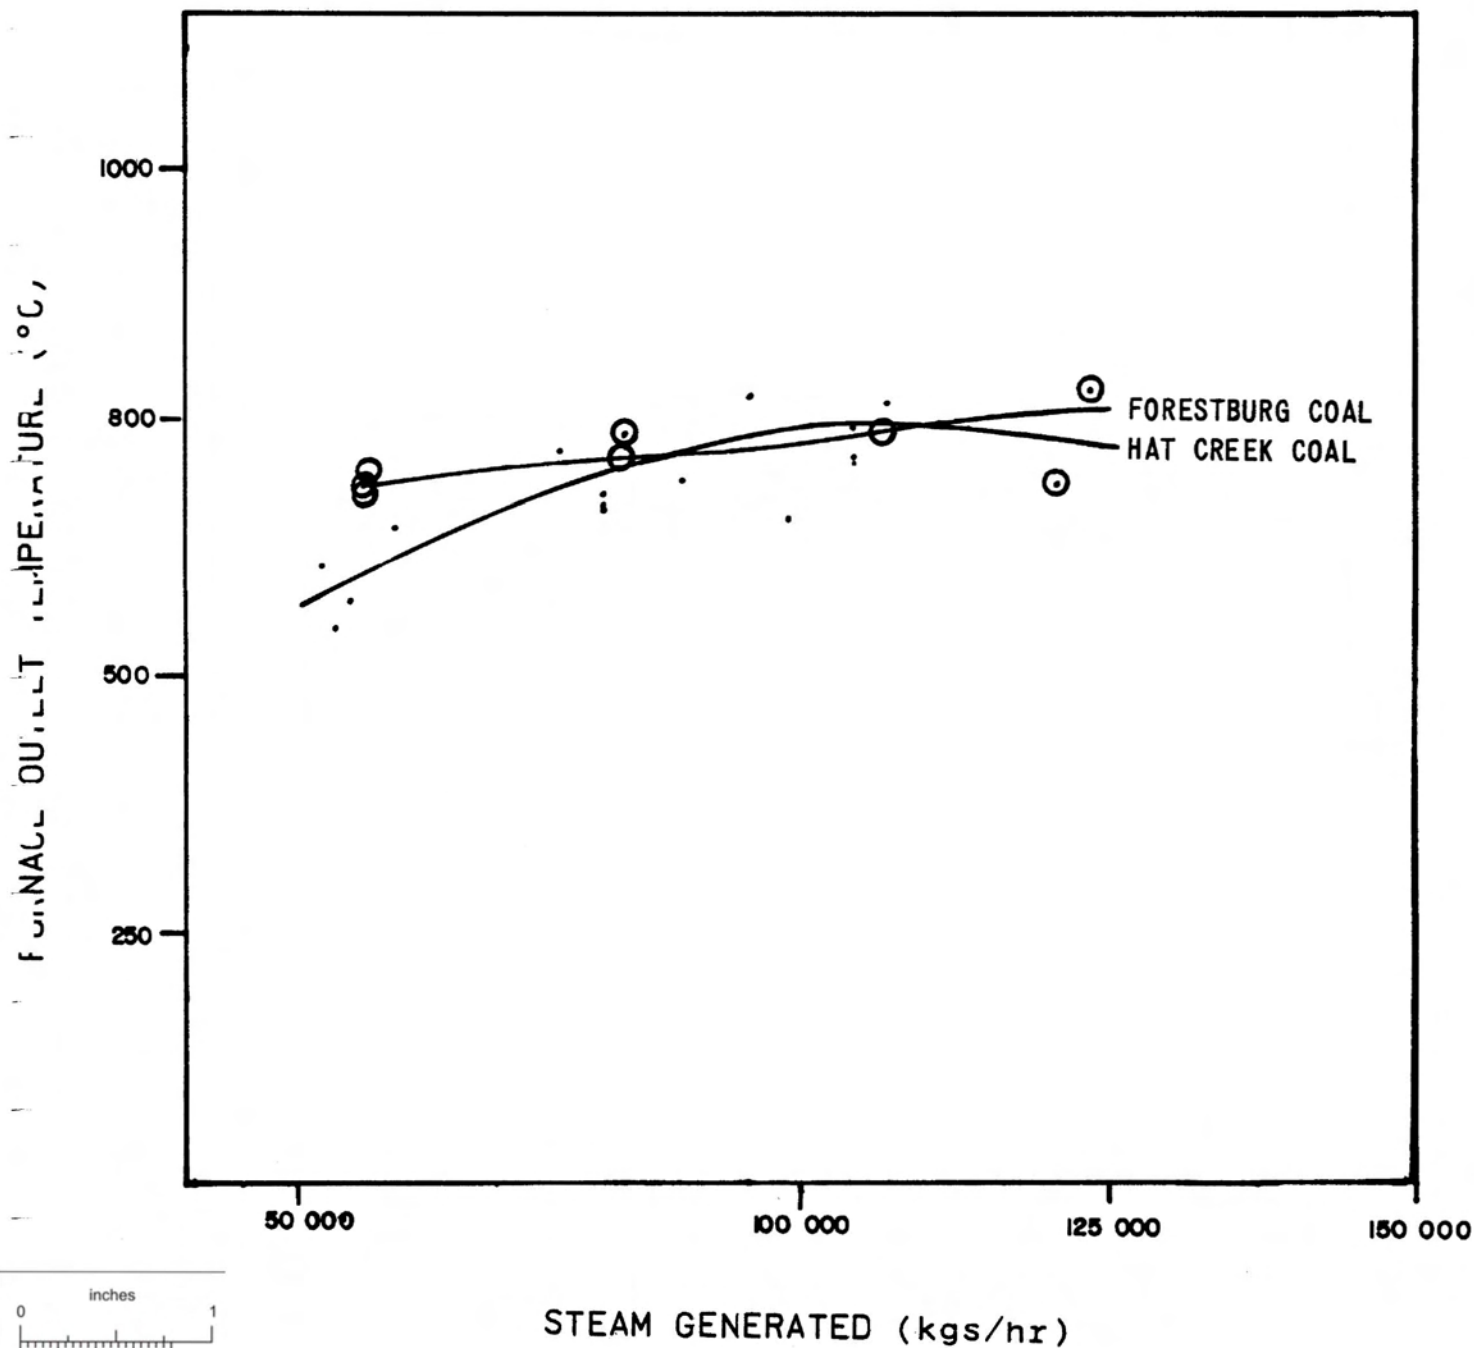
FIGURE 17

FURNACE OUTLET TEMPERATURE
ENTERING SUPERHEATER (LOCATION B)
VS
STEAM GENERATED

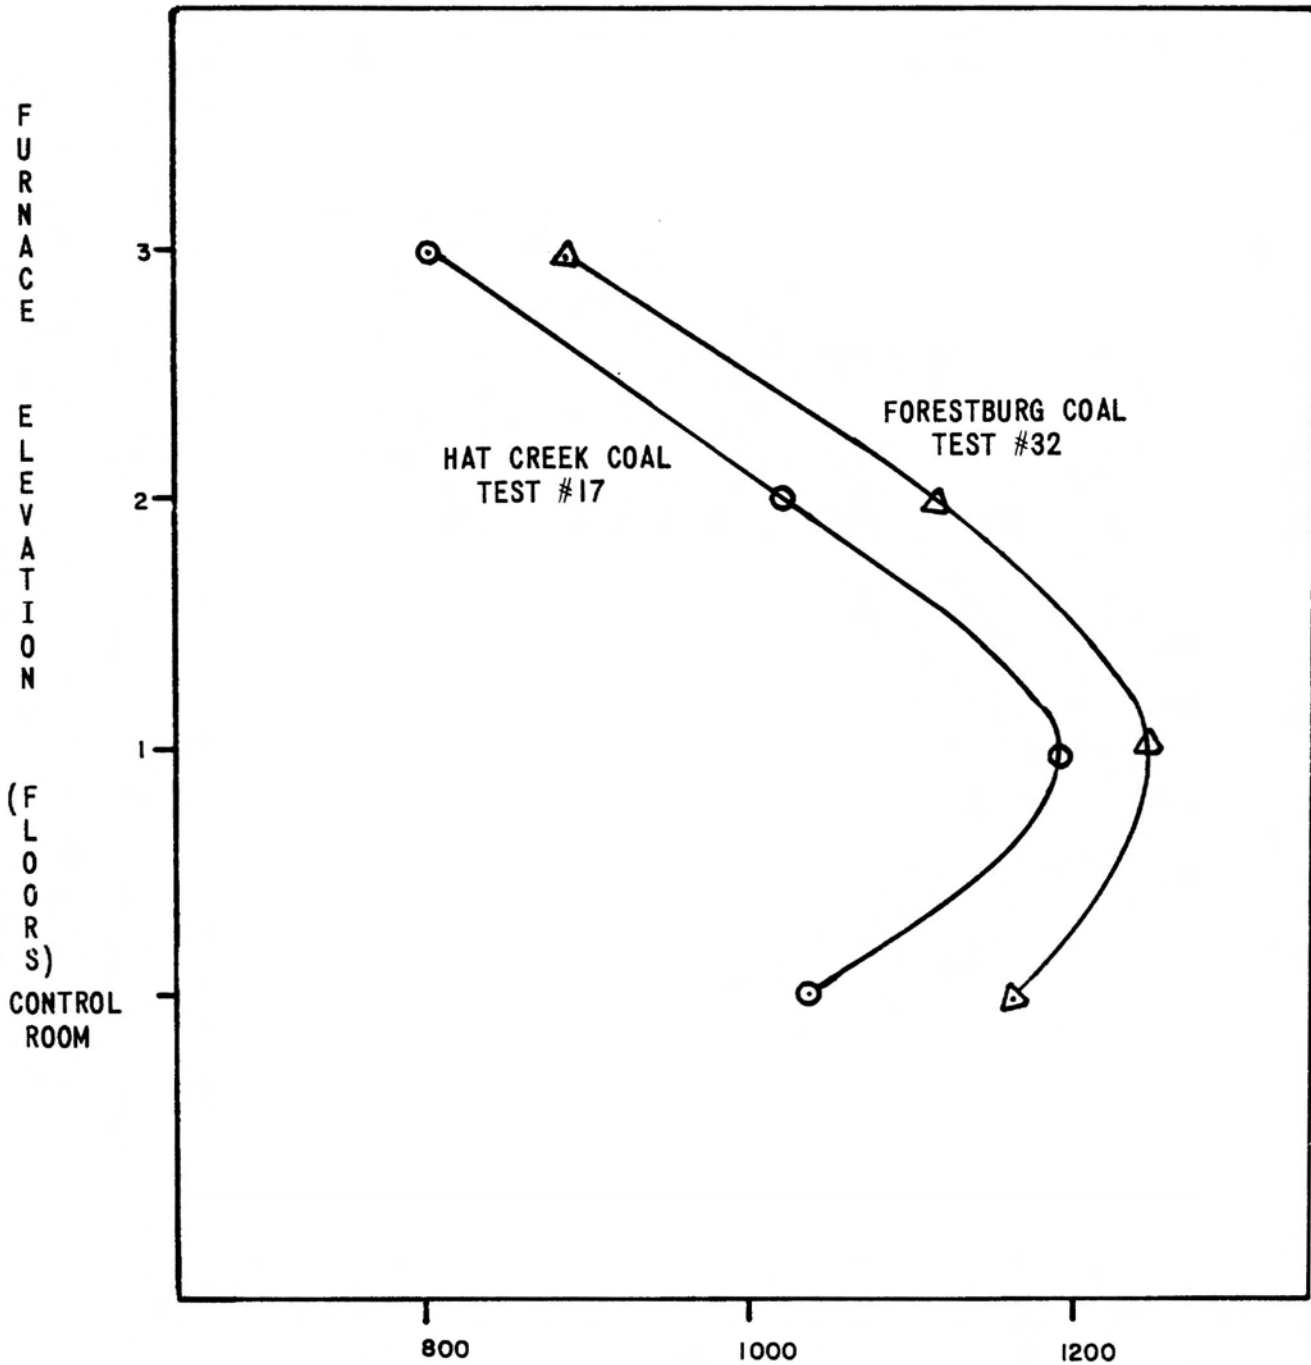
FIGURE 18

HAT CREEK PROJECT BURN TEST

AT 102,000 kgs/hr STEAM FLOW

(TEMPERATURES MEASURED WITH L&N OPTICAL PYROMETER)
