FIG. 3
COAST INTERIOR EXPLORATIONS LTD.
ASSAY PLAN
TRENCHES ON PARK #12 - M.C.
NUGGET MTN., CARIBOO DISTRICT B.C.

TO ACCOMPANY REPORT BY J.A. MITCHELL, P. ENG.

OCTOBER 1970

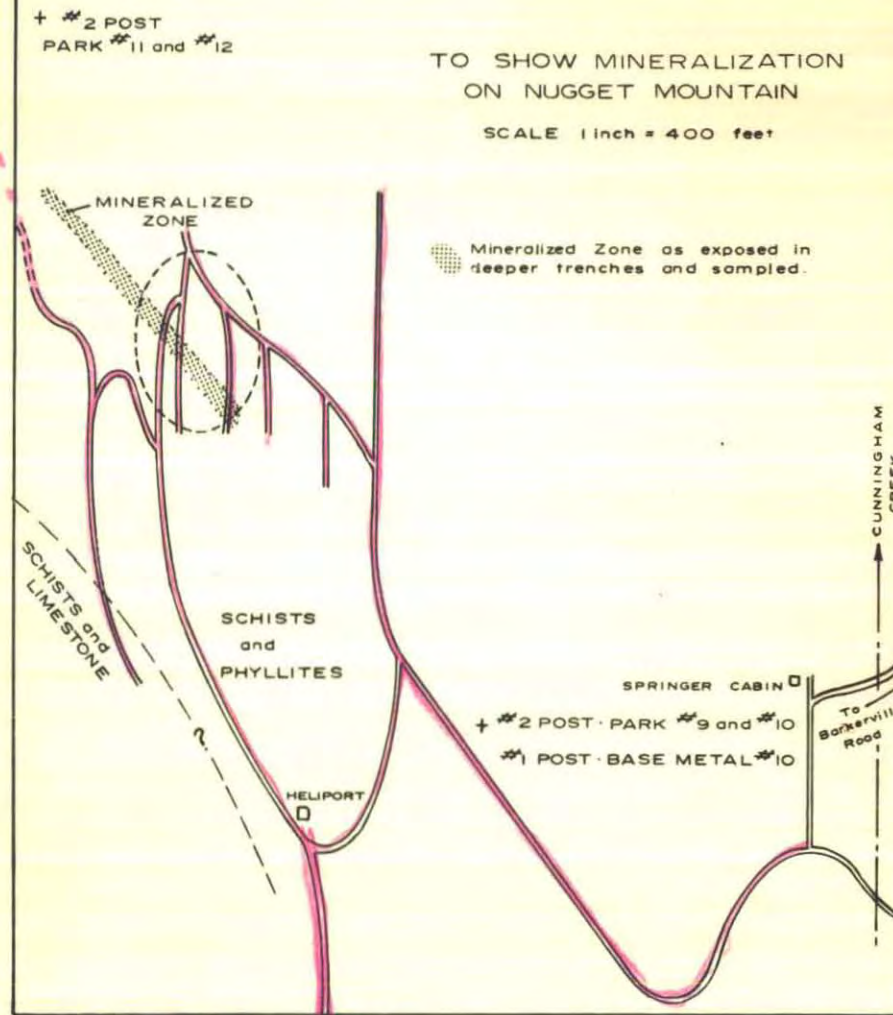
BARREN QUARTZ VEIN

TRENCH (10' DEEP)

5454 D - 32" - 0.22 - 4.7 - 10.83

5455 D - 10" - 0.06 - 3.9 - 7.38

5456 D - 6" - Tr - 0.42

5457 D - 20" - 0.06 - 3.9 - 7.38

5458 D - 52" - Tr - 2.3 - 4.50

5459 D - 20" - 0.04 - 14.9 - 23.48

5460 D - 52" - 0.06 - 2.5 - 4.54

(DUPLICATE OF 5467 D and 5458 D AFTER TRENCH DEEPEMED.)

5464 D - 72" - Tr - 0.3 - 1.24

5466 D - 4" - 0.06 - 2.3 - 4.02

5465 D - 60" - Tr - 1.1 - 2.40

5463 D - 144" - Tr - 0.2 - 0.52

5461 D - 12" - 0.22 - 5.5 - 9.52

5462 D - 54" - 0.02 - 2.9 - 6.48

5467 D - 120" - 0.10 - 3.2 - 6.81

5468 - 24" QUARTZ - Tr - 1.7 - 3.77
