## Deer Home No. 2 Mine, Extension. R. Hamilton, Overman.

DEERHOME MINE Nº 2

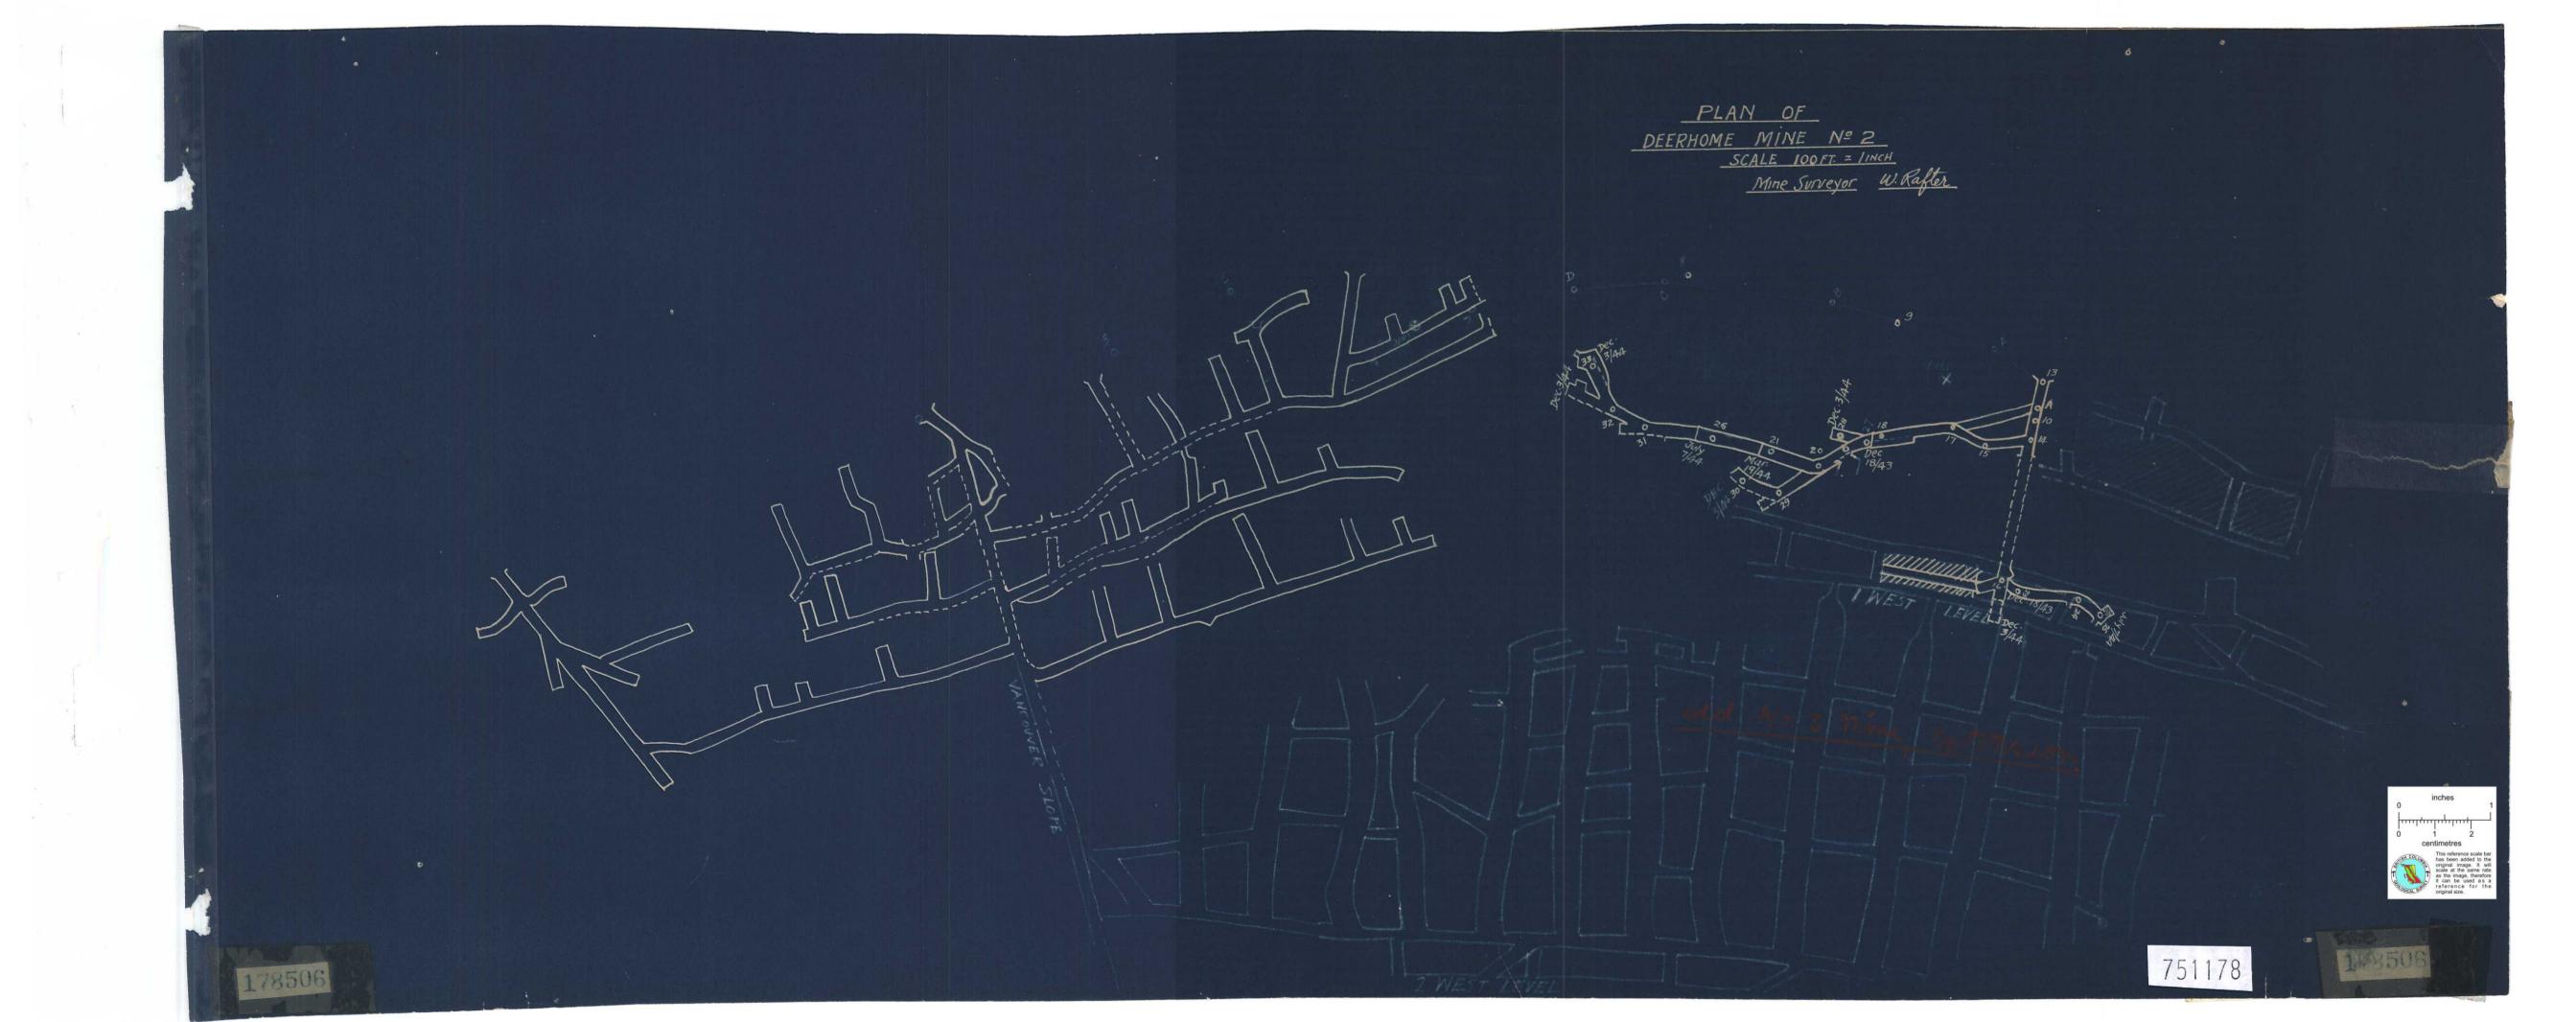
This mine was driven from the surface to contact the outcrop pillars left in when the old No.3 Extension Mine was abandoned in this area. As you will note from the plan, contact was made with the seam a short distance from the surface but this proved to be a comparatively narrow strip of coal left in to protect the surface from breaking and prevent water from entering the workings in the early days. The main slope, for the most part, has been driven through the old gob and had just contacted some top coal again at my last inspection on January 10th. The level to the right of the main slope is now retreating as it was found impossible to make contact with the workings of the old vancouver Slope ddue to the badly caved condition of the old gob. All water drains away to the low side and eventually makes its way to the old Extension main tunnel and thence to the surface at the village of Extension. The workings in the above mine have been in contact at one point or another with the old gob at all times.
