WEST MIN

Aug. 27/89
Sunny 25°C

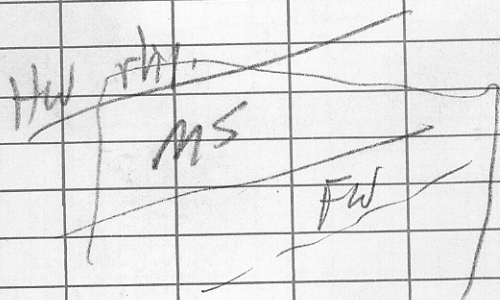
PHOTOS M.S. + FW on schist
(+ copy 'stringers') - contact
~22 Level 5368 slope
+ Tennantite (?) in FW

PHOTO - 'Fixing' loose back in
HW
