May 25, 2005

**Nanaimo Lakes Property**  
**Progress Report**

**KONIGSBERG EXPLORATIONS INC.**  
**NANAIMO LAKES PROPERTY**  
 NANAIMO MINING DIVISION

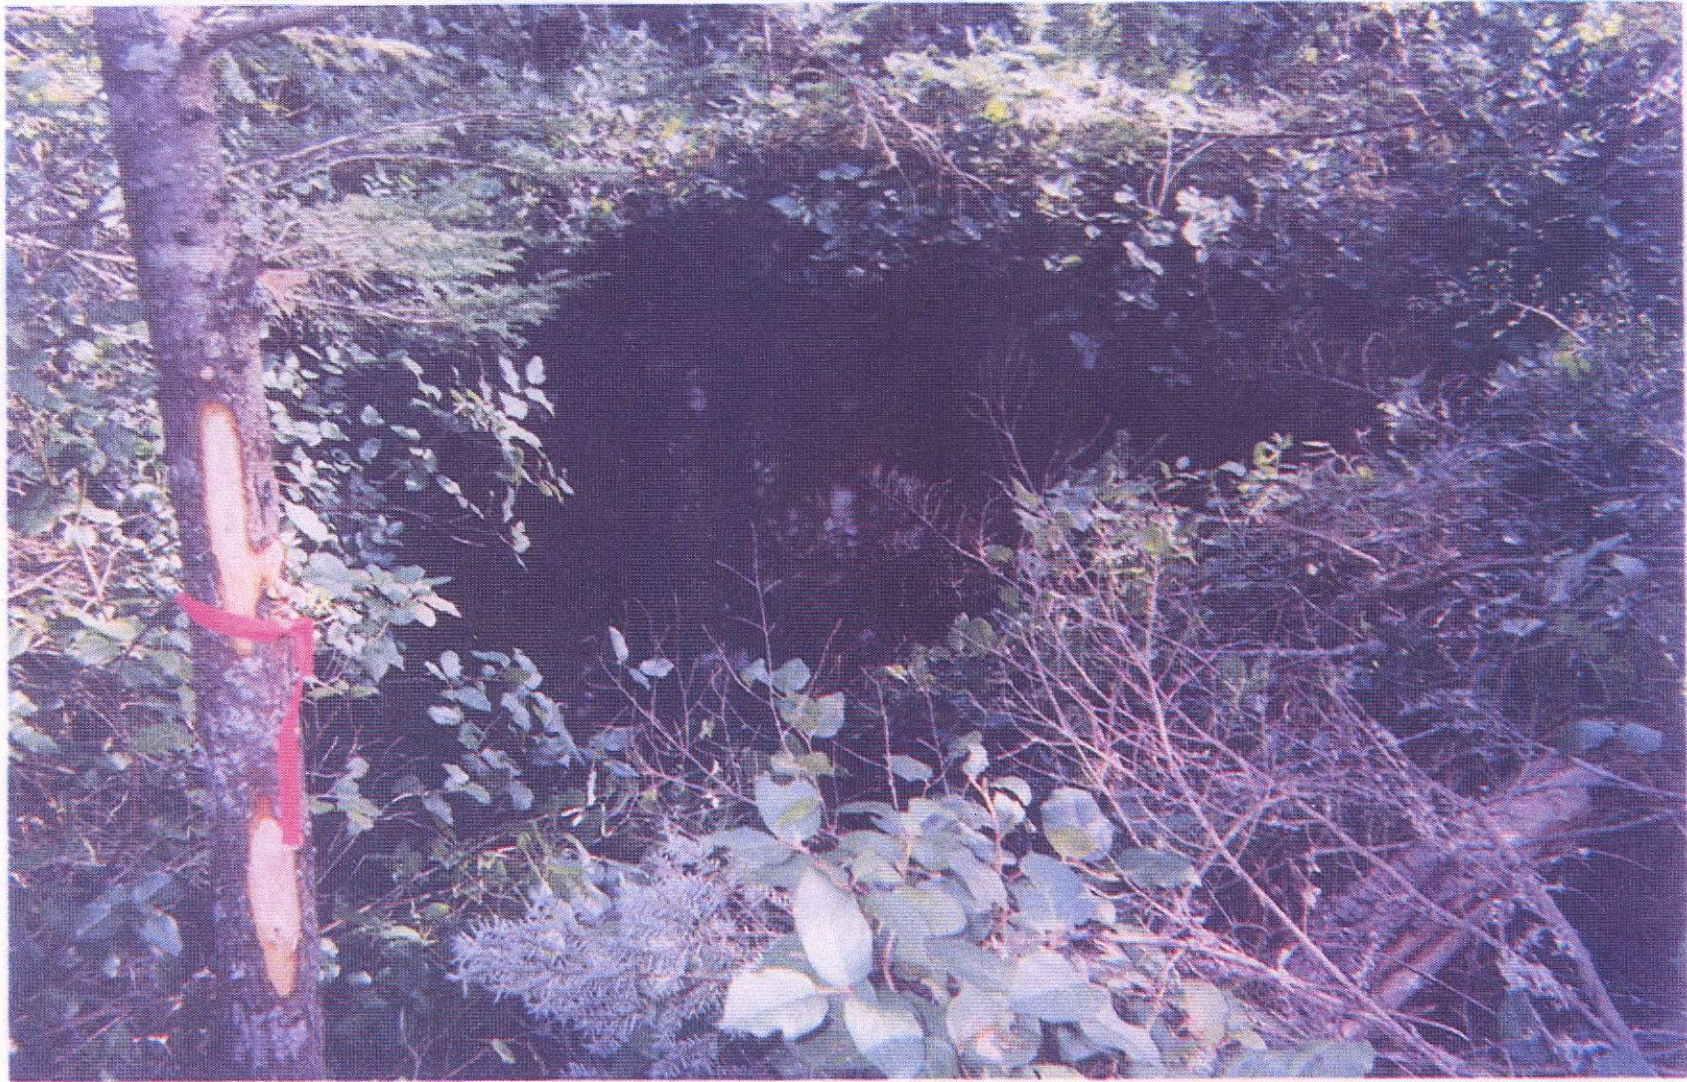
Nanaimo Lakes Property – Test Pit

Relocation of showings on the Nanaimo Lakes 1 and 2 claims proved difficult due to thick new growth of vegetation and underbrush; however one pit containing a strong quartz vein some six feet in width was found (see photos). The vein strikes to the northwest and dips vertically. Five samples were collected from the vein structure as listed below.

<u>Sample No</u>	<u>Type</u>	<u>Copper %</u>	<u>Au Oz/ton</u>
NL 1	Grab	0.19	<0.06
NL 2	Grab	0.04	<0.06
NL 3	Grab	0.19	<0.06
NL 4	Grab	0.01	<0.06
NL 5	Grab	Trace	<0.06

The quartz vein structure intrudes Upper triassic Vancouver Group basaltic rocks.

Initial exploration has indicated the presence of copper and low gold values with minor silver credits. It is recommended that additional prospecting be carried out in order to locate the other known reported showing on the Nanaimo Lakes claims, as well as further trenching and sampling of the quartz vein structure along strike as part of the Phase II recommended program in my report of November 20, 2004.

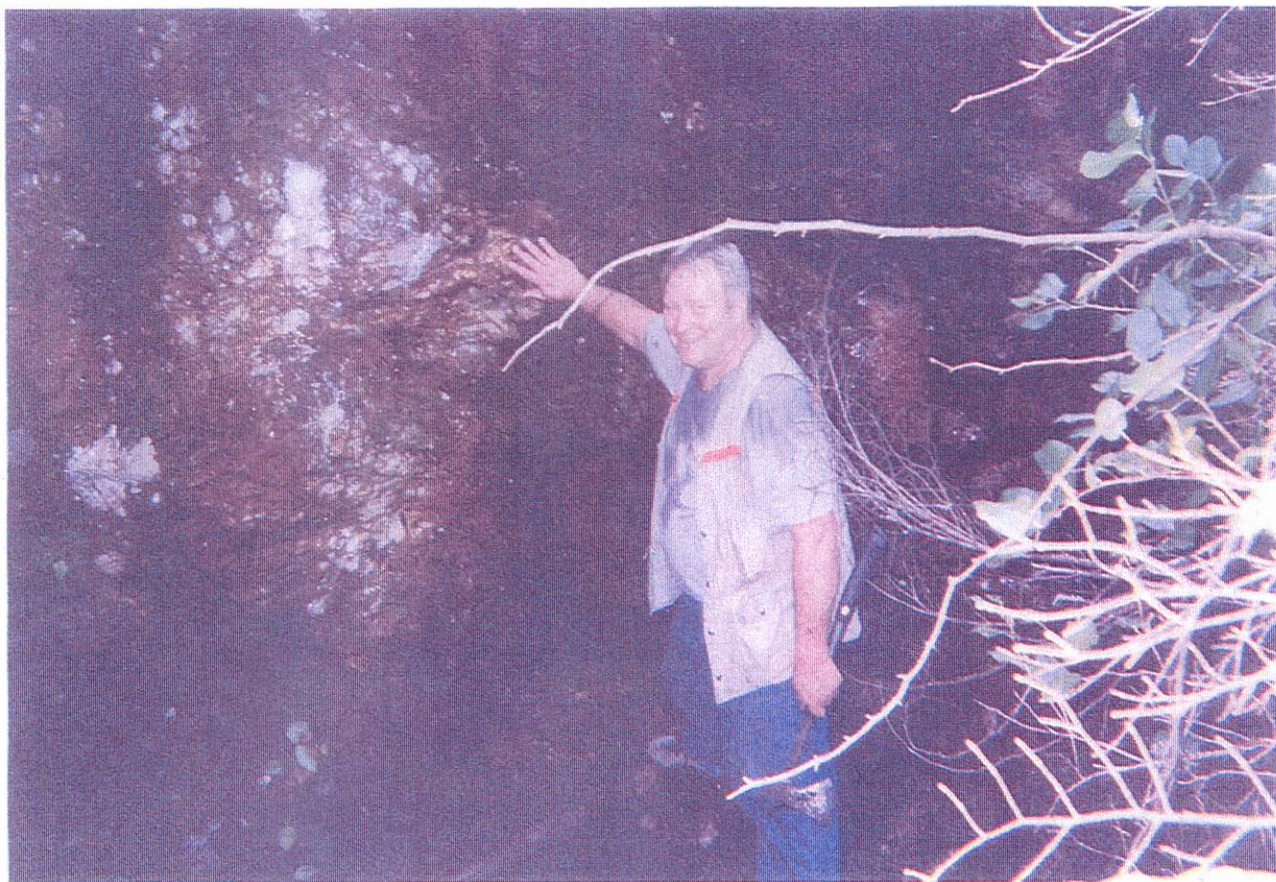
**Quartz Vein Structure – Test Pit**

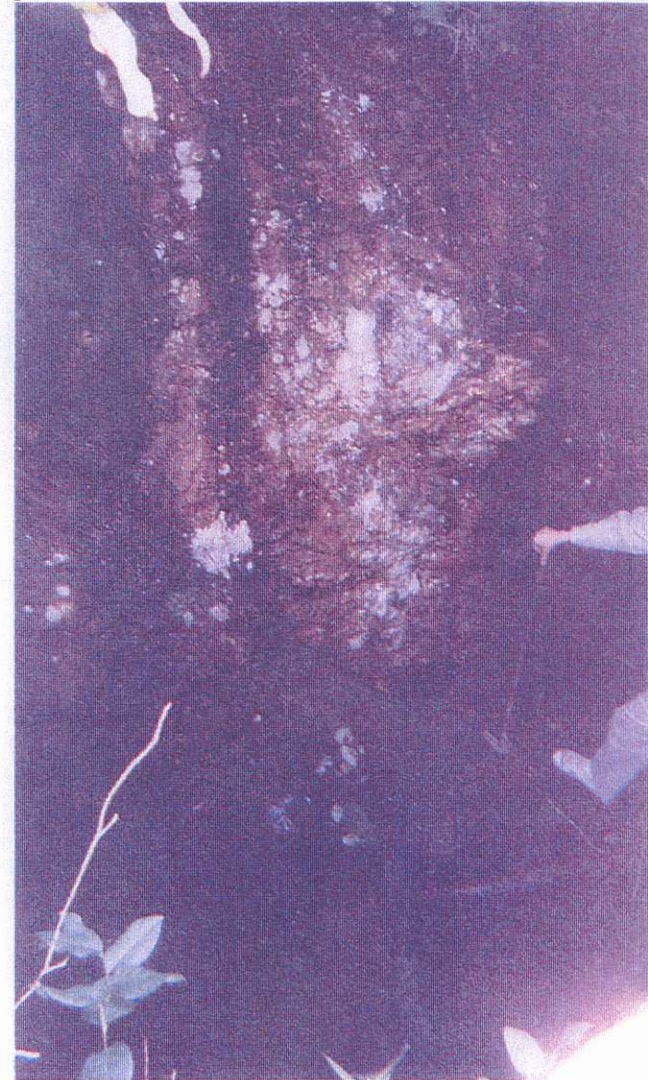
**Quartz Vein Structure Nanaimo Lake Claims**
