JA Drilling Pattern
Late Summer 1972

Bedrock geology - plan view
Interp. #1

Geology Interp. #2

Geology
Faulted Model

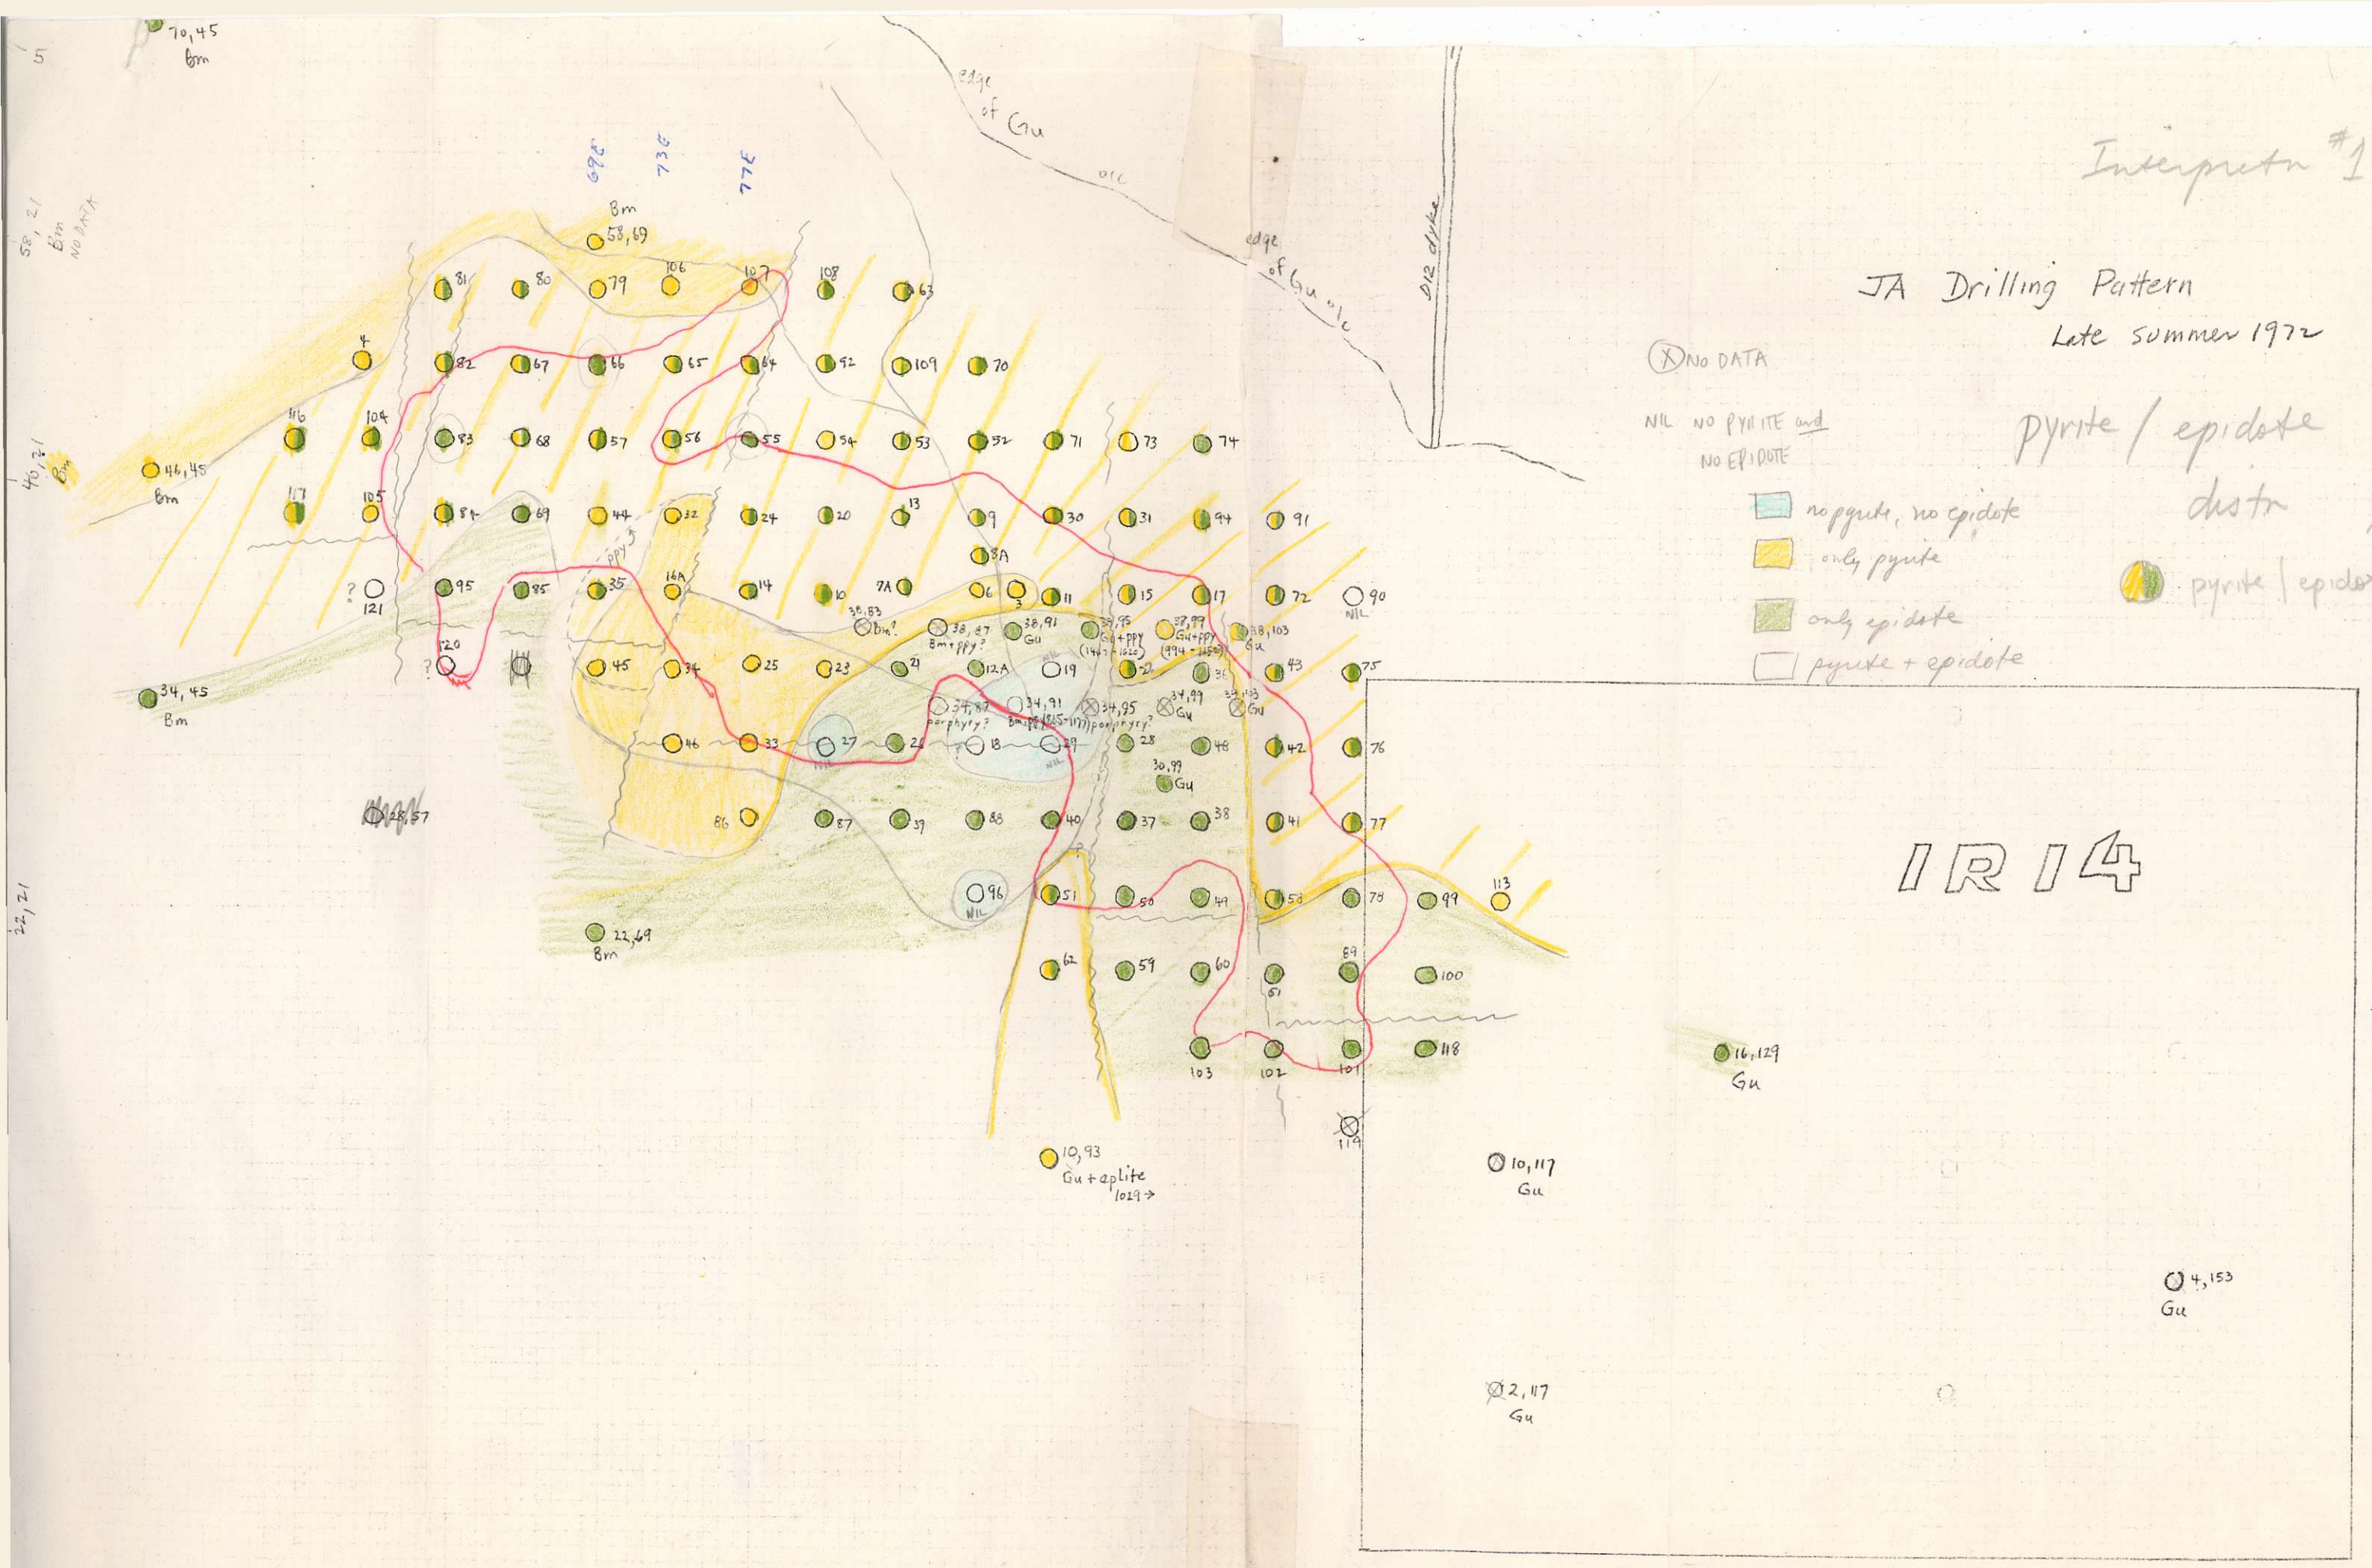
pyrite / epidote
distr

- no pyrite, no epidote
- only pyrite
- only epidote
- pyrite + epidote

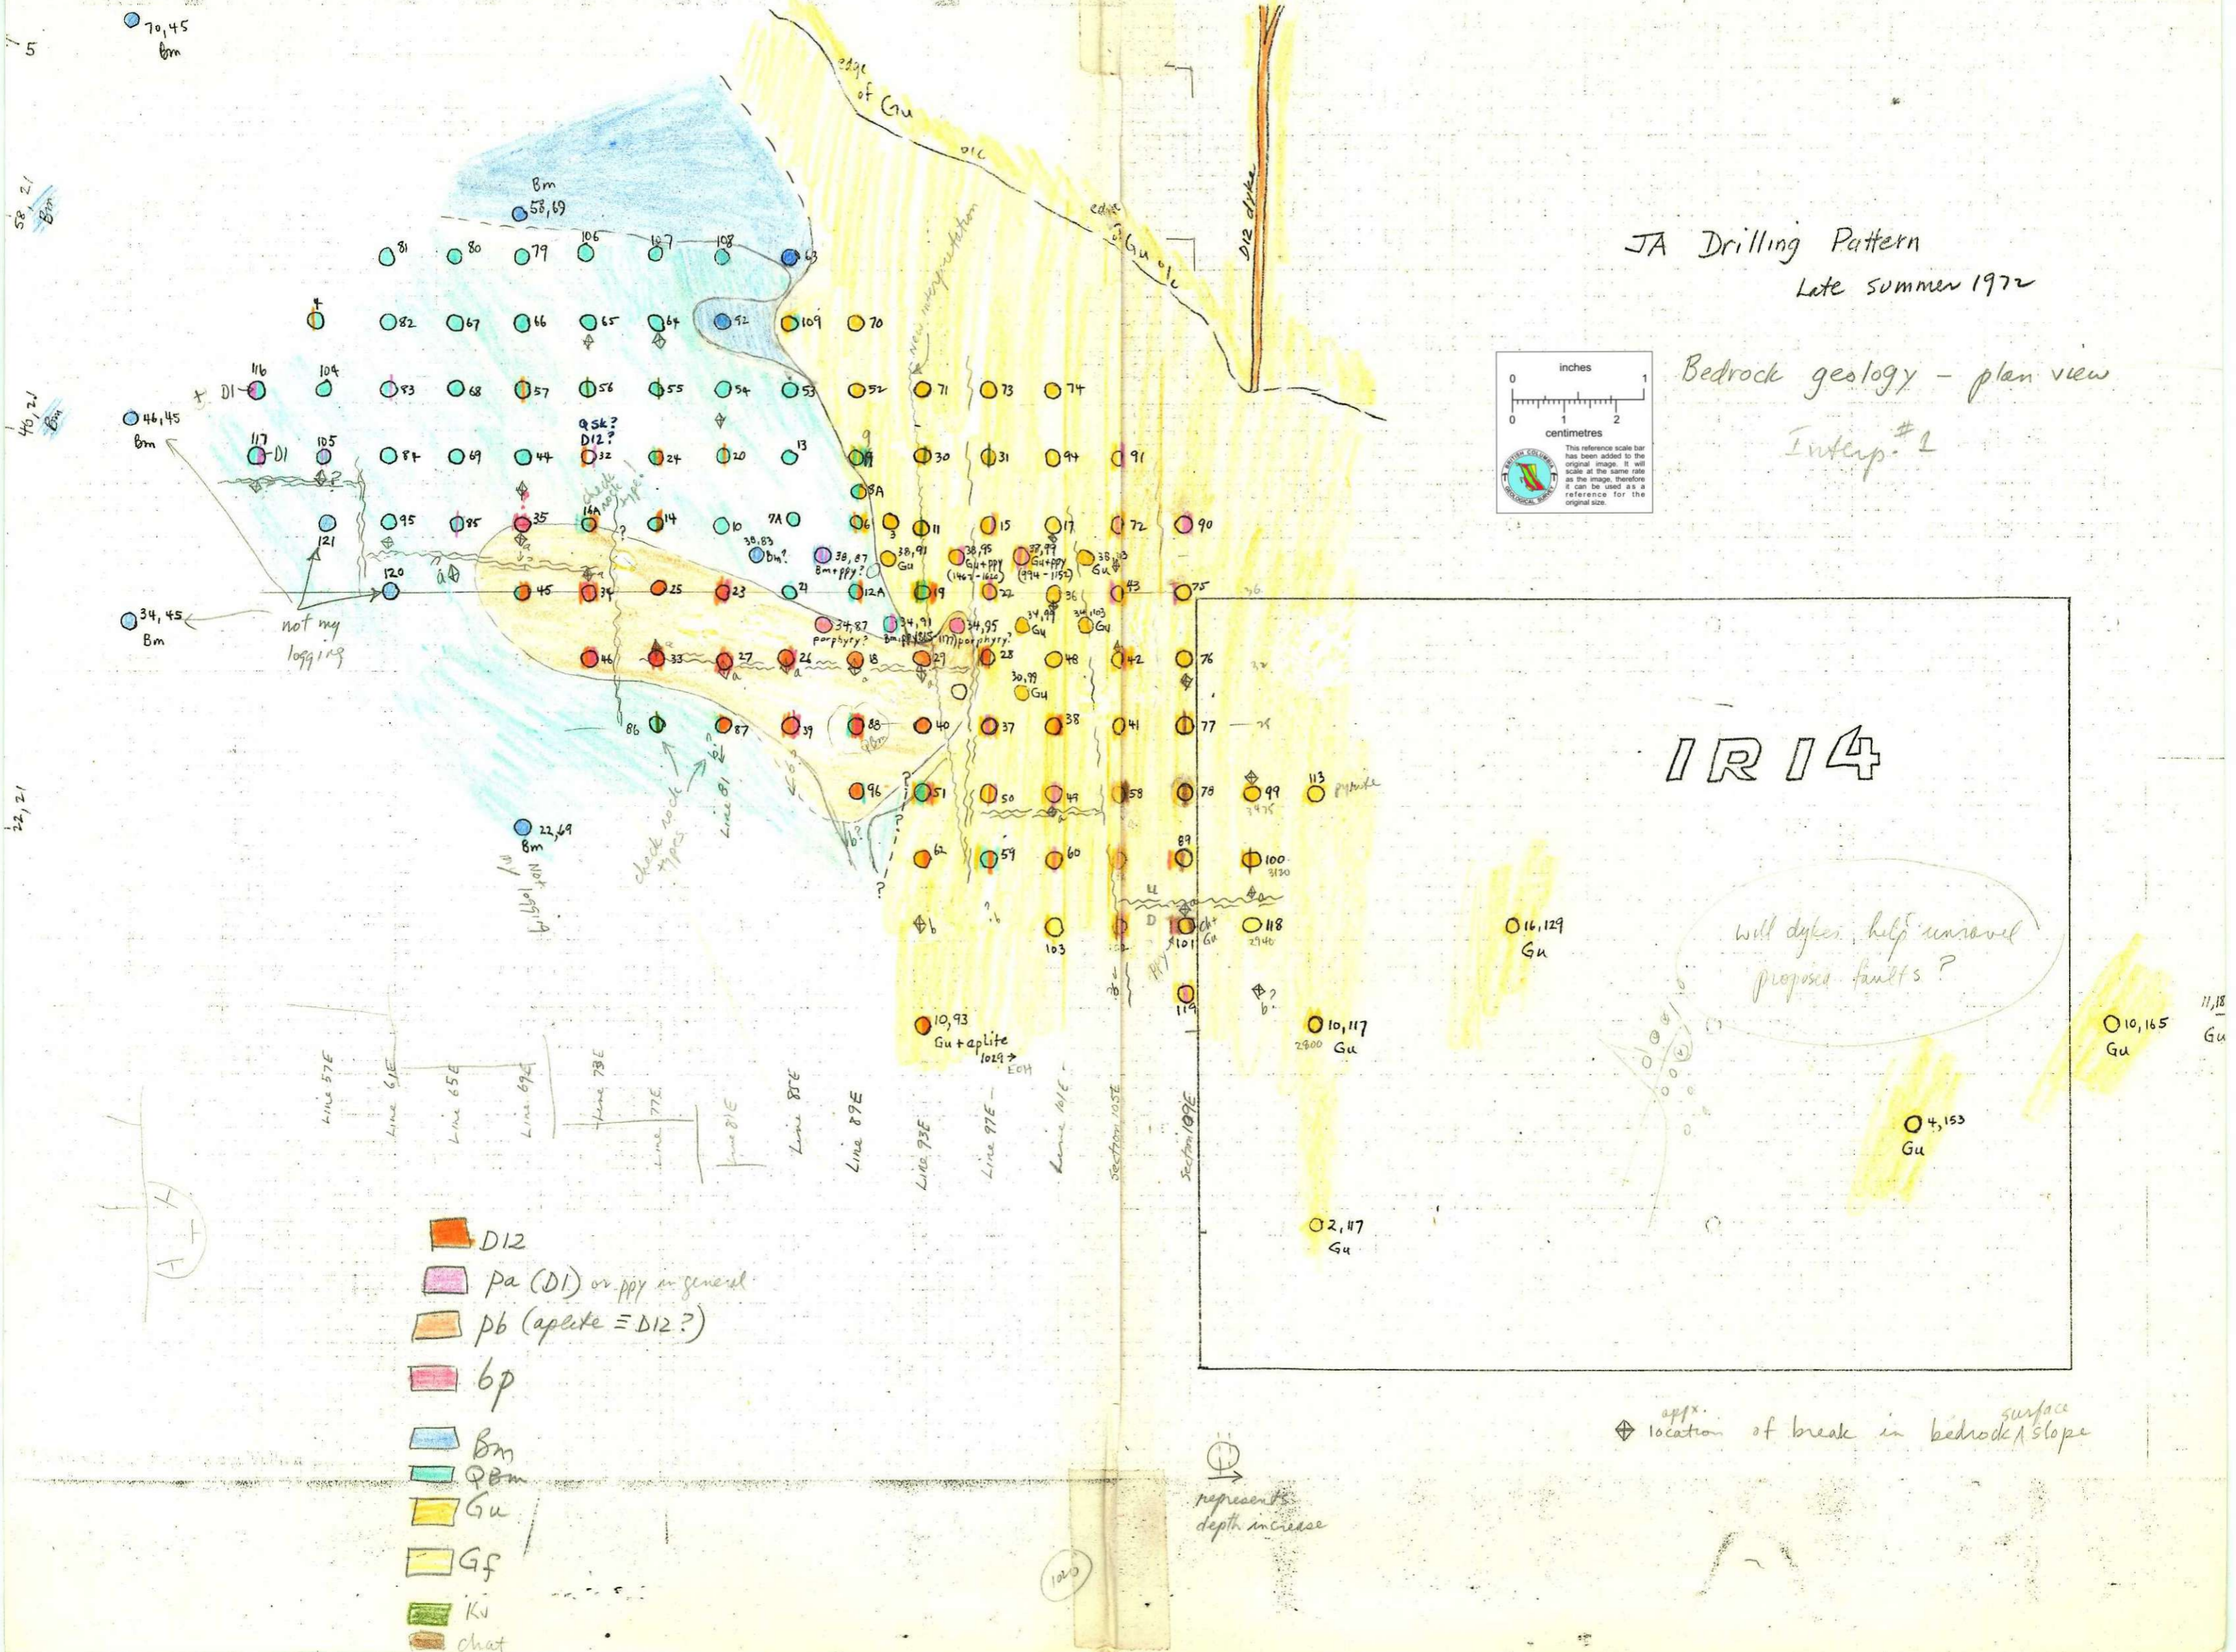
will dykes help unravel proposed faults?

represents depth increase

approx. location of break in bedrock surface

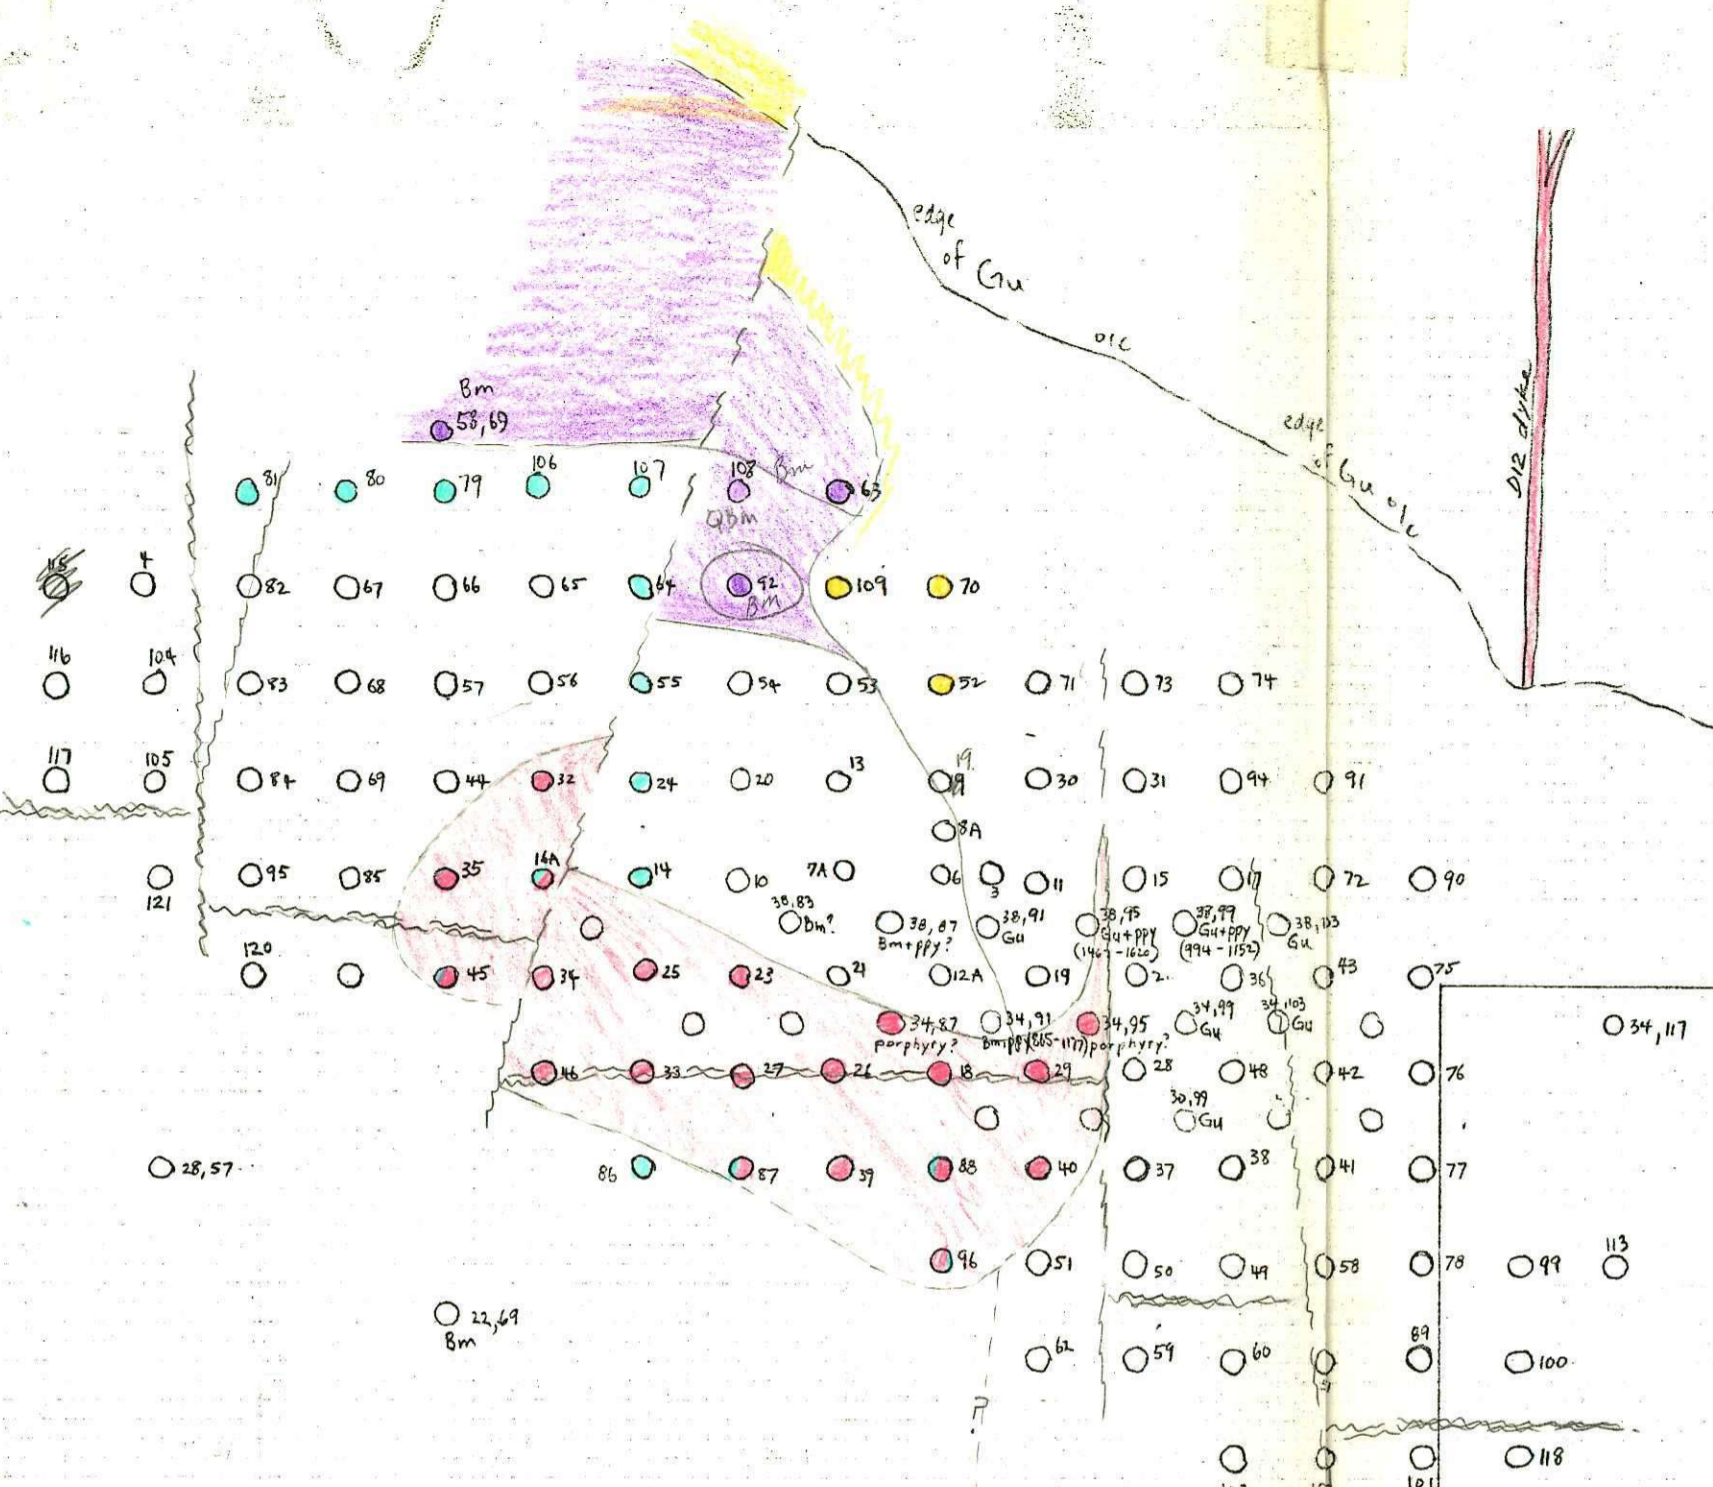
* faults changed - reinterpret.
needed locally
