East Jersey Pit - faults + ore

FIGURE 1
A generalized ore outline
Faults pattern on the 4840 bench of the
East Jersey pit, Bethlehem Copper Corporation
(reproduced by courtesy of the mine staff)

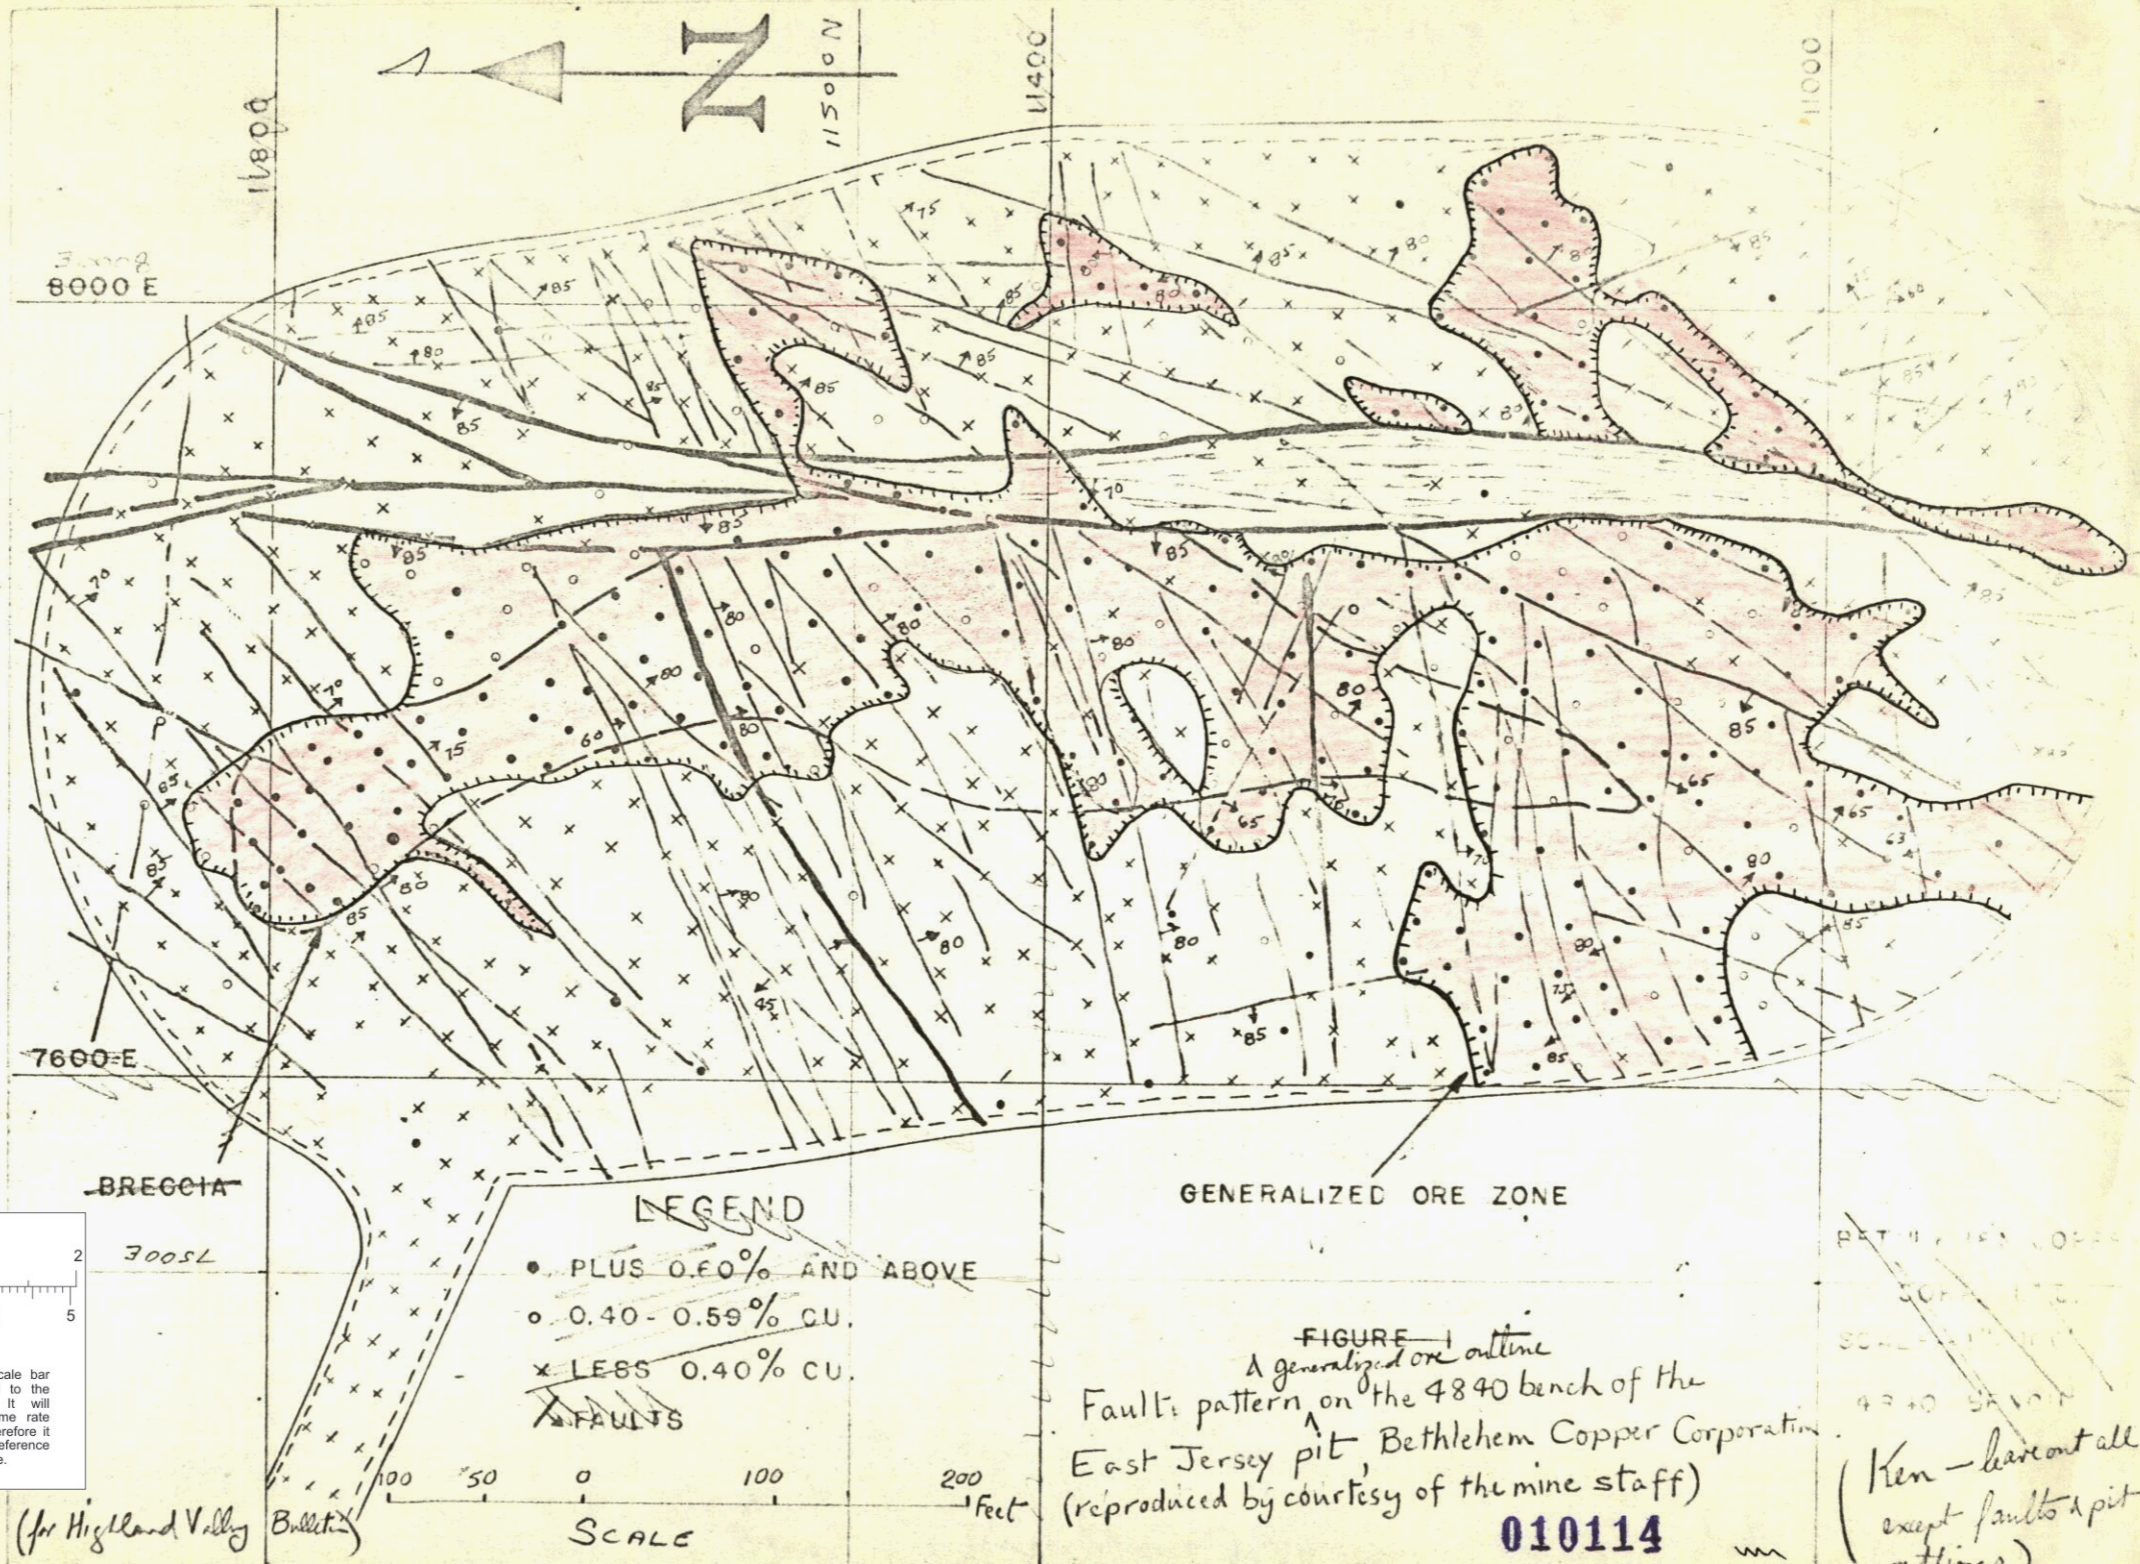
- LEGEND**
- PLUS 0.60% AND ABOVE
 - 0.40 - 0.59% CU.
 - × LESS 0.40% CU.
 - ▲ FAULTS

GENERALIZED ORE ZONE
